Eric the Viking – a restoration in many parts – April 2020

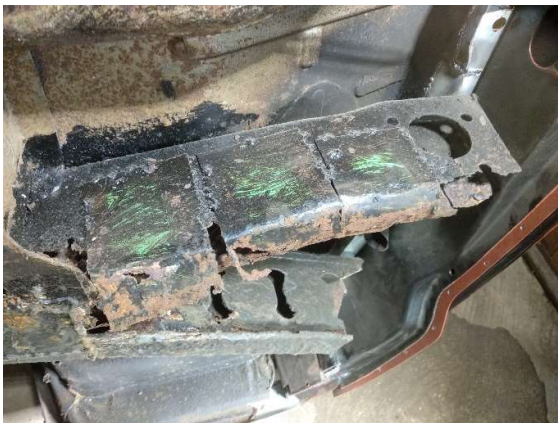
His passenger side pair were rotten on the bottom two inches of both chassis boxes that form most of the strength at the front. The picture shows a very badly patched inner box and where they join together had been patched without cutting out the previous rot and even that patch was rusted. Anything forward of the middle of the front wheels was pretty much toast. The outer of the two passenger side boxes can be purchased from the normal suppliers, but the inner one with the big circular hole in the “before” photos is not available – according to one supplier because “late Bays do not rot in that area”. Trust me, they do! I bought a straight box section from the same supplier, even though the original is shaped, and made a plan to chop it around to make my own.

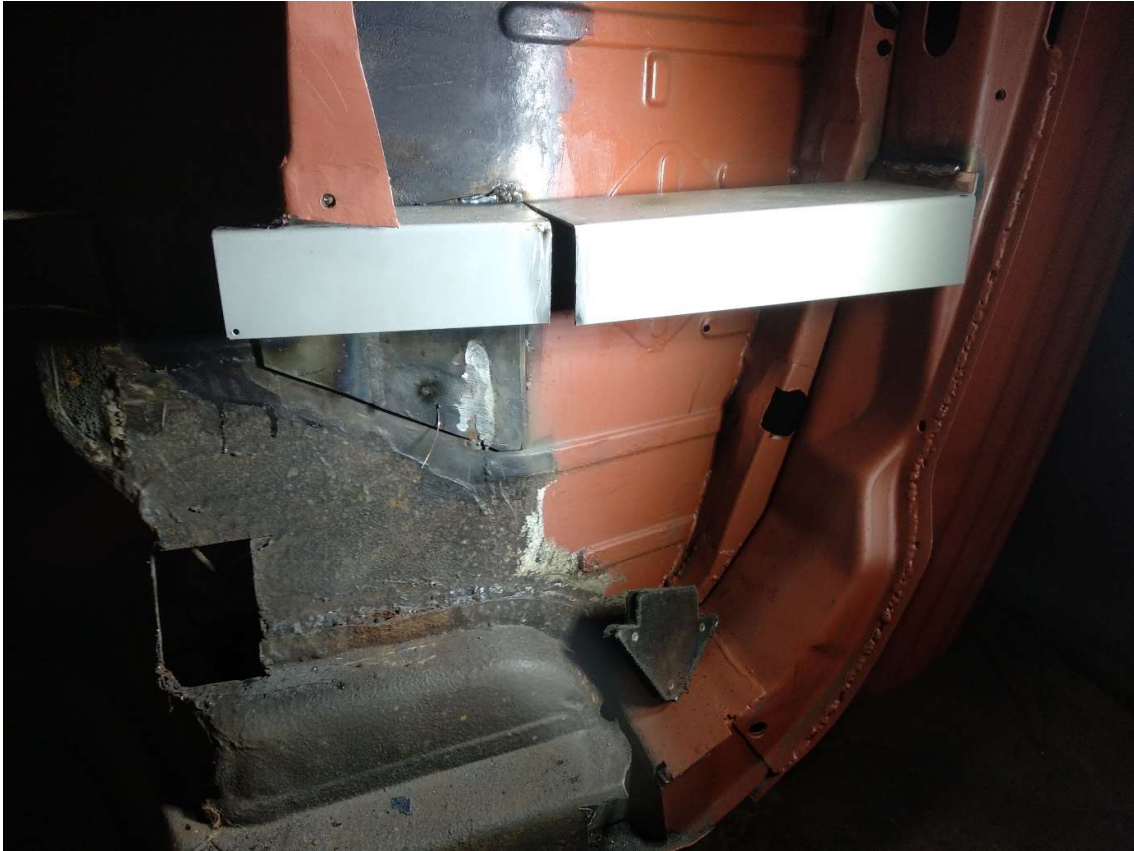
Straddling the two box sections on the passenger side over the top of the Y is a 2mm triangular plate of steel providing strength and rigidity to where the passenger puts their feet. That is visible with some rotten pieces taken out and the remainder now purple in the second photo where the Kerrust has done its magic. With the old chassis rails out and the whole area primed, it was time to start building up the new rails.
