Eric the Viking – a restoration in many parts – February 2019

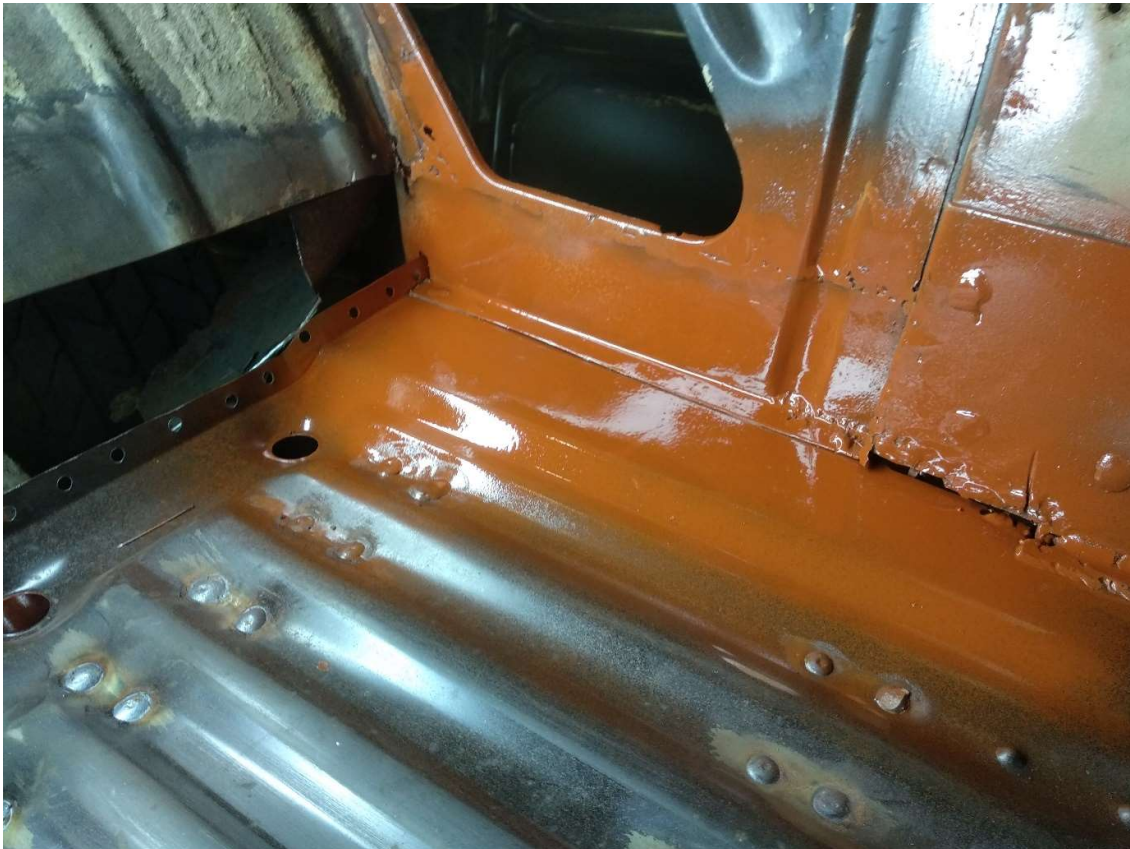
Starting with the one that was easiest to access by request of my back, just behind the sliding door, I took an empty pizza box and started back on the CAD once more – cardboard aided design. Sufficiently funny to use the acronym again! Then traced that to a flat piece of steel and shaped it before welding it in vertically in position.

The picture was taken after the first rust proofing paint coat went on, not the last! It isn't perfect, as I am still working out how to identify Eric's good metal from his bad. If I take off too little, I end up blowing holes in the extremely thin stuff. Once enough primer was down and the floor had its black

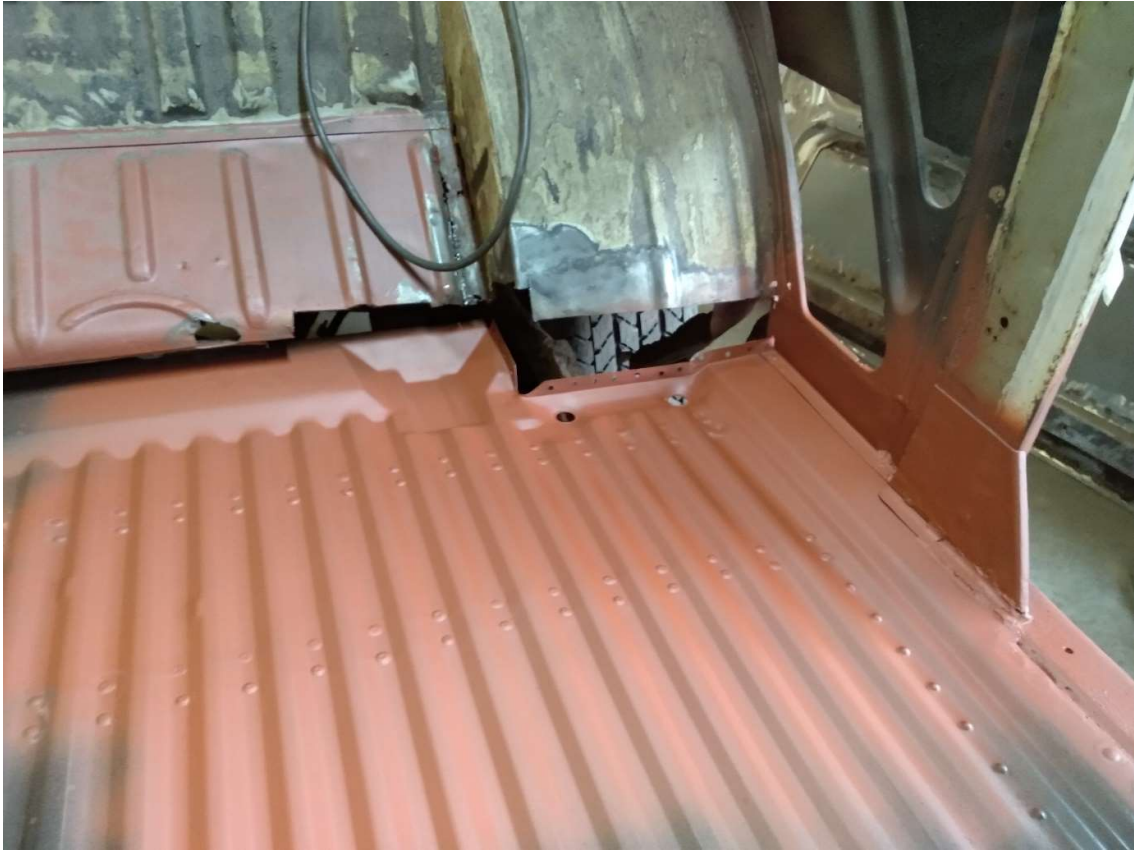
transit paint removed, you can see the missing metal that needs shaping and fitting, which sounds trivial!

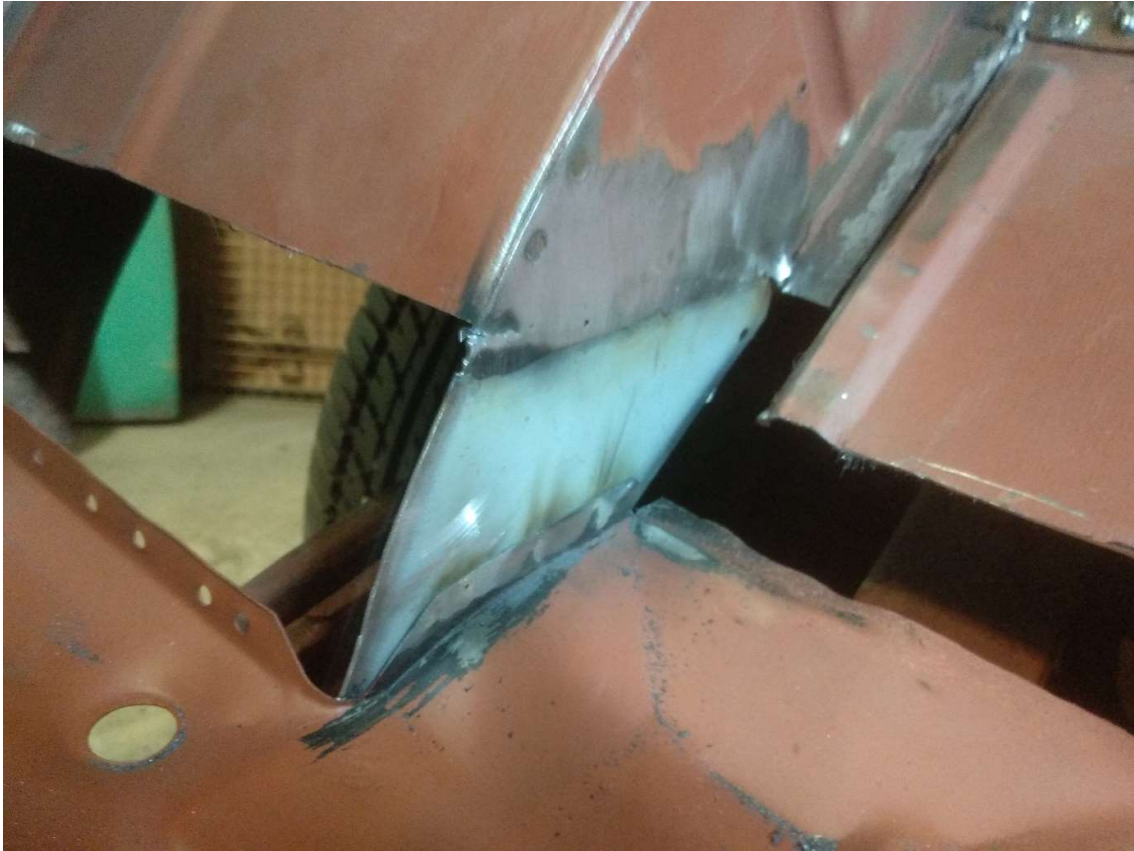
Offside rear wheelarch did not need shaping for the first piece, which makes things faster!

The difference in colour between the top original metal and the infill piece is the galvanized coating of the replacement steel, hopefully it will help the longevity of this high impact area. The top join is butt welded to keep it completely flat. The wheelarch then joins the floor where the floor is folded vertical and the two pieces were spot welded. MUCH faster than butt welding but not always possible. Now a complex piece:

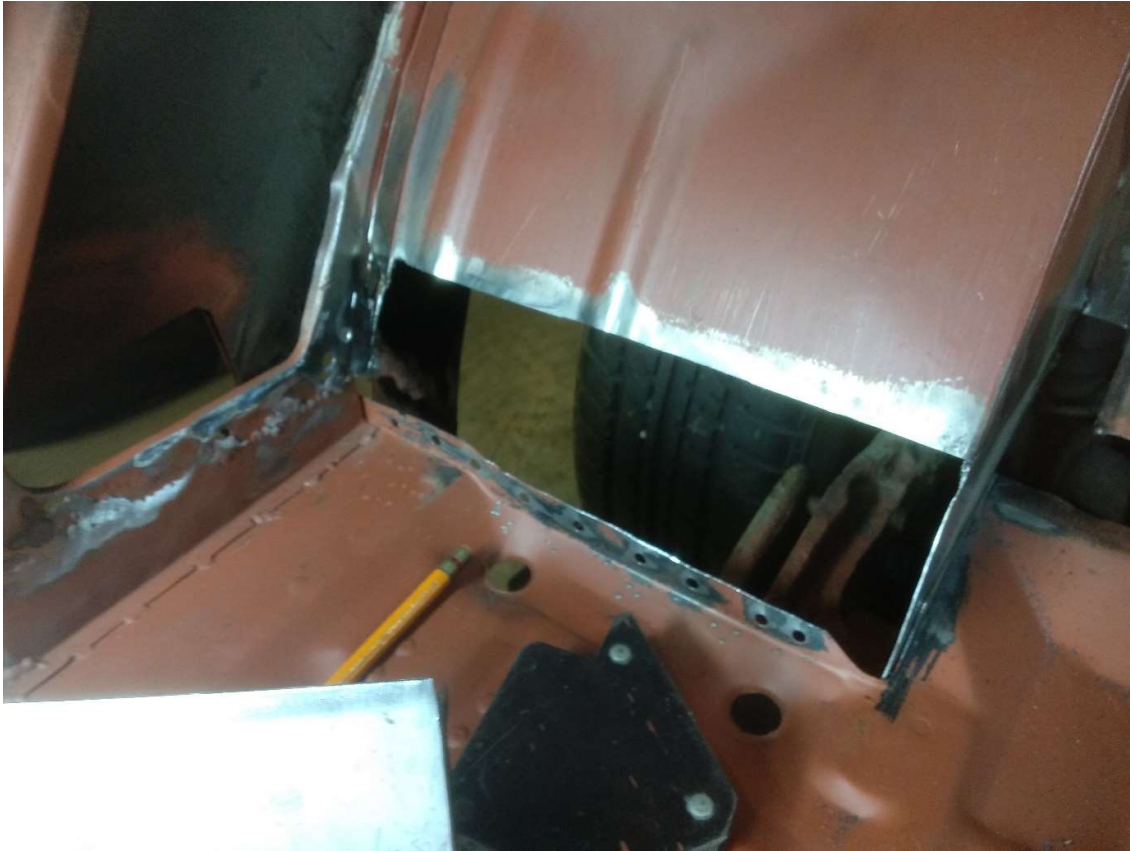
The front curve of the rear driver's side wheelarch. See the folded edge of the floor and the holes for the spot welds, that should not be too complex but how far under the floor do you go when you have no way of seeing the original? Then how far outside to go when the piece connecting to the outer (visible) wheelarch panel is also missing due to rust? Once those decisions are made, the new piece needs to curve as it goes upwards with folded flaps to join to the previously pictured piece and similarly at the other side and there needs to be those little strengthening dimples too.

Again, more pizza box cardboard was cut and shaped, laid flat on the Zintec steel, cut with an angle grinder cutting disk, final-shaped with some tin snips / steel cutting scissors and sanded to remove rough edges. Then put on the vice and the indentations made to get the dimples. Further details on shaping metal and the simple tools required are covered in the "Poor man's metal fabricating kit" web article that will be published on May 31<sup>st</sup> 2019 as I have so many other articles that I am trying to publish to help out you lovely lot!

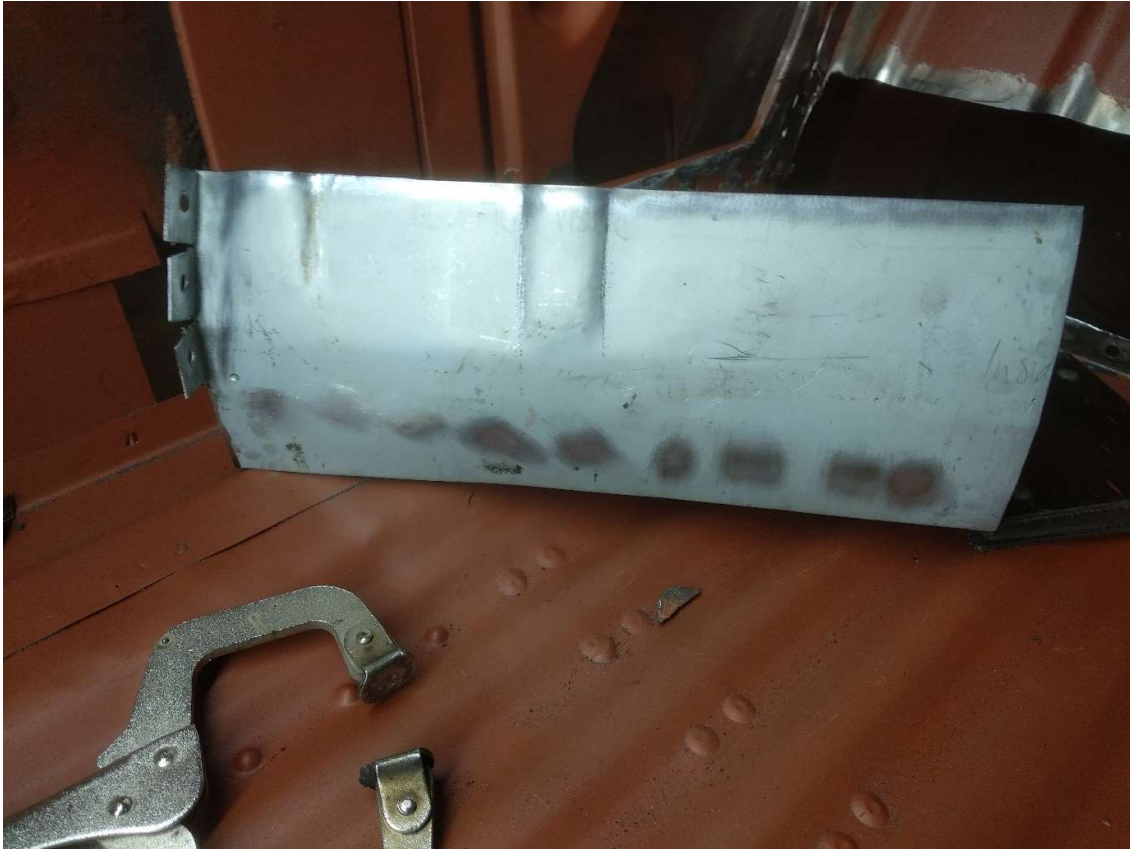
The fabricating of that piece probably took 90 minutes including the cardboard and the hammering of the dimples. Welding it in took similar as the top was butt welded since the original would have been a continuous run of metal all the way down and butt welding needs to go slowly due to heat build up and then needs grinding. Once ground back, I then put a light on the far side, in this case inside the wheelarch, and look for pinholes in the join and weld those up before applying some paint. Turned out nice again (nod to George Formby who I hope will be heard at a club camp again this year, much

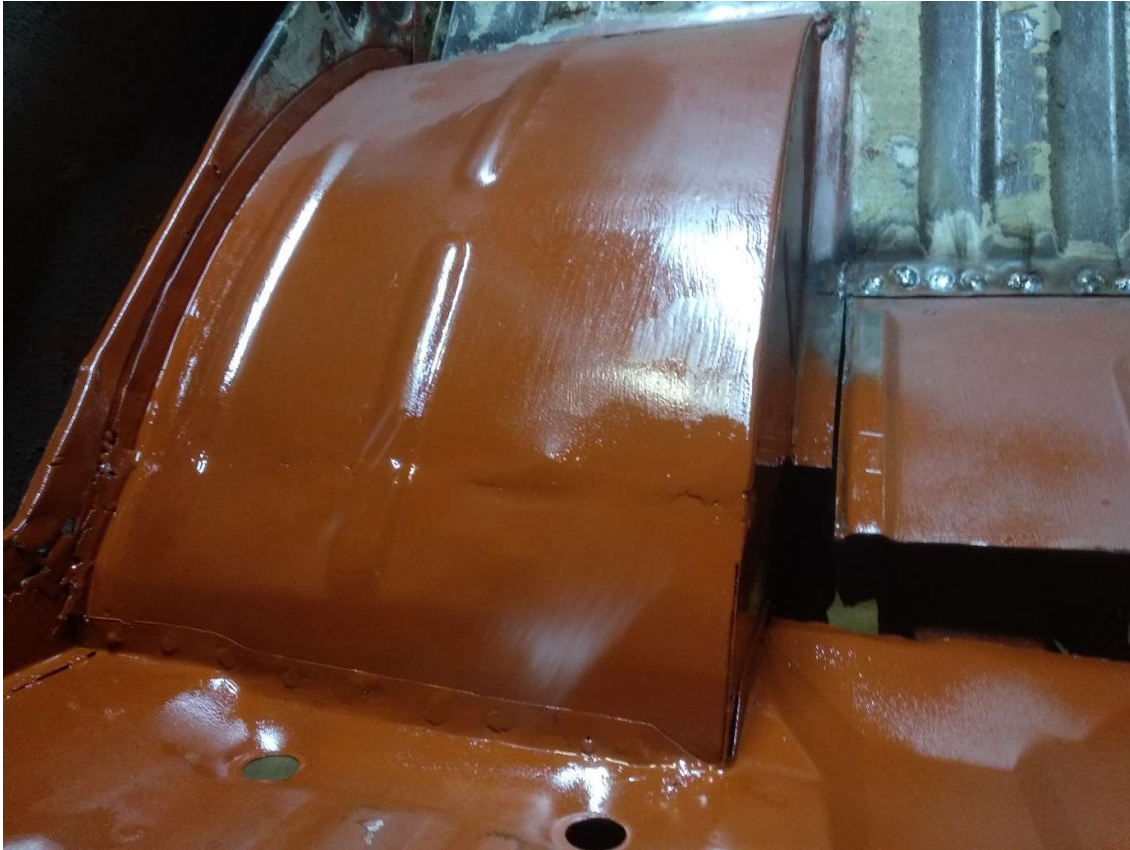
About 8 more hours sorted the passenger side in two pieces. Yes, I will sort out the glob of weld at the right of that curved wheelarch in due course! The primer is covering the spot welds where it joins to the floor and will be ground back but I was going to be busy working and entertaining for a week and I wanted to keep the air away.

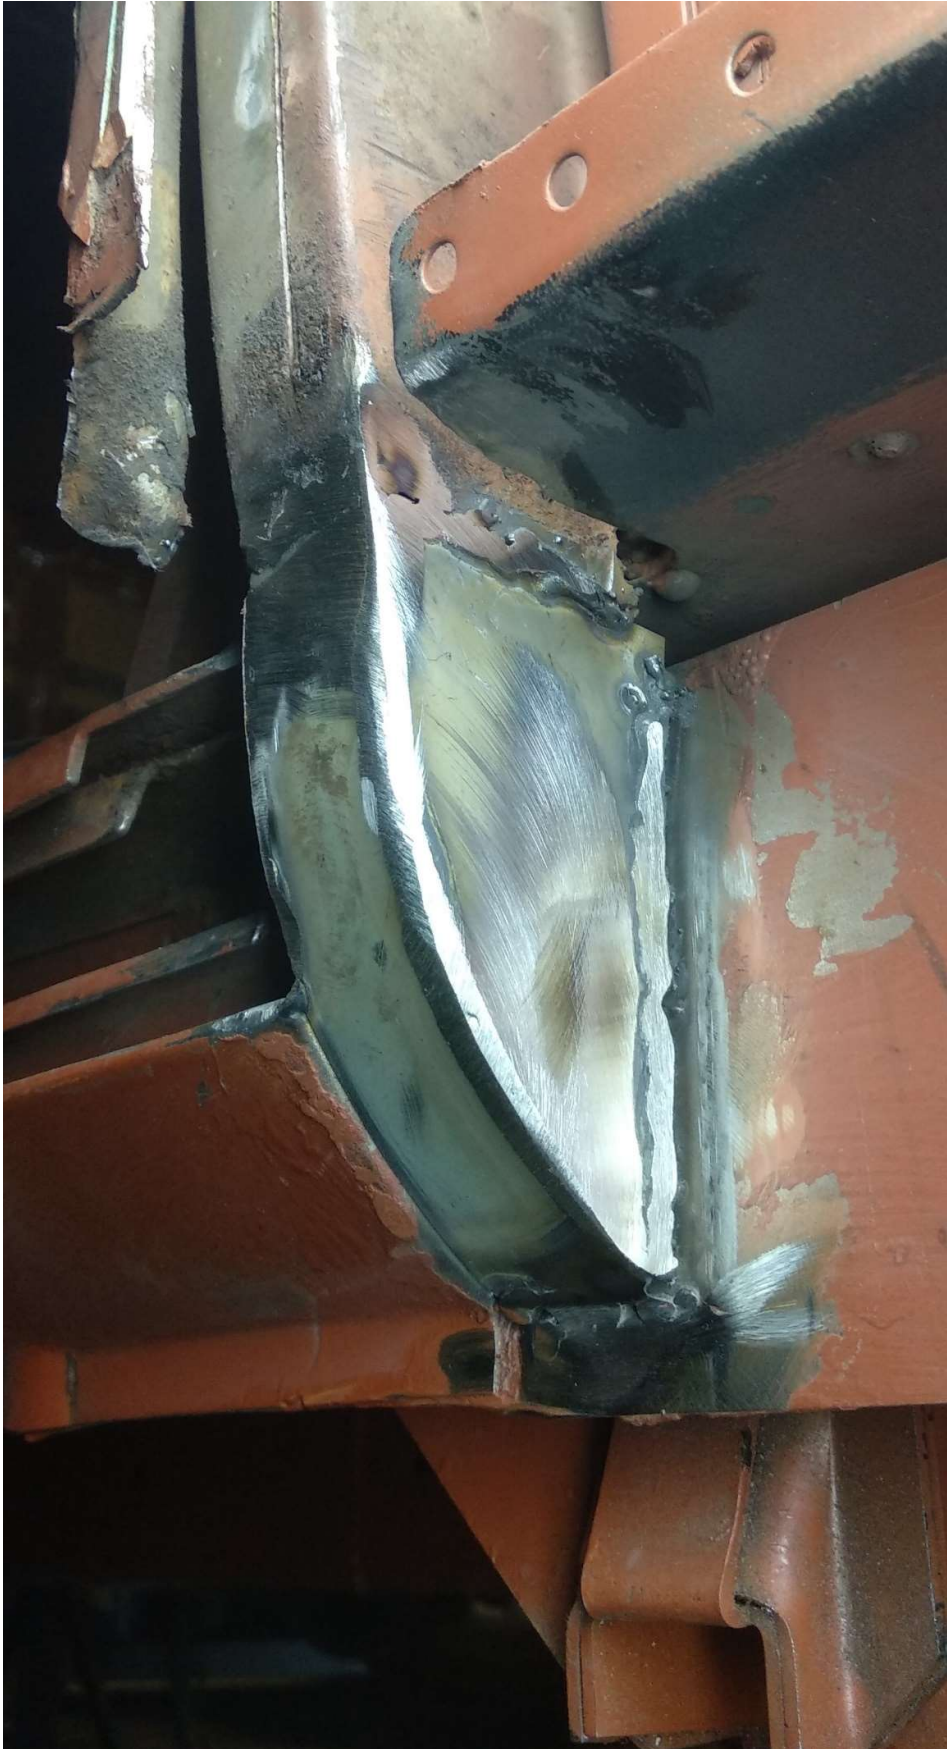
I knew that the C-post that separates the sliding door from the rear window was good down to nearly floor level and was entirely missing below that where it needs to join solidly to the middle sill. This is a structural piece and needs to be strong. Two pieces of roughly quarter circles were welded in and a cover bent around their outside was added. Very pleased with the results!

Until I remembered that I need to put the outer visible panel on there and I'm not sure it will fit over that one. Oops. Because this is new steel, I should be able to use a cutting disk to reshape the quarter circles to something smaller, which will cut off the cover. Once trimmed, a new cover can be cut, shaped and welded in.

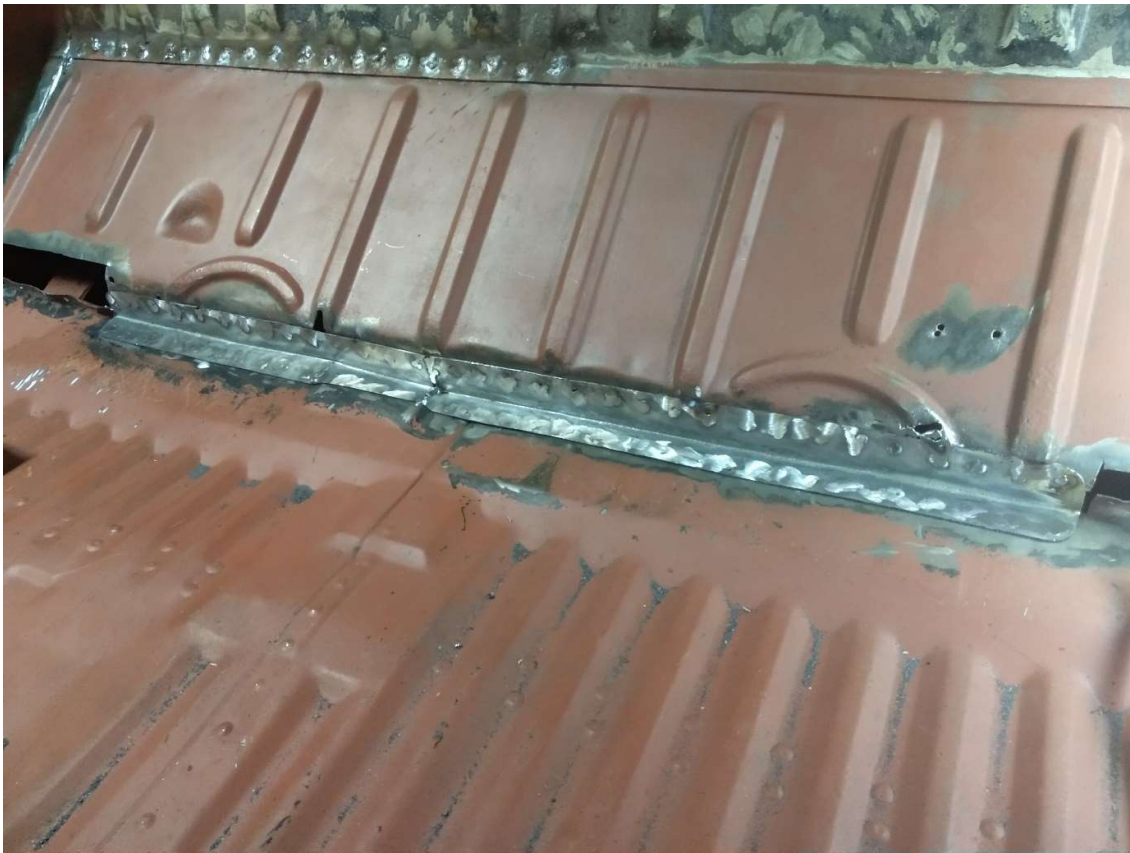
Finally managed to be fit enough for the work in between the wheelarches. This was a mess of rot and is still not fully complete but at least the main strength has been added joining that panel that has been floating for two years onto the new floor. You cannot get access underneath to weld as per the original and there are 3 main ways to achieve a similar result.

Not exactly pretty or original but it will be strong and once covered in primer, top coat (white), a wooden floor and a rock n roll bed, it should not be much of an issue.

Next jobs are to finish the far left of the last picture to join that panel to the offside wheelarch, finish any final detailing and celebrate the inside cargo floor completion. Spring is coming, much planning of events with the club and excitement about making progress on Eric. See you next time!
