Eric the Viking – a restoration in many parts – June 2023

Eric the Viking – a restoration in many parts – August 2023

Eric the Viking – a restoration in many parts – December 2023

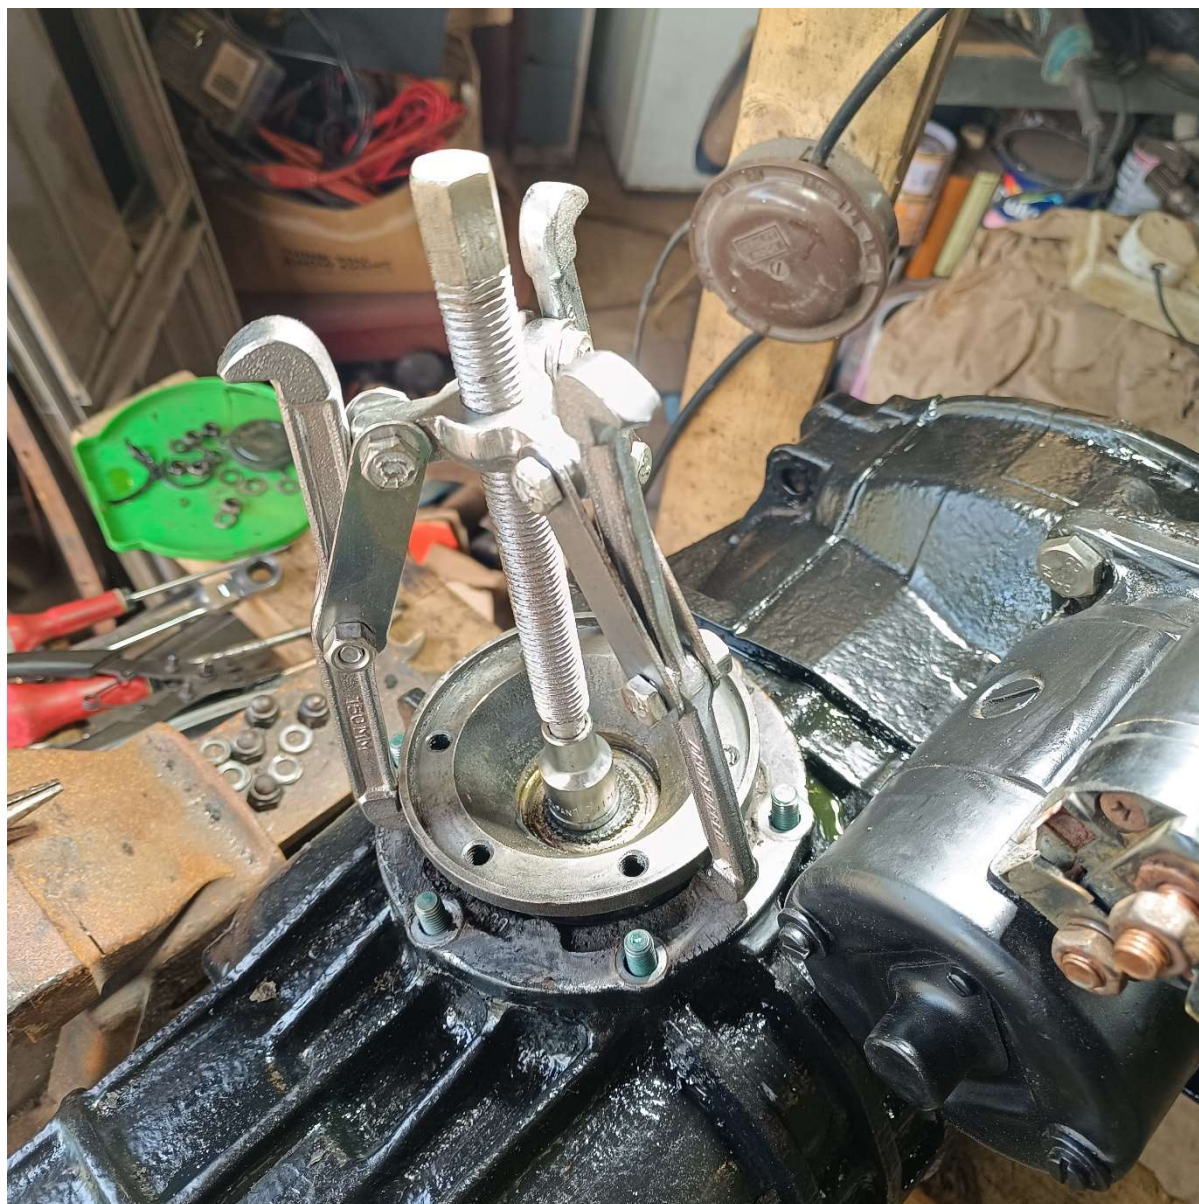
First, the easy job. Having mostly cleaned the outside of the gearbox last year, I did a final clean, then anti rust paint mainly as a habit. On top of that was primer and my preferred top coat of John Deere black paint. I also took the opportunity to take out the ends of the driveshaft section and clean behind, changed the gearbox oil and degrease the inside of the bell housing. As a word of warning – do not empty the oil from the gearbox until you can verify that the filler plug can be removed! With the gearbox on the bench, I also removed the

nose under guidance from the restoration manual and changed the gasket there that had perished and cleaned the “hockey stick” that operates the gears.

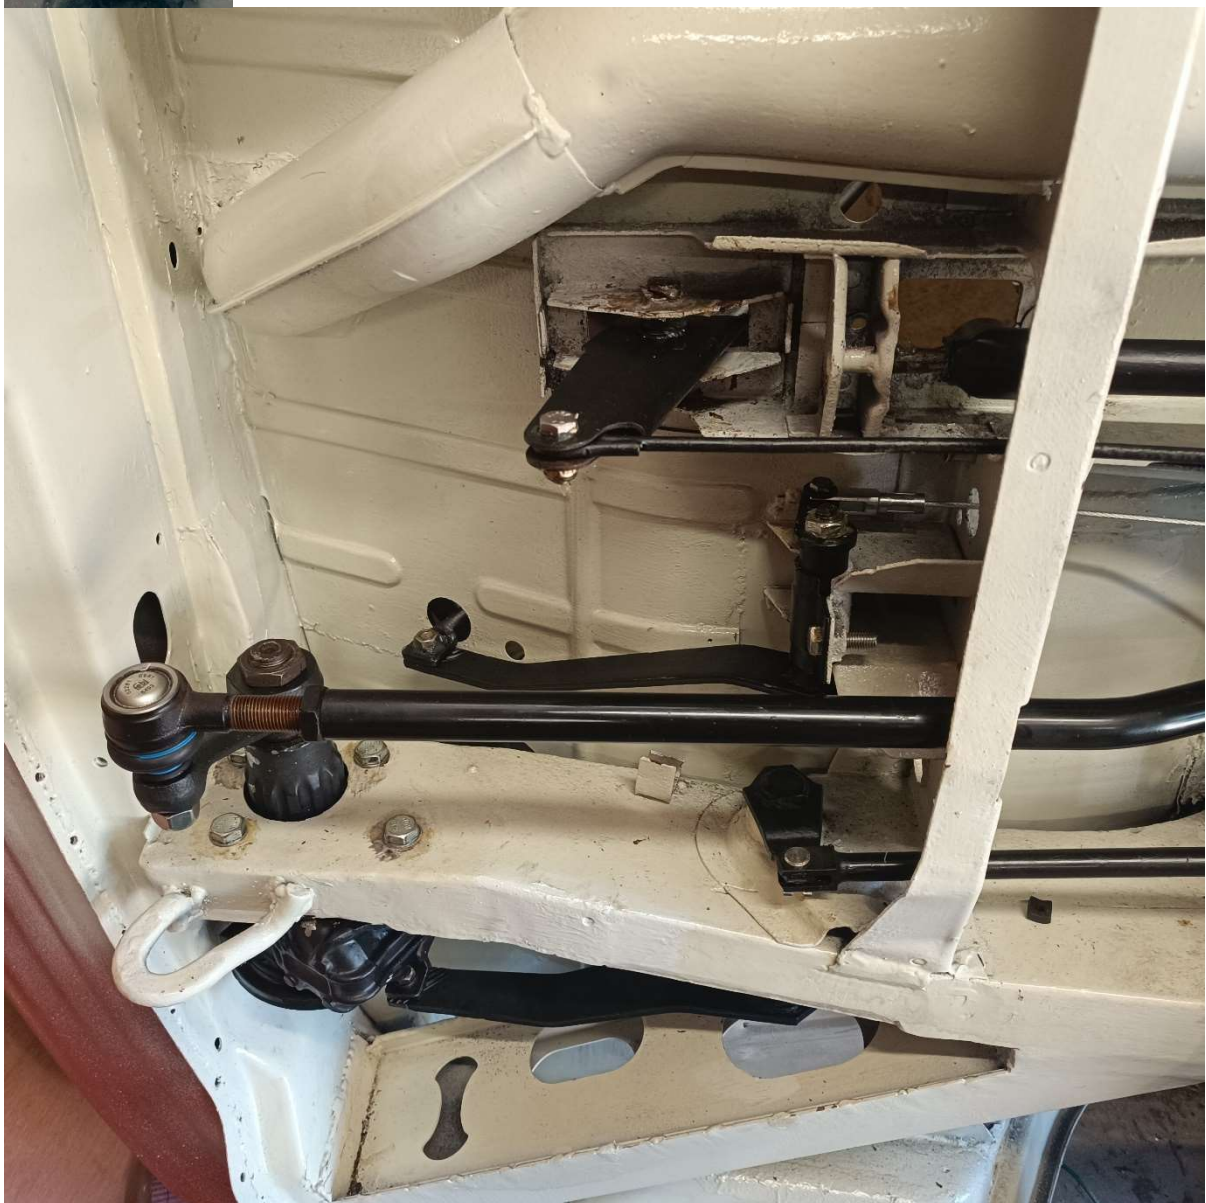
The steering box was leaking on reinstallation but this was caused by the bung on the filler hole having a perished O-ring.

Next up were the pedals. With the underside all painted, I was able to install the steering box, drag link (steering box to beam pole), handbrake arm, brake pedal and clutch pedal. All were carefully cleaned back to bare metal then anti-rust paint, primed and top coated in black again.

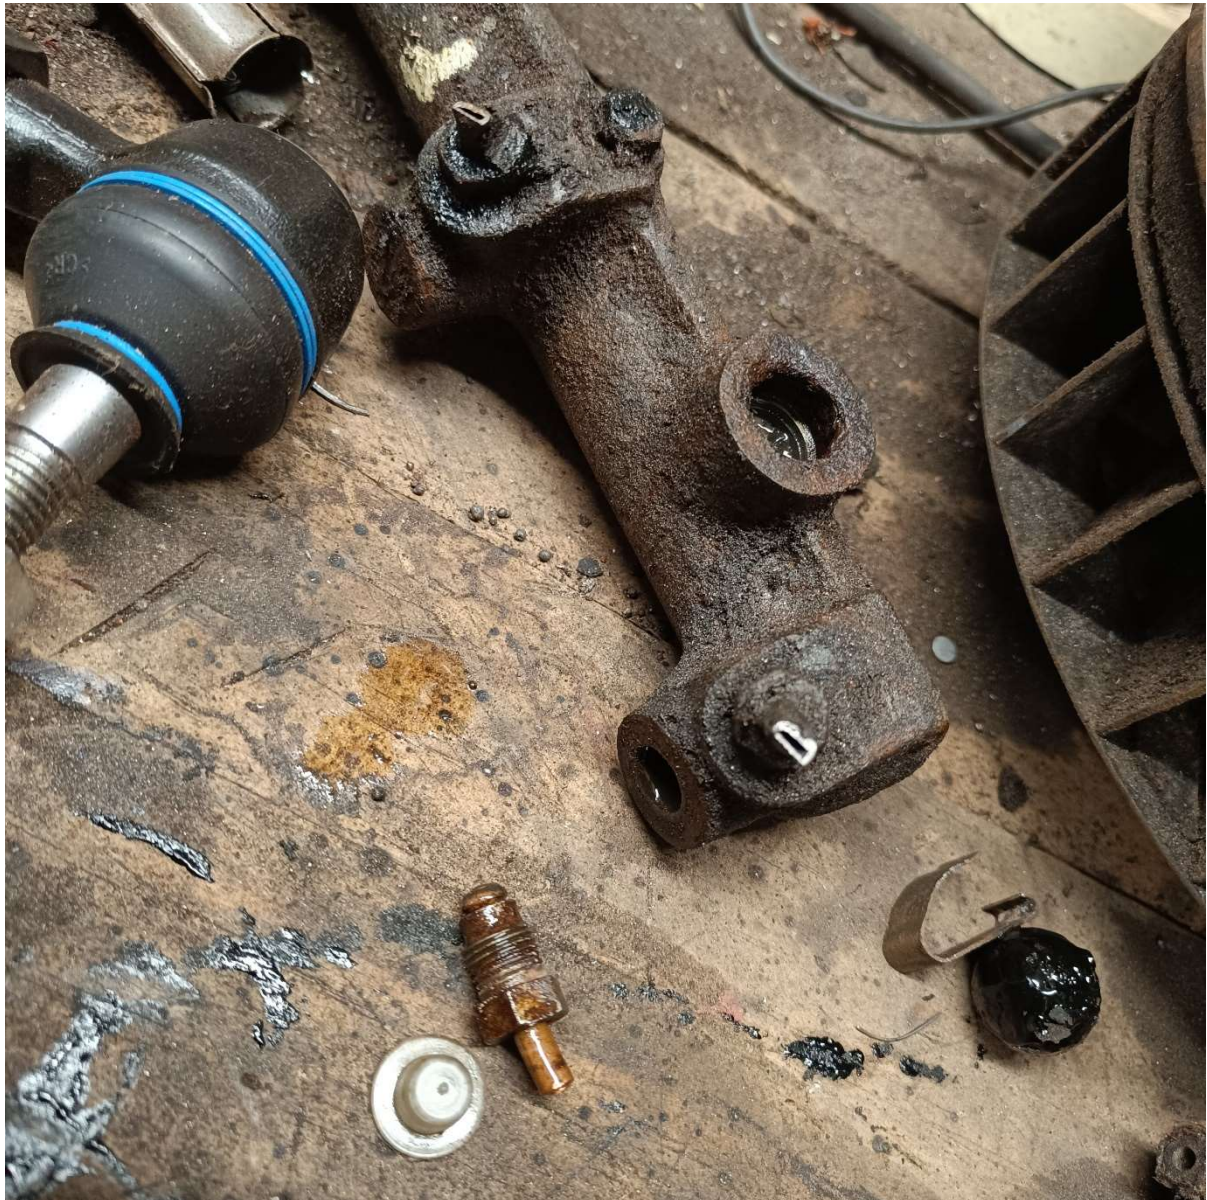
Then I turned my attention to the brakes. The master cylinder pictured was past its best and was replaced. The previous brake set up was not servo assisted, so I bit the bullet and purchased the master cylinder for servo brakes, along with the servo itself, vacuum pipe and other associated bits.

Again, I called on Malcolm's knowledge and experience to help me to take the first step. Eric's beam is an original German beam and the servo is a new Brazilian one meaning that the holes did not line up. An annoyance due to the extra time taken to make new holes in the servo mounting bracket on the beam, and the additional extra time to prime and paint the bracket that I painted last year!

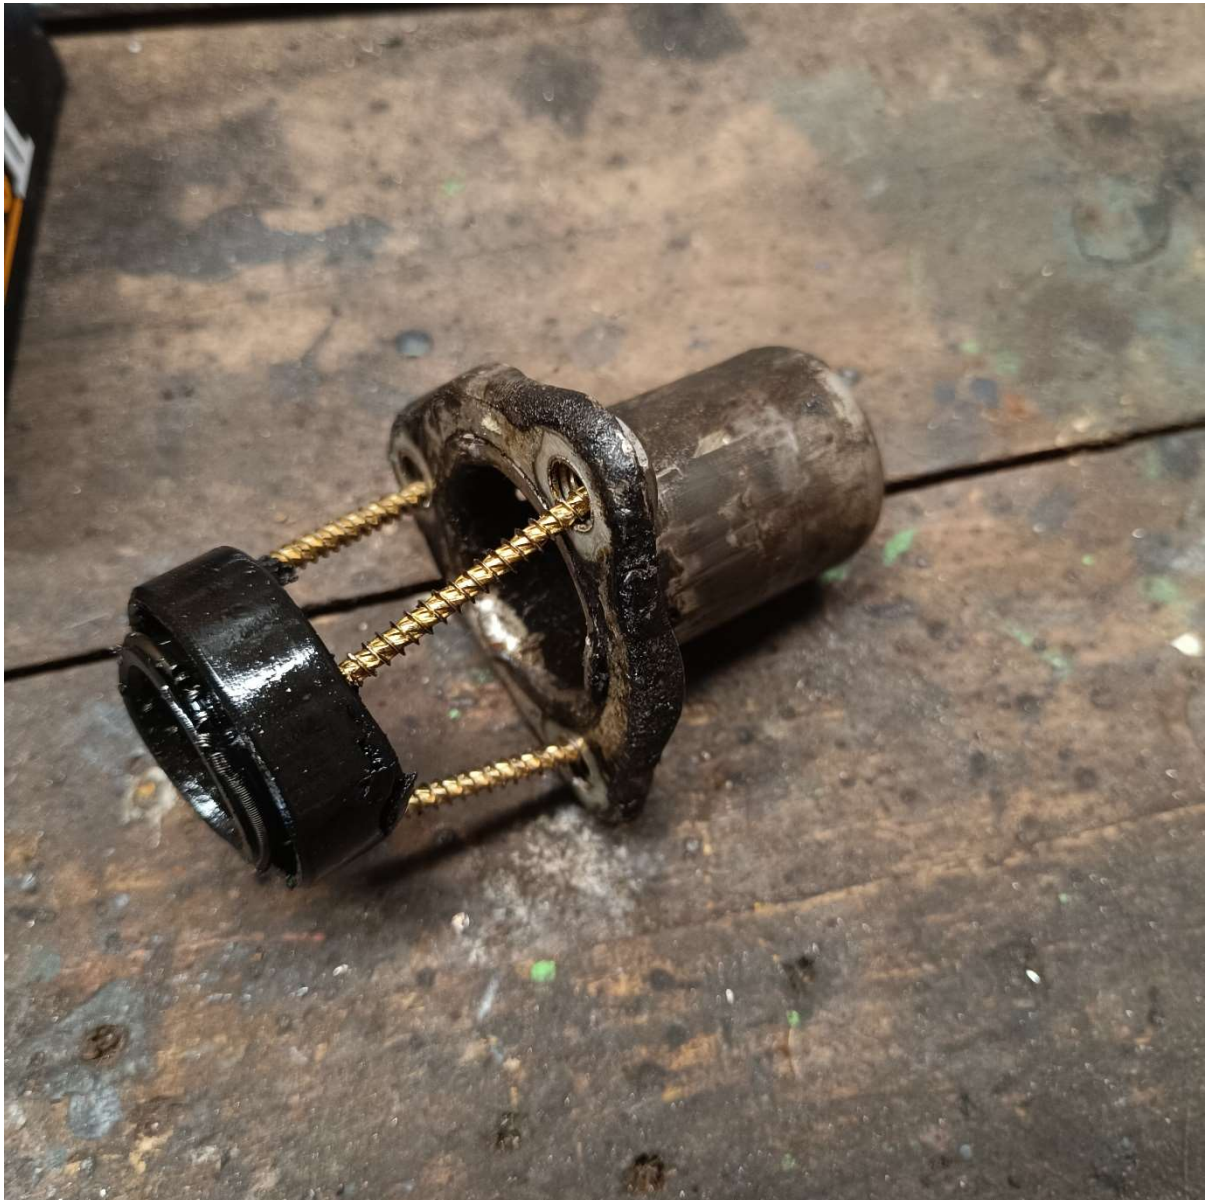
Who knew two months ago what fate would have in store for me. I had planned to be away a lot in Lorna's crossover Poppy and in amongst that, be in the garage working hard on Eric the Viking. Sadly, neither came to pass. In June, I managed to finish the cleaning of the outside of the gearbox, the top coat and the new input shaft seal as planned. The input shaft seal is a pain to remove and needed 3 self-tapping screws drilled through the metal collar and then a puller to bring it out as nothing else seemed to work. The new one does not leak which is rather nice.

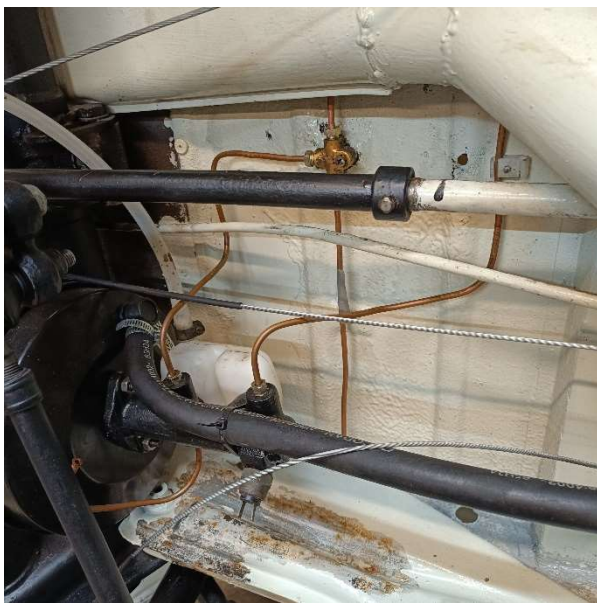
More seam sealer was added on joints to really try to keep the metal from rotting and as I was there, I added some insulation to the central hot air pipe which is easier when Eric is on his side. Bolts have been checked, the clutch cable bracket on the torsion tube was advised by an ex-air cooled mechanic to be a little flimsy, so that received a further 2mm steel plate to make it stronger.

The discolouration on the lower part of the photo is where brake fluid was coming out of the reservoir during my convalescence! Brake fluid is a great paint stripper, so that area has been cleaned down, neutralised,

rust proofed, primed and painted. Again.
