Eric the Viking – a restoration in many parts – April 2024

Spend since last report: £508. Total hours labour since last report: 88.9

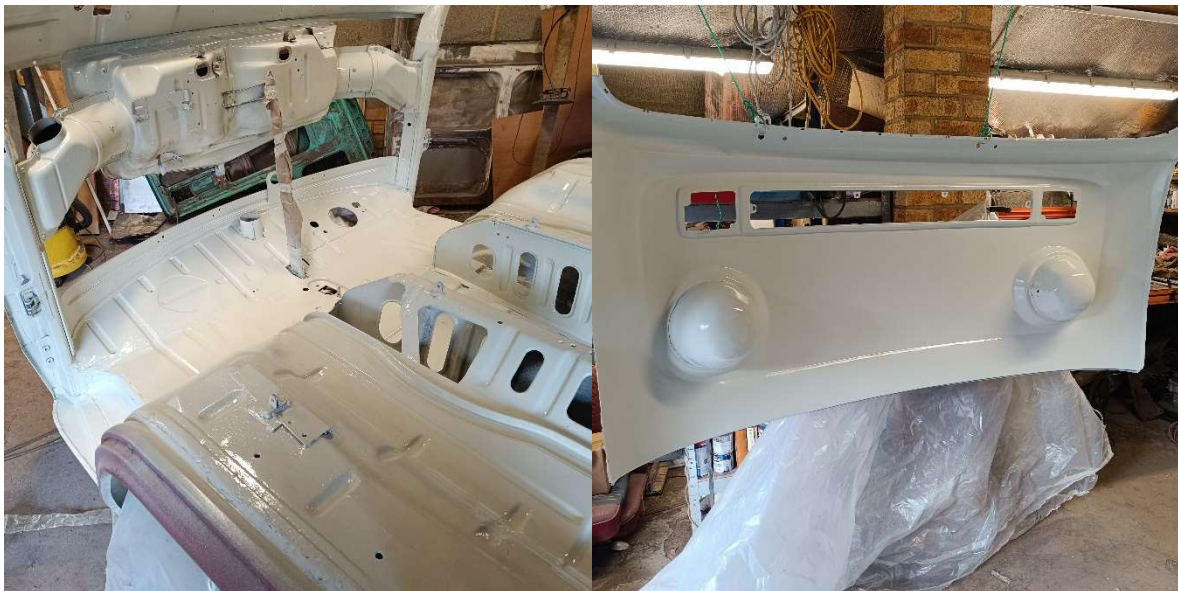
I'm not very good at paint and for sure others would be faster. My garage is dusty, so there's a few bits under the paint here and there but it is on and looks great. The feel of 2-pack paint is that it is really durable and smooth (dusty bits excepted!).

Yes, that is a lot of hours since the last report. Yes, progress has been made! Last report, I noted that I had purchased a new spray gun and it was time to test it out. Prior to installing the nose / front panel, I decided to spray it before installation to get down to the bottom that is hidden when installed. At the same time, there is a lot of metal to spray on the cab floor, kick panel, seat tubs and main cargo floor. I mixed up my 2-pack L90D Pastel White and donned my trusty 3M mask and did a test spray on some cardboard to check the spray pattern. Once that was about right, I set to work and used about 750ml of paint.
