Eric the Viking – a restoration in many parts – August 2024

Spend since last report: £73. Total hours labour since last report: 16.1

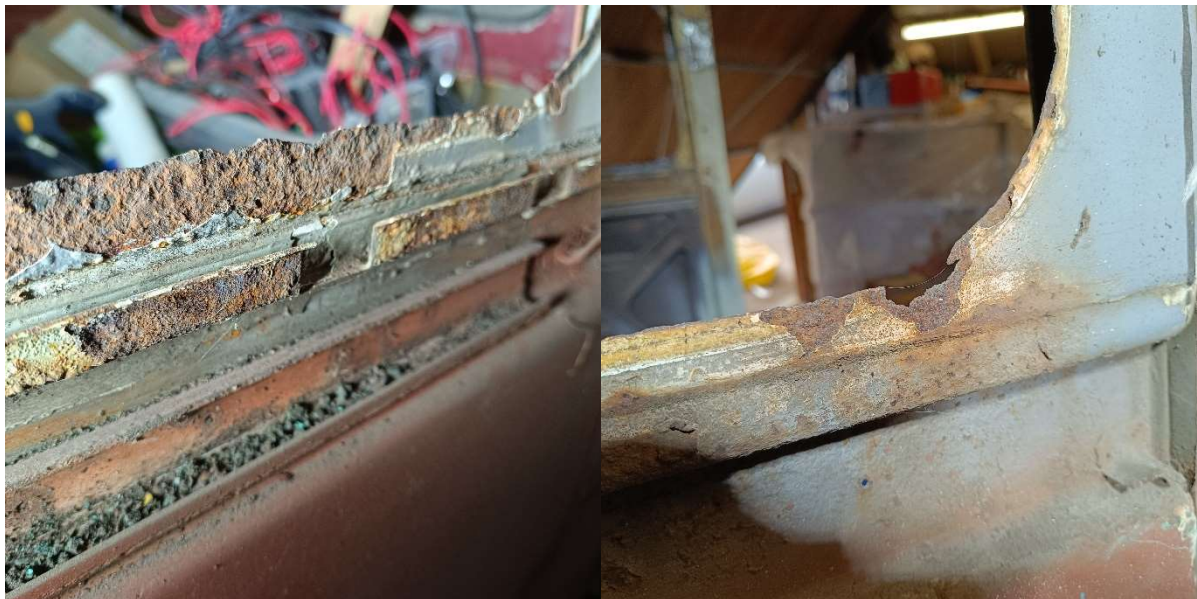
The rear windows had also seen better days and needed some attention – very frilly metal was removed, new sections added, and welds tidied up. The external covers on each side sit on clips nearly a metre long which had also perished and have been removed. New ones are a continuous U-shaped steel section, the old ones were more like fingers which makes them very fiddly to make. JK came to the rescue (with club discount) supplying the simple rectangle of steel folded over. There were no mounting holes either, so I drilled holes ready to weld them to the body.
