Eric the Viking – a restoration in many parts – April 2018

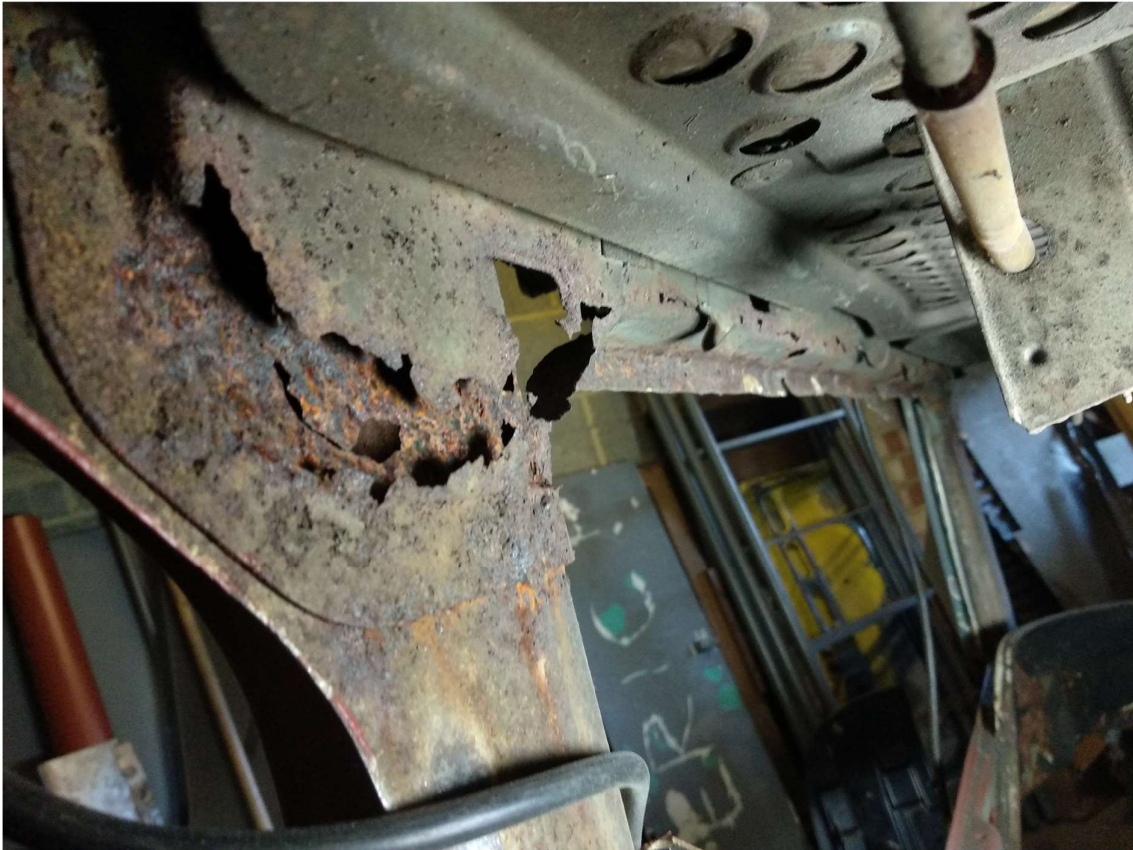
Then I saw the back of that D post I just spent a day welding the front. What do you mean it looks like this?
