Eric the Viking – a restoration in many parts – June 2017

Spend since last report: £49.10. Total hours labour since last report: 36.75

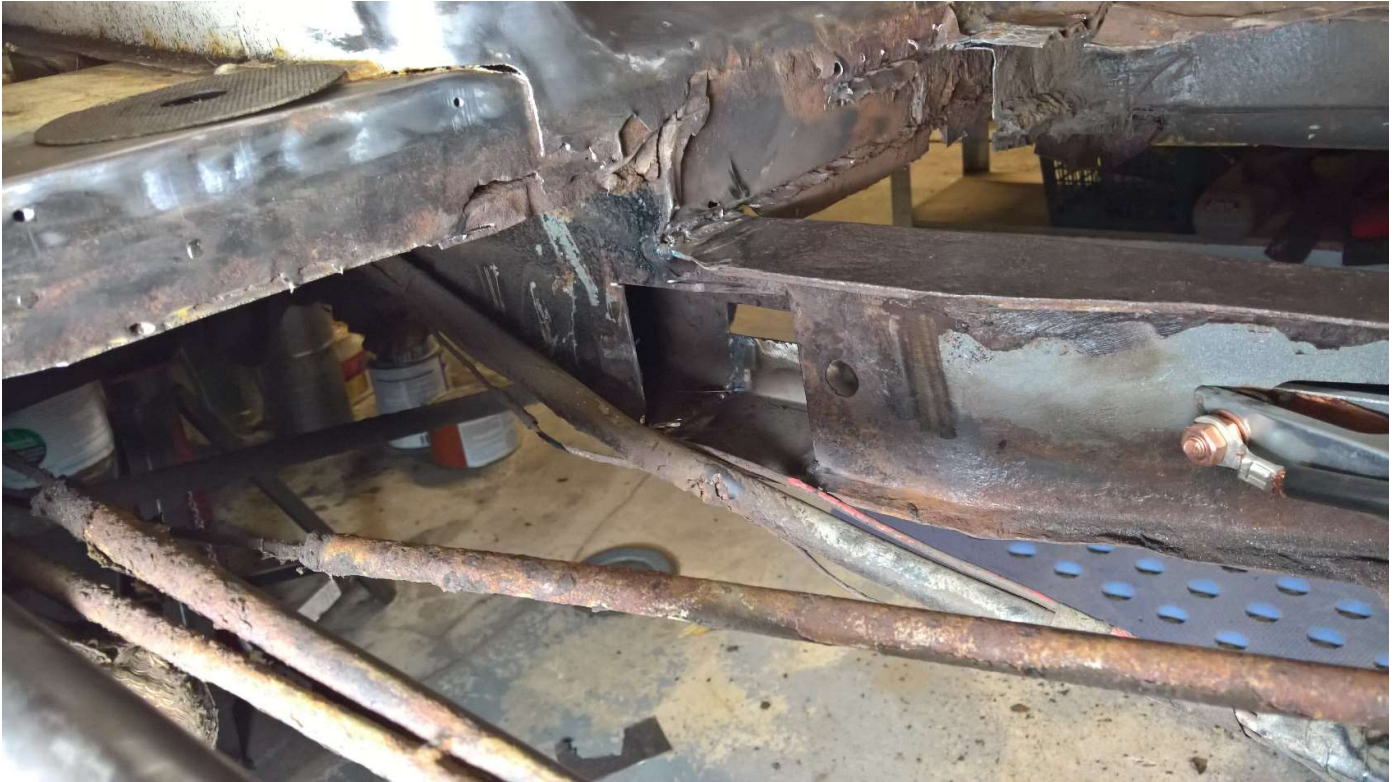
The offside chassis rail almost underneath the back of the driver's seat used to be joined to the front top hat and the support section between the rails.

All bad metal was cut out.

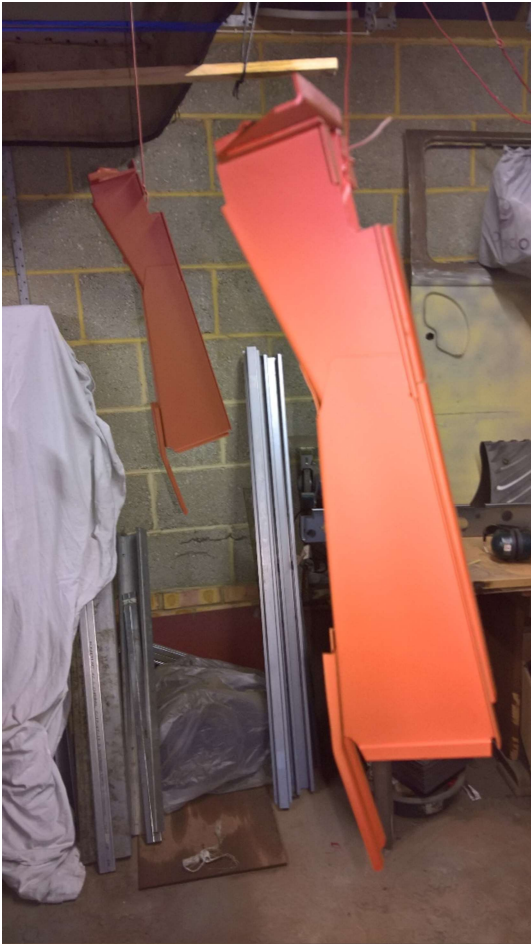
The two main chassis rails had enough metal to merit adding top hats across them, if only that last piece got finished to add the middle support below the back of the seats. Getting close to putting bits in, I need to paint some parts!

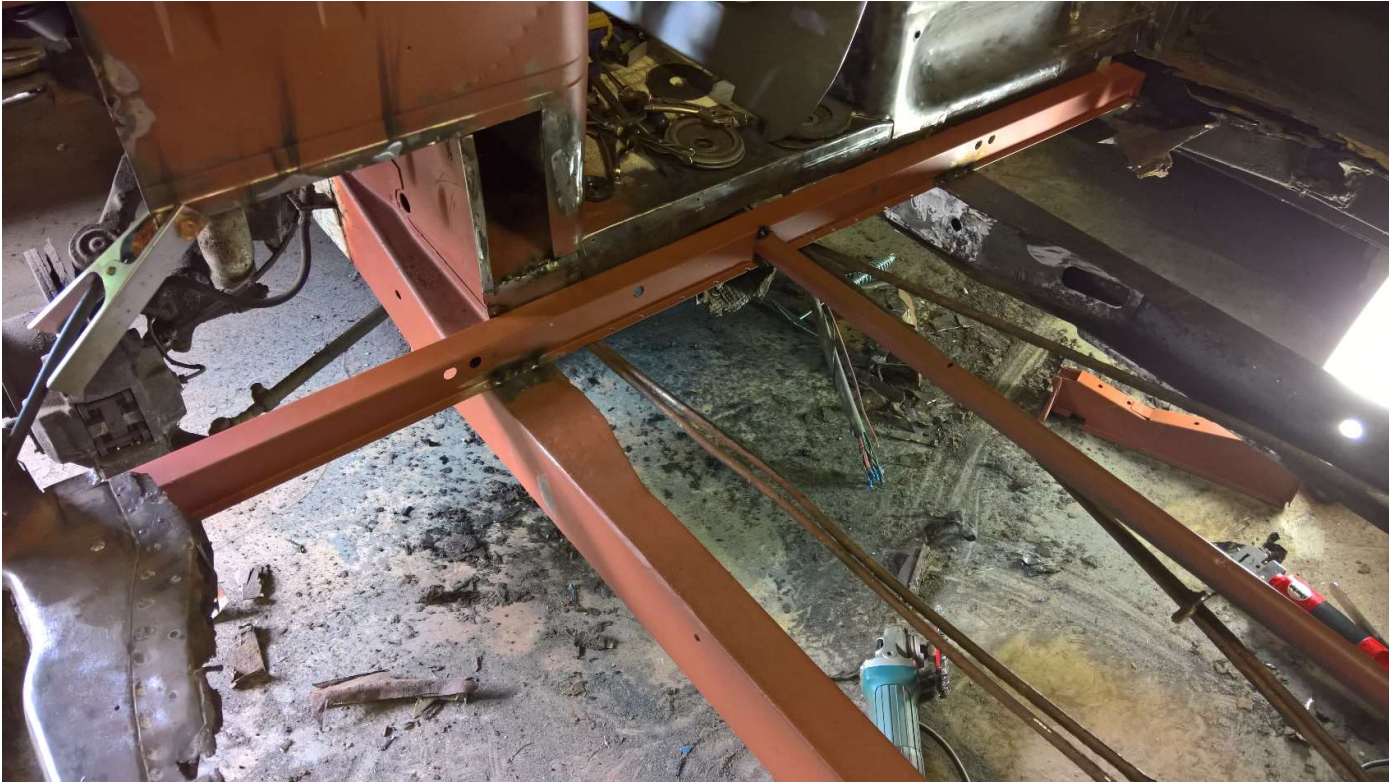
Then.... Drum roll please. Time to weld in a purchased part not cut up bits to patch chassis rails. Keep me covered, I'm going in. Front top hat positioned and welded, done it, my bete noir, 138 hours of learning, false starts, working on the sliding door instead of a non visible part, I did it.

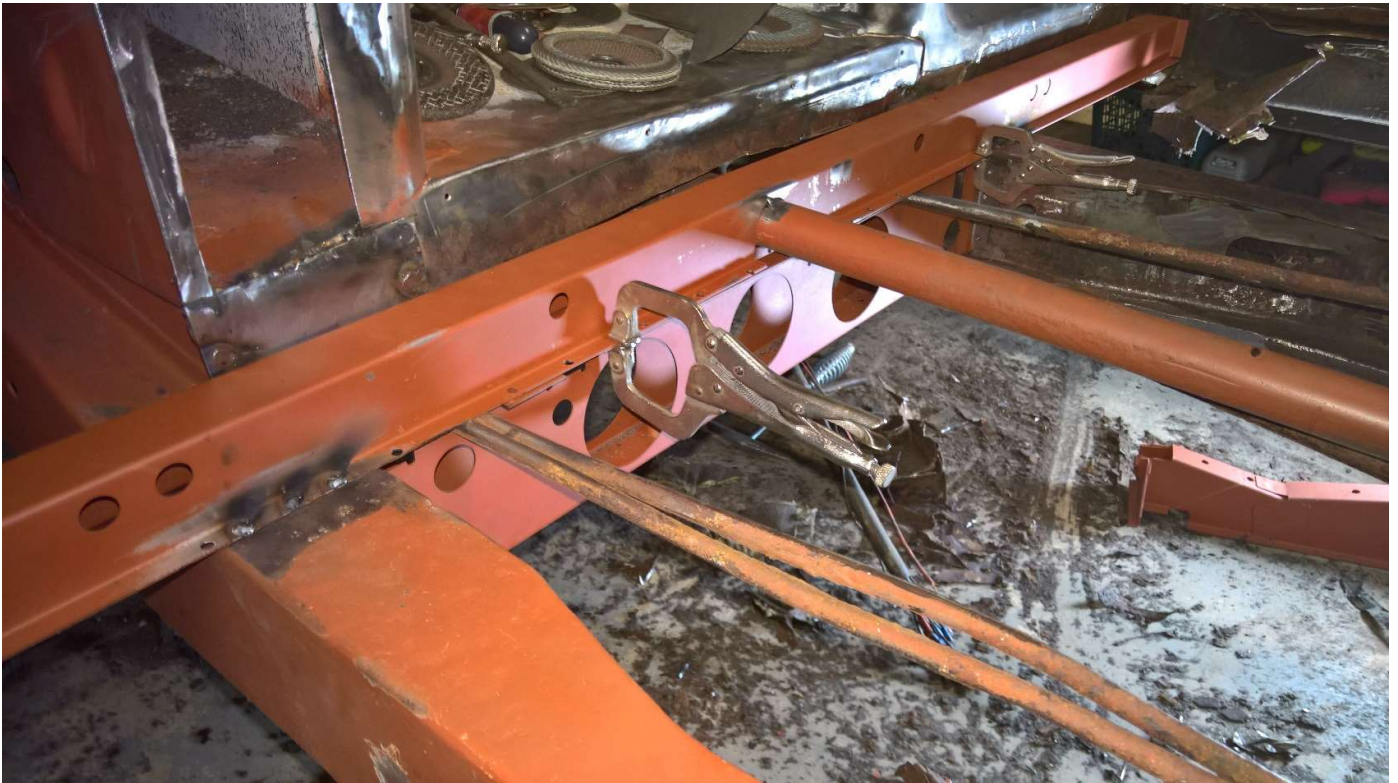
Then the painted support under that new piece welded in.

Wow, looking great. Next come the jacking points and I actually don't like that flat plate instead of the bulge behind the passenger seat. A weekend to fit, 90 seconds to chop out.

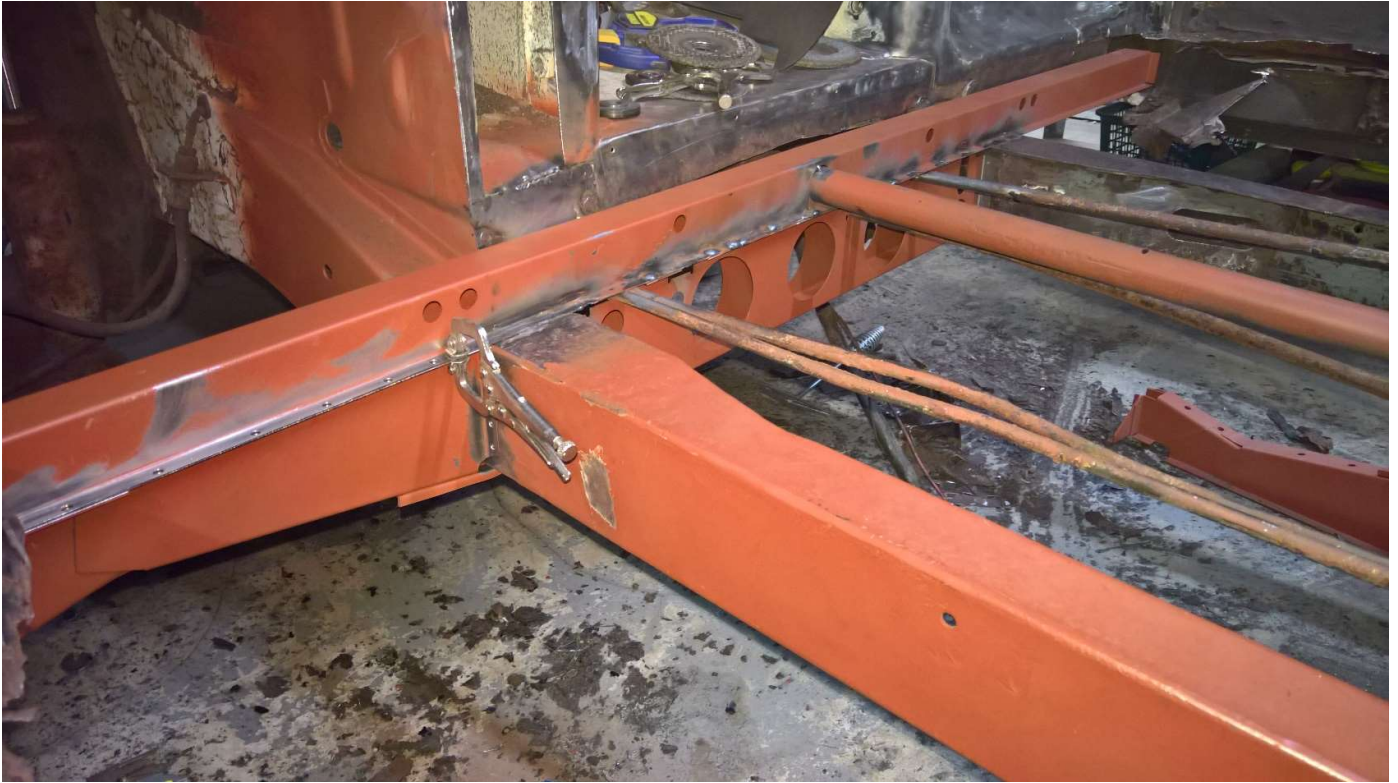
Near side jacking point in.

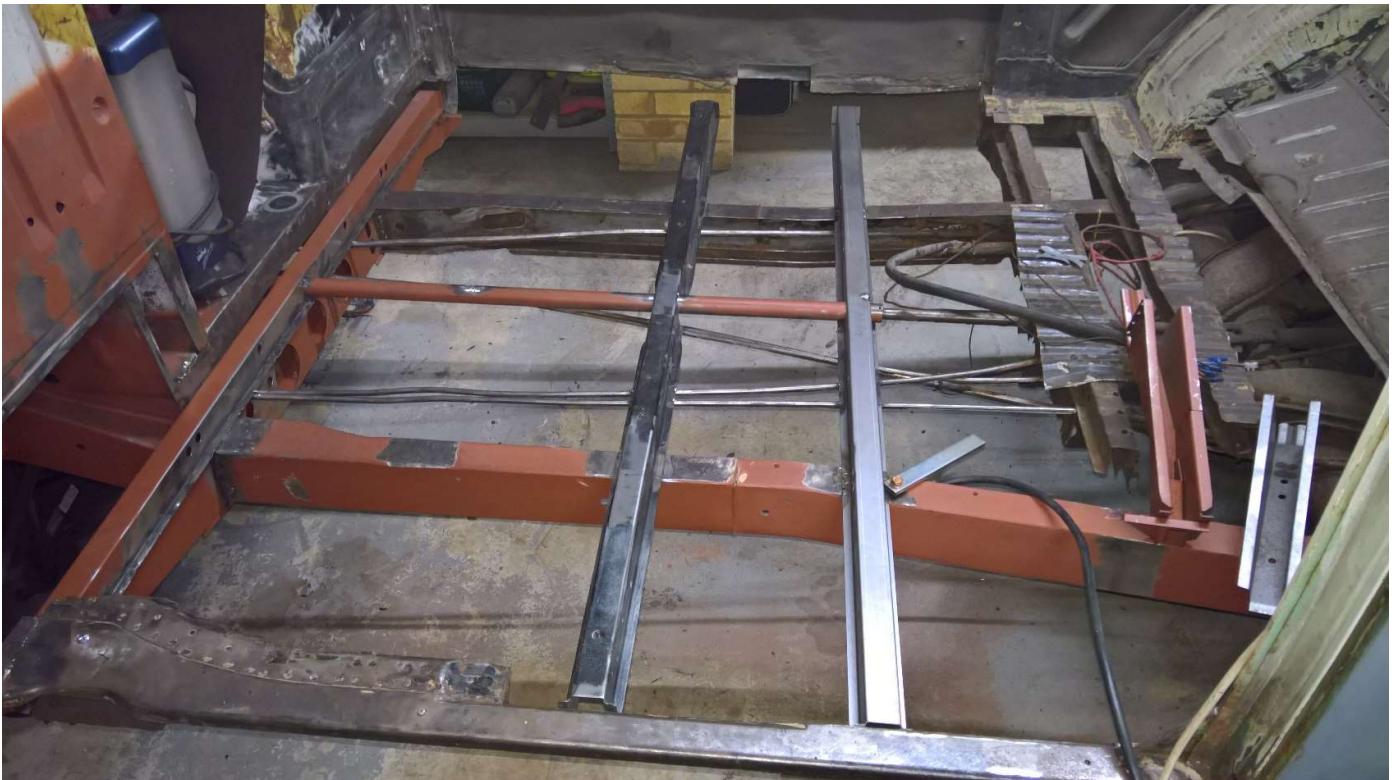
Offside needed the bulge tidying. Progress and pleasure in equal quantities. Now the fourth top hat almost at the back of the sliding door, both of them new and silver from Just Kampers then the third, old but unused, heavy and black that came with the bus, chosen as the middle one for strength under the floor when you step in. Four big supports fitted then welding the brake lines, gear selector and other tubes to these new pieces and tidying up, more sanding of surrounding areas still rusty but not rotten.

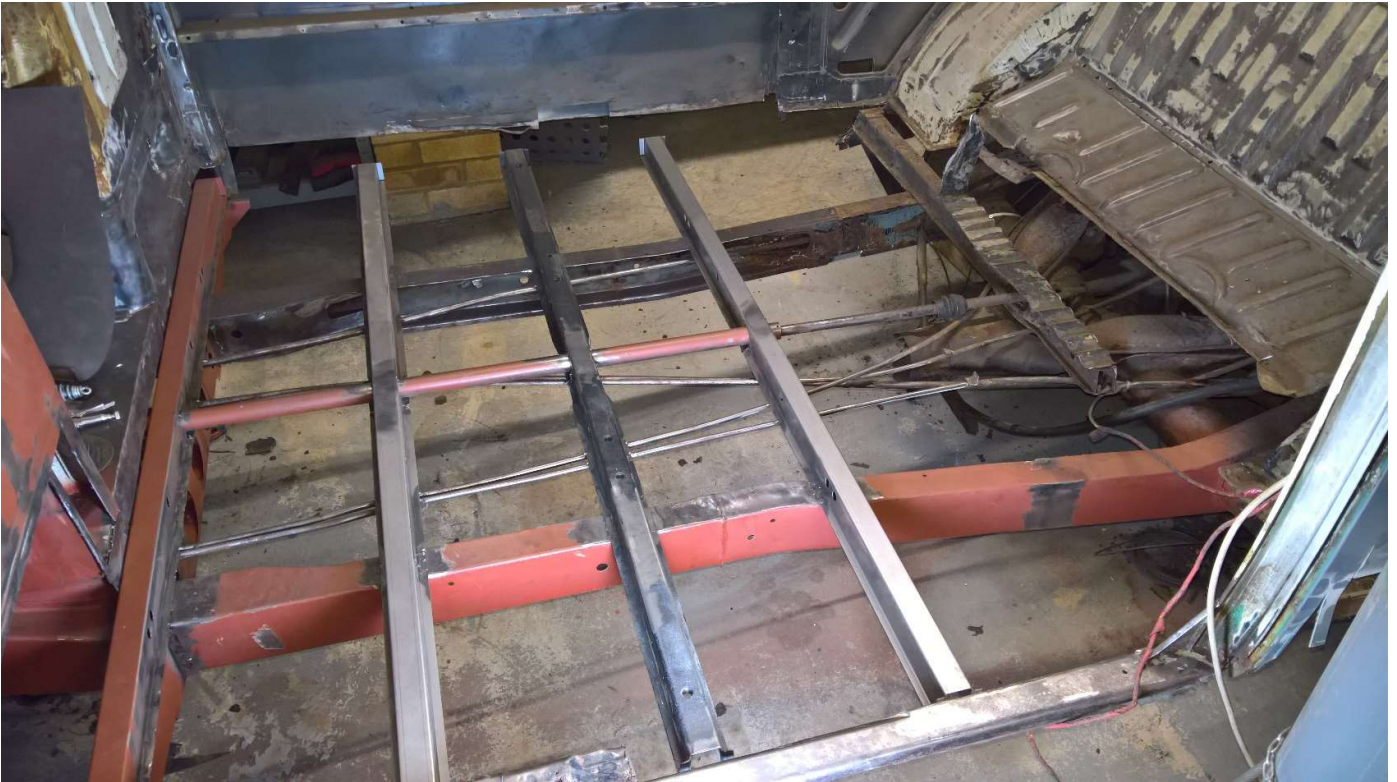
The fifth floor support, its middle support beam under and the offside jacking point also came out ready for replacement. OS rear jacking point had a lot of filler and underseal and you know that from the smell and the speed that the cutting disk moves through it.

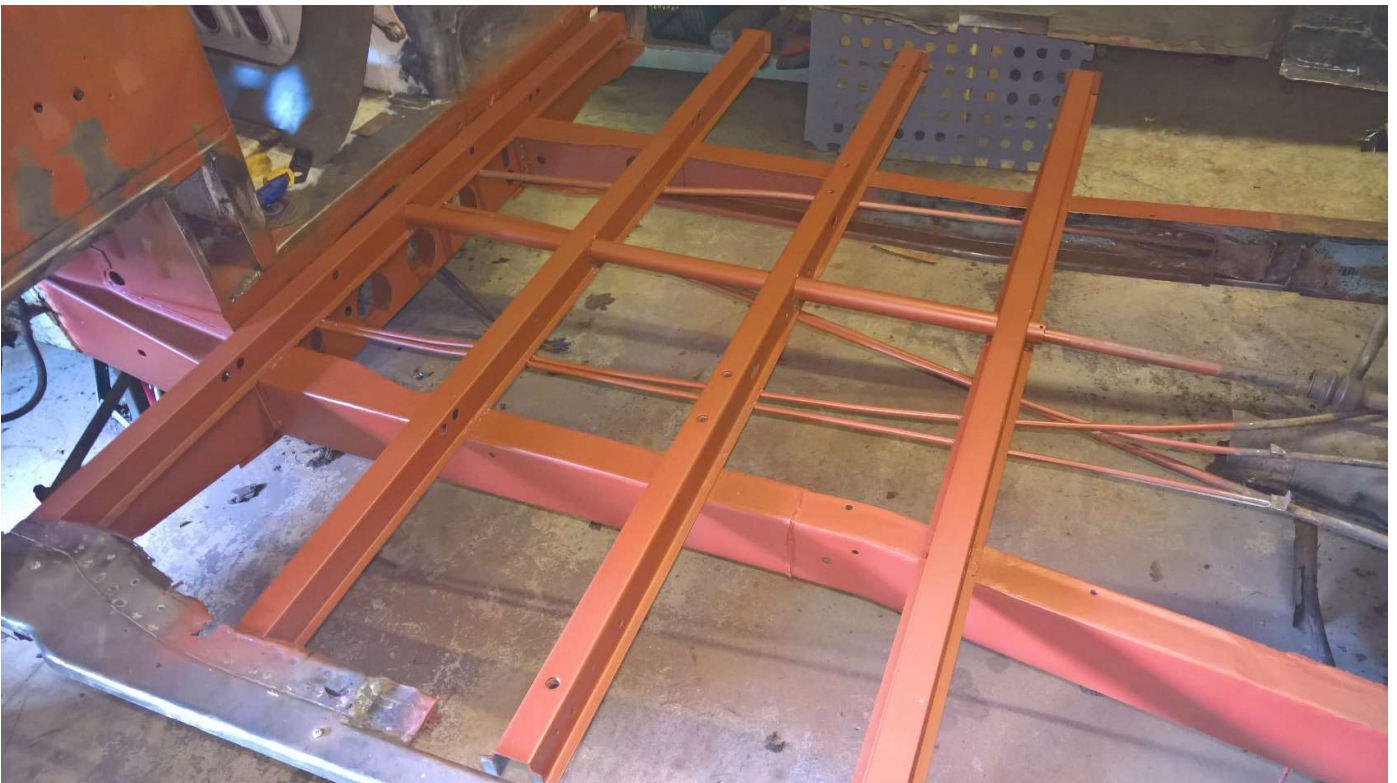
If there are 4 completed, let's get this spraying on the road. My first go at spraying from the spray gun not a rattle can.
