## Eric The Viking – A restoration in many parts – Part 1 - August 2015

## Eric The Viking – A restoration in many parts – Part 2 – 17<sup>th</sup> December 2015

## Eric the Viking - A restoration in many parts – 16<sup>th</sup> June 2016

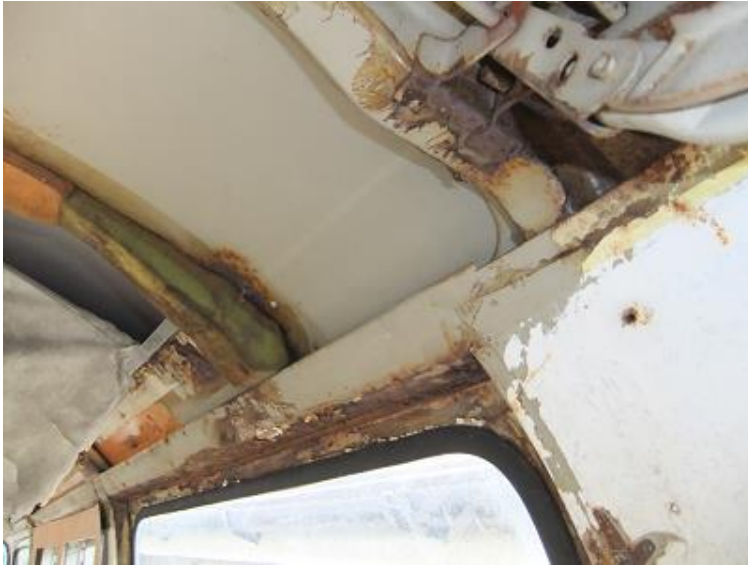
New carpet rolled up, dozens of new kitchen floor tiles, wood screwed to the wall and the back of the driver's seat divider. Rust. Lots and lots of rust. The picture shows the driver's side back window up into the roof and the back door hinge mechanism with daylight above the glass. Once it was empty, we started sanding paintwork to see what was underneath which is a mix of rust, rot, grot, filler and in places some metal. Sliding door removed and on the bench as the easiest bit to do in the garage. Passenger door lock rekeyed to take the ignition key which was easier than expected although fiddly. Bumper off and starting the strip of that back to bare metal too. The main battery tray is almost non-existent with a block of wood the only thing that would keep a battery there. Offside whole corner needs an awful lot of work on the whole panel and can't be saved. Nearside rear corner only needs the lower half and since I'm at it, I'll change the battery tray on that side too ready for a leisure battery. With the sliding door lower outside repair panel that makes 5 new panels ordered on the weekend that Just Kampers had their sale.

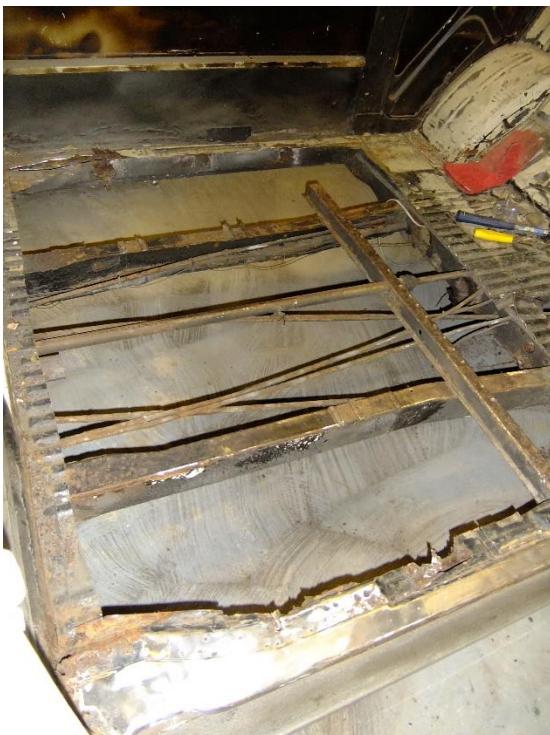
The floor between the top hats was cut out into rectangles, and then the floor that was welded to the top hats was drilled out. Top tip – spot-weld drill bits are annoying, an air chisel would have been better. Two of the top hats were removed and the third, rearmost one has lost the outer six inches or so. Since you cannot buy just the ends, it will probably also come out. Then came the chopping out of the sills. Removing the top hats ended up with a hammer causing poor Eric to rain rust from multiple places underneath! Both support beams feel like papier mache but used to be metal and need replacing. All outriggers and jacking points are in a similar condition. The nearside chassis rail has started to go where the front support section has rotted away, too.

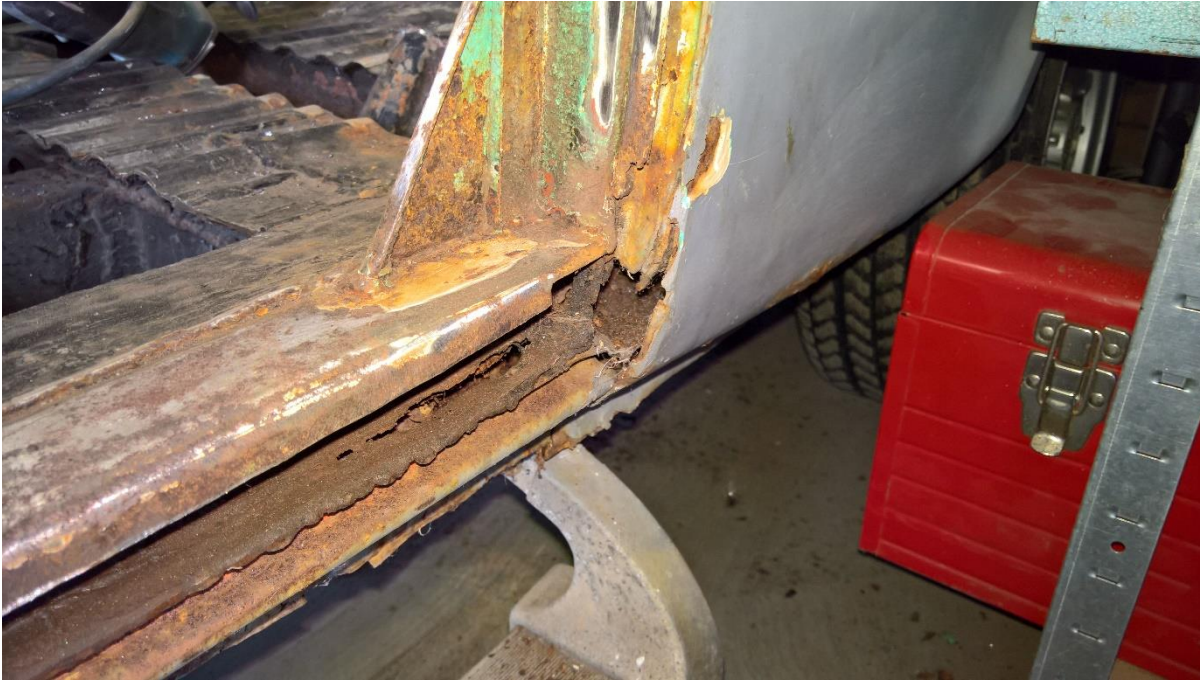
The nearside sill was nearest the work area - keep me covered, I'm going in! Chop off the outer sill which is only a trim panel it says. Check. Then cut horizontally through the middle sill from the outside and the inner sill from the inside. Erm. The middle sill is missing barring the front six inches and even that is frillier than my Friday night outfit. The inner sill is there for the most part but at crucial points is either filler, fibreglass, underseal or holes - rarely good metal - and given my size it is not easy to get to the right angle to chop it, but progress is being made.

Once the nearside sills are fully removed, the whole lot will be replaced barring the top of the sliding door track and the step that it sits under. This is going to bring much needed strength once the chassis rail work starts.

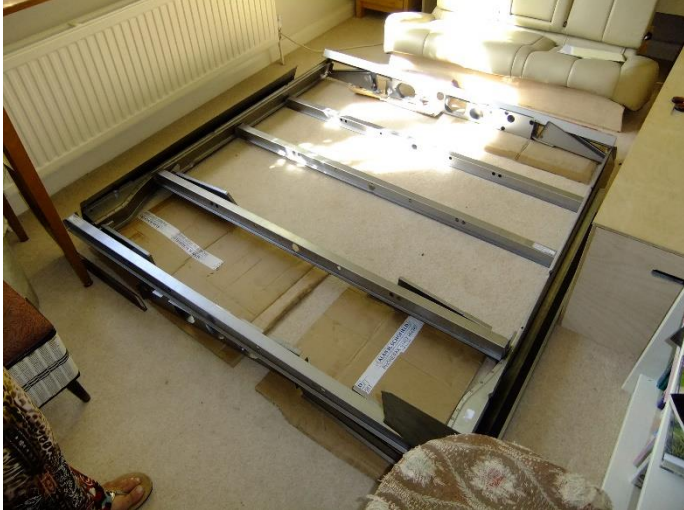
Once the moths had found their way to the light and we stopped coughing from the dust, my wallet was open and used to buy the parts. All outriggers, jacking points, support sections, six top hats, all sills on both sides and the repair sections for the bulges at the back of the front wheel arches for your feet if you are on the middle row of a dormobile bus. It all came beautifully packaged, bare metal covered in grease. I laid it out carefully indoors to see how it all fits. I am still none the wiser but it is a start.

Together with the new rear corners, battery trays and other parts that I bought a year ago, they remain steadfastly in the house whilst Eric sulks in the garage.

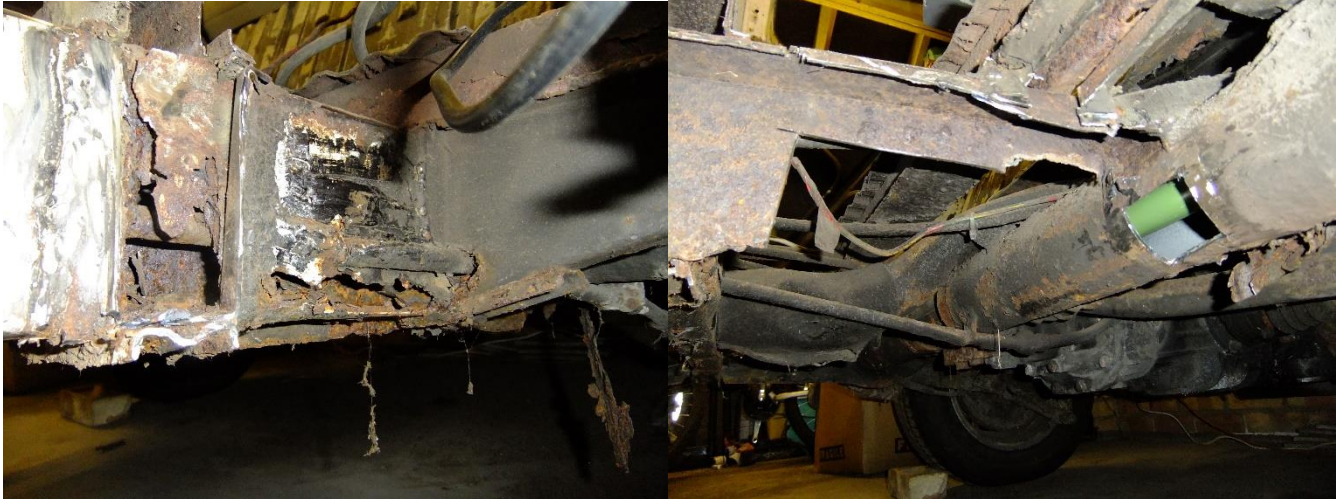
Then we moved back to the rear of the cargo floor area to the join with the rear jacking point. Water has been sitting in there for years and both jacking point and chassis rail at that junction are totally rotten. Jacking point removed, chassis rot removed, patch built. Hmm, not happy with the patch or the chassis rail further back. A good job that we abandoned that plan as the rest of that chassis section is also rotten all the way back to the torsion tube. No, we didn't know what that did either. The big side to side tube just in front of the back wheels with a cover on each end in the shape of a trapezium is the torsion bar but we didn't know what it did, we're only amateurs. Where the chassis meets that tube was all rot and rust, so it all got hacked away with a cutting disk and a grinding disk. Eventually shiny metal was seen on the tube and we cut a little hole in the 2mm metal about 2 inches each way to see what is inside. Gingerly. Green and shiny metal is what we found, seeing the light for the first time in 43 years but the pilot hole piece was half rotted and needs replacing. Almost certainly on the other chassis rail too. Before the rot was removed and after:

Repairing the tube is difficult as access from above is tight due to the rear panel between the wheels and welding in a confined space laid under a rotten bus is just no fun. Next job then is to remove the panel between the wheels.... All the spot welds drilled out carefully and start easing the panel away. Turns out that panel forms part of the fuel tank ledge, so a wasted hour and now need to make that good again.

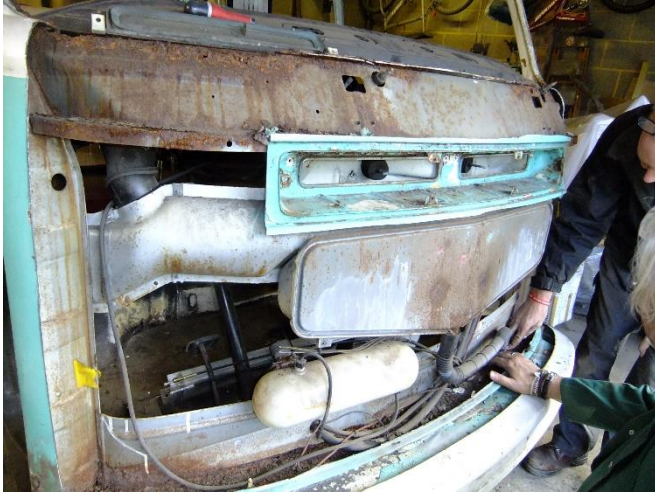
More weight loss program, chopping from the windscreen down the nose near the edges, leaving the air intake grill and down to the bumper. Looks better already, let's see what is going on underneath. Bumper is ok and reusable. Deformation panel is pretty much dust, the front chassis sections are too, the floor of the cab isn't great and all inner front panels are wrecked too. New plan, don't look at the rest of the bus to see what you have got, fix the current bit only then move on. The path to the end is taken by looking at your feet taking one step at a time not looking at the mountain wondering why on earth you jumped into this money pit in the first place.

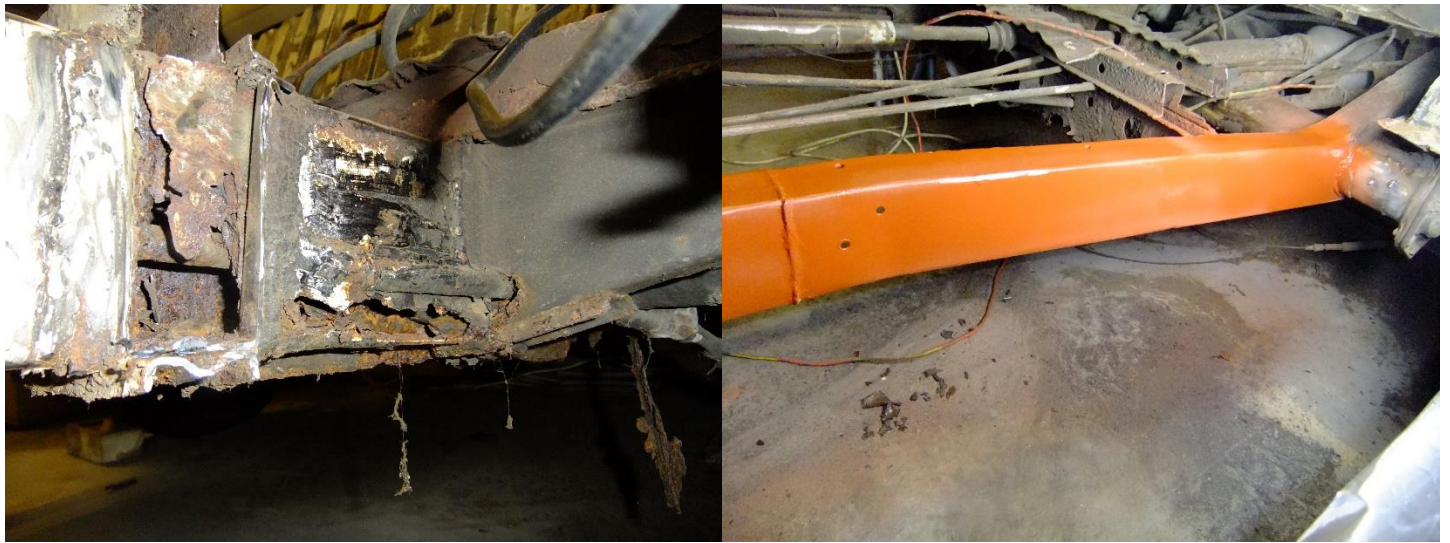
The winter months are long and dark. More to the point they are cold and damp, so the enthusiasm for restoration remains but the enthusiasm is dampened by the erm...damp. After a 3 month hiatus of any form of warmth, dryness or renovation, the overalls were donned once more and work started again on that nearside chassis rail. Before we can go any further, we need that solid base on which to build. A section of chassis about 18 inches long was rotten but if you just chop it out the bus will fall apart! To get around this we left the best bit which was the top and chopped the sides and the bottom off (see first picture on the state of it). Then we bought a new chassis section, chopped off the top to fit and welded the side and bottom in, now we have some strength along the whole length. Then we removed the rusty top from the bus and then welded that new top back on to the side it had arrived with. I think you'll agree that the newly red undercoated chassis looks a bit better than before!

Of course, it isn't quite as easy as that and around the torsion tube was a bit frilly and needed strength too. I bought a 300mm square piece of 2.5mm steel and we borrowed a metal folding machine off a mate - it looks just like a mangle for those of you that remember them. We ran this through and through making it more and more curved until it was nearly a 120mm cylinder and started welding that to the torsion tube in sections where the chassis will meet it. Then weld the chassis to it. Then ultimately we'll fit some covering metal to make it all look pretty and protect it from the weather. Next job was to complete the missing fourth side of the box section since you can't buy this piece of the chassis and have to make it from bits that are similar. Cardboard templates at the ready, transfer the final shape to the new steel and start to weld that in.

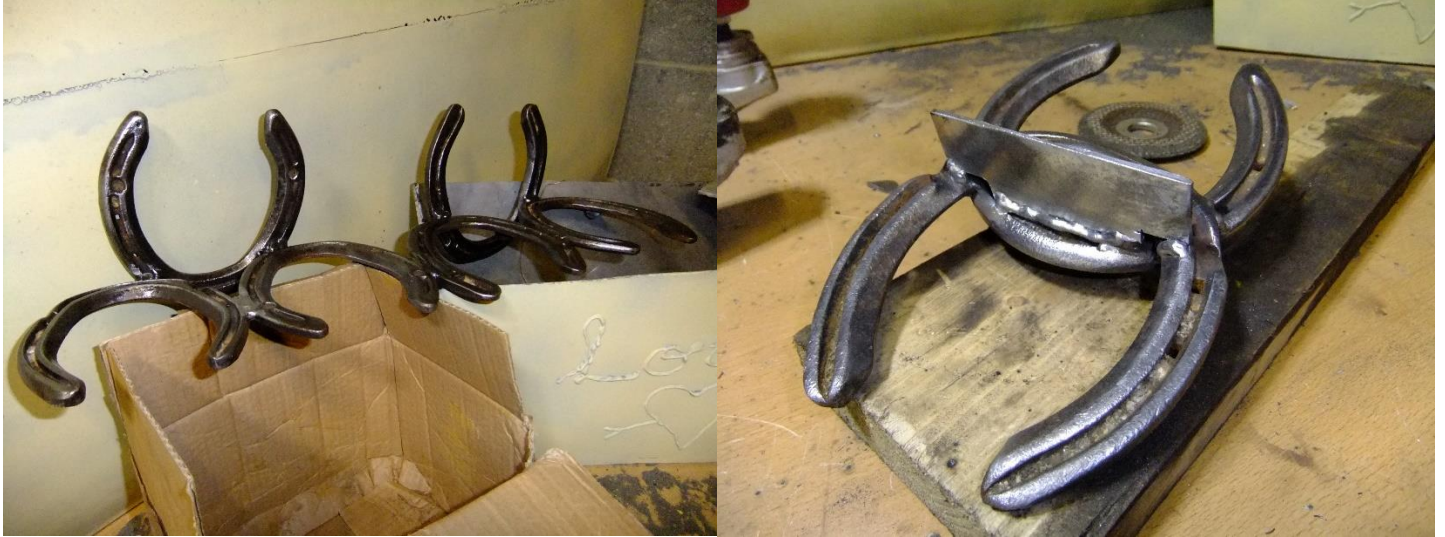
The welding practice continues and I hope that the welding quality is improving. Horsepower of a different variant loomed again with the imminent birthday of a friend and hearing his wife note that he rather likes my welly boot hanger, I decided to make him one plus a mud remover and welly remover combo - a lot faster than I made the first ones! You stand on the lower horse shoe, remove the welly from your heel with the open end of the upper horse shoe and the flat metal in the middle can be used to remove mud. It won't make me rich as I spent about 4 hours on the two pieces.

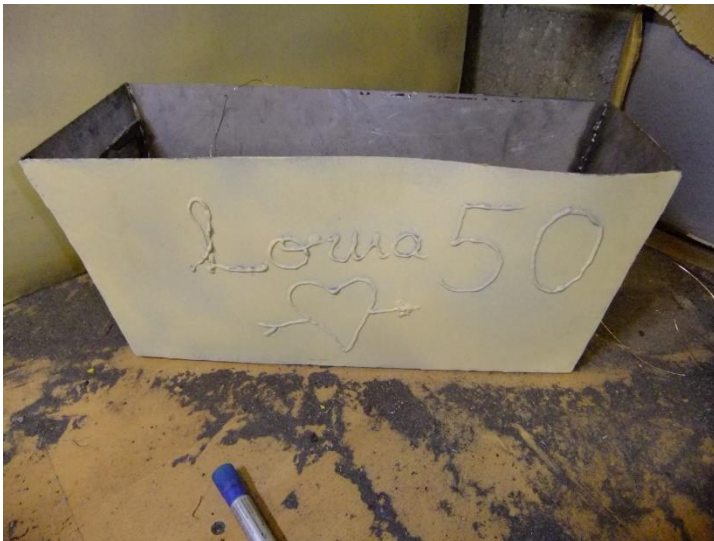
Further progress on the planter for my lovely wife as well. That is almost finished and has been undercoated but do I chop a little section to straighten up the front (it had to be the front didn't it?) which got too hot and warped? I'd like to point out that I mean the planter not my lovely wife. Only the outside is being painted, the inside is galvanised steel which won't rust and mild steel welding that will rust so I'll put paint or sealant down the edges.

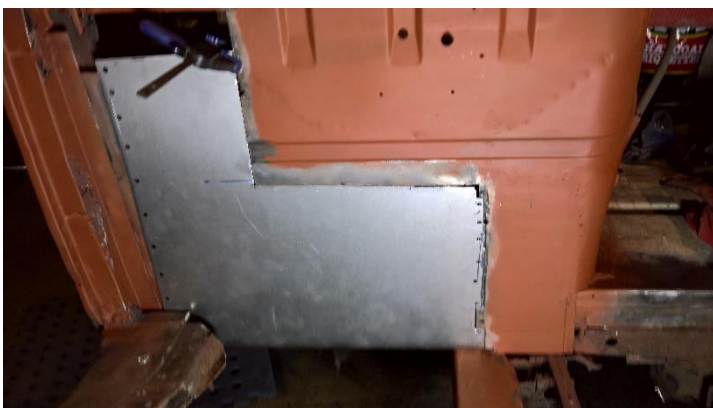
Seat tub with new piece

From a pragmatic point of view, a flat piece of metal is faster and easier to fit. Out came the scallop for your toes using the angle grinder, making the hole a lot bigger. The last of the dish is part of the bulkhead under the seat and is 2mm structural steel. That needed addressing first to make it flat. A cardboard template helped get the shape correct before welding. Once that was flat, the hole between the walk through and the wheel arch was filled and rubbed down leaving the big hole at the back of the wheel arch. This was measured and cut from a new sheet of 1mm steel with a mix of seam welding (edges together and much blowing of holes) and joggled welding (one is overlapped across the other). Once in place there is a lot of rubbing down and then more weld going on to get the right smoothness, which should get less as I continue my experience.

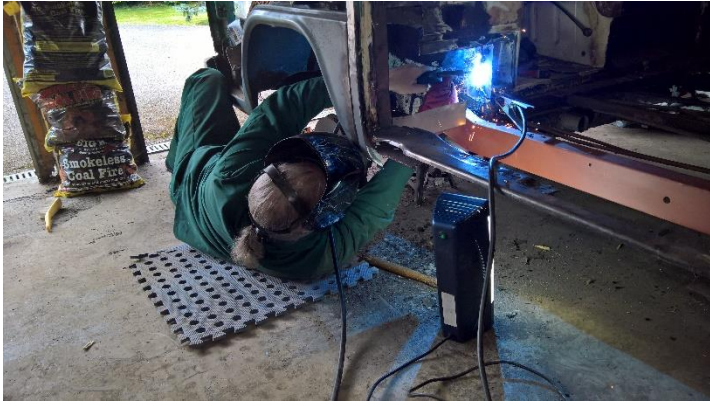
Welding action shot

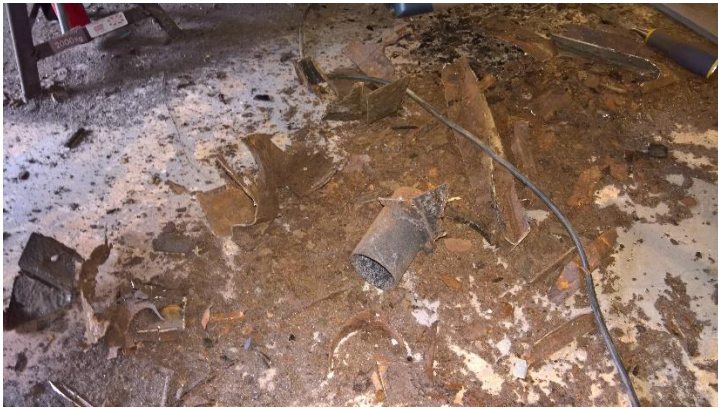
What is left of the front cross member

Predictably, this piece was in a terrible condition, yes the bits in the picture really are what is left of that part. It still took an hour of sweat and wriggling to move around and chop it out with a cutting disk. The inside edge of the near side chassis looks to be ok, the inside edge of the offside chassis member is still hiding under 44 years of accumulated rust and is a job for another day. The outside edge of the offside chassis member where the jacking point connected has not fared well and is badly holed through 2mm steel and will need the same treatment as the other side that I did last year. The last time put my heart in my mouth and it looked to be terminal for the van, now my experience or my gung-ho attitude are saying crack on. This chassis rail is no match for unlimited optimism, determination, a liberal dose of ambitiousness and probably a dash of stupidity. Repair that hole, weld in the new piece in the middle, chop out the remaining rot of the rails, reveal the next big patch of rot, rust and headaches. Just time to show a picture of the driver's front wheel arch, tyre to right of shot, side of the van to the left. It isn't a leaf, that is all that is left of the end of the sill.

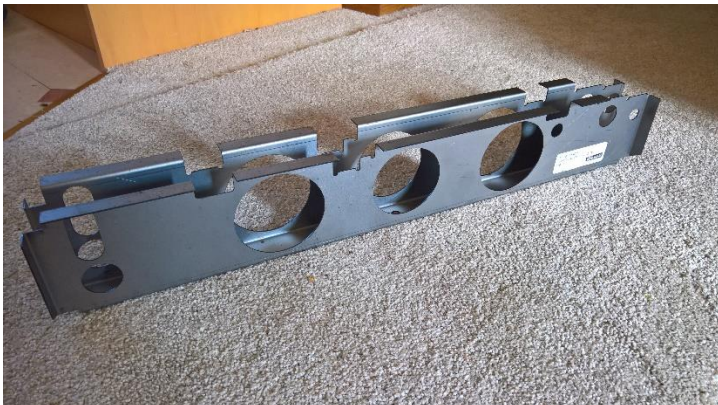
What a new front cross member looks like (hopefully to be fitted soon)

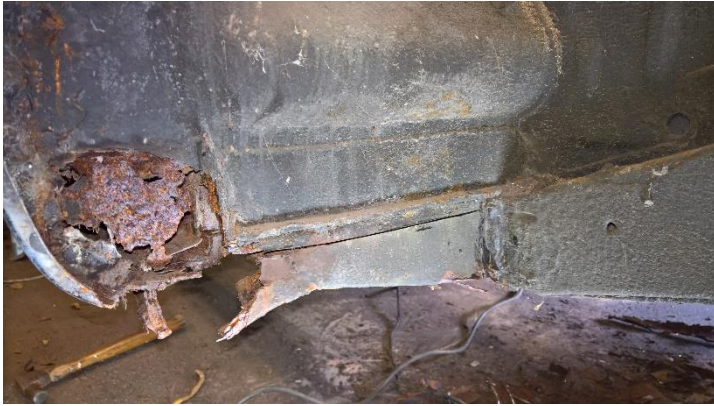
Driver's side front wheel arch

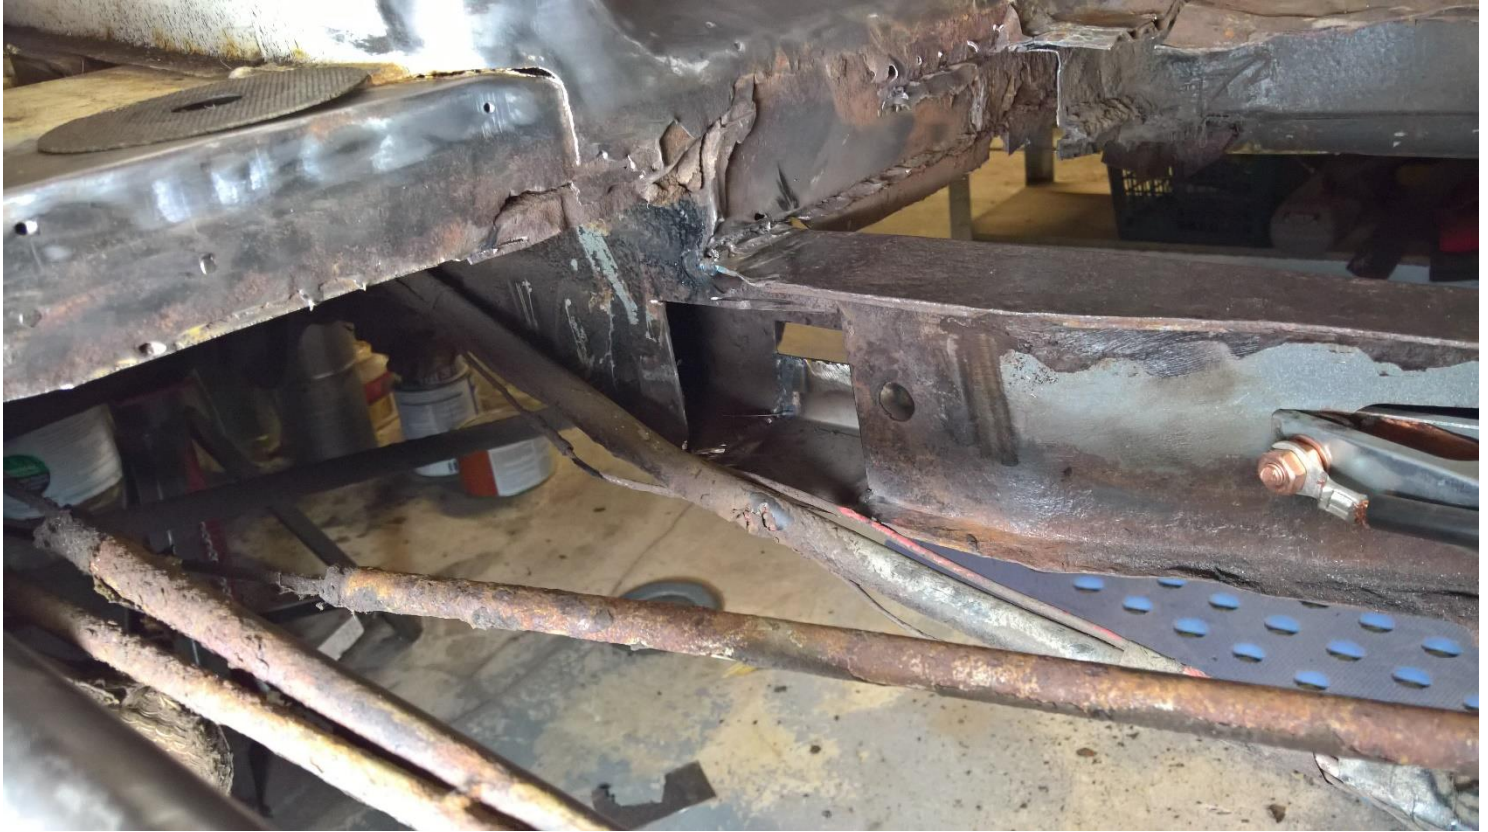
The offside chassis rail almost underneath the back of the driver's seat used to be joined to the front top hat and the support section between the rails.

All bad metal was cut out.

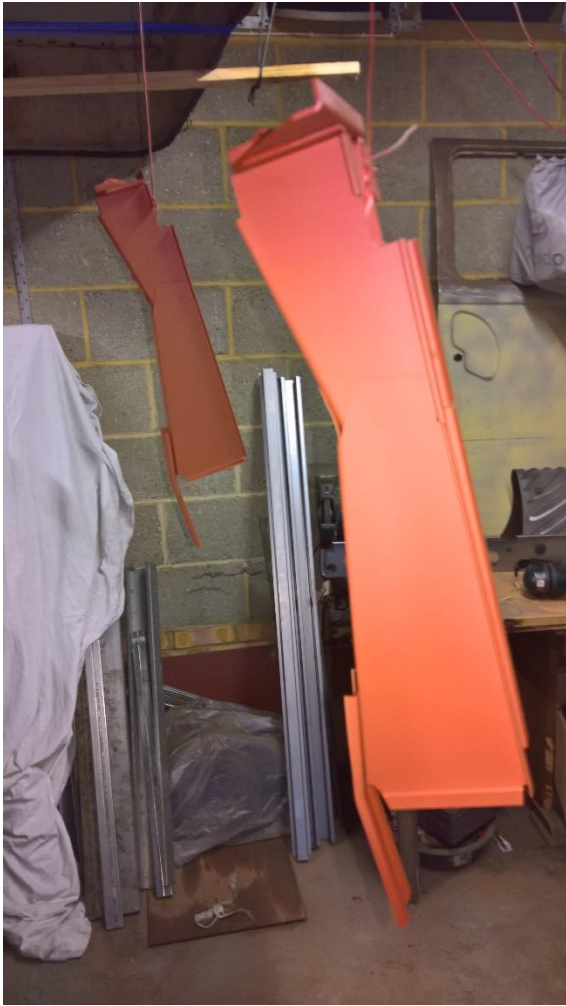
The two main chassis rails had enough metal to merit adding top hats across them, if only that last piece got finished to add the middle support below the back of the seats. Getting close to putting bits in, I need to paint some parts!

Then.... Drum roll please. Time to weld in a purchased part not cut up bits to patch chassis rails. Keep me covered, I'm going in. Front top hat positioned and welded, done it, my bete noir, 138 hours of learning, false starts, working on the sliding door instead of a non visible part, I did it.

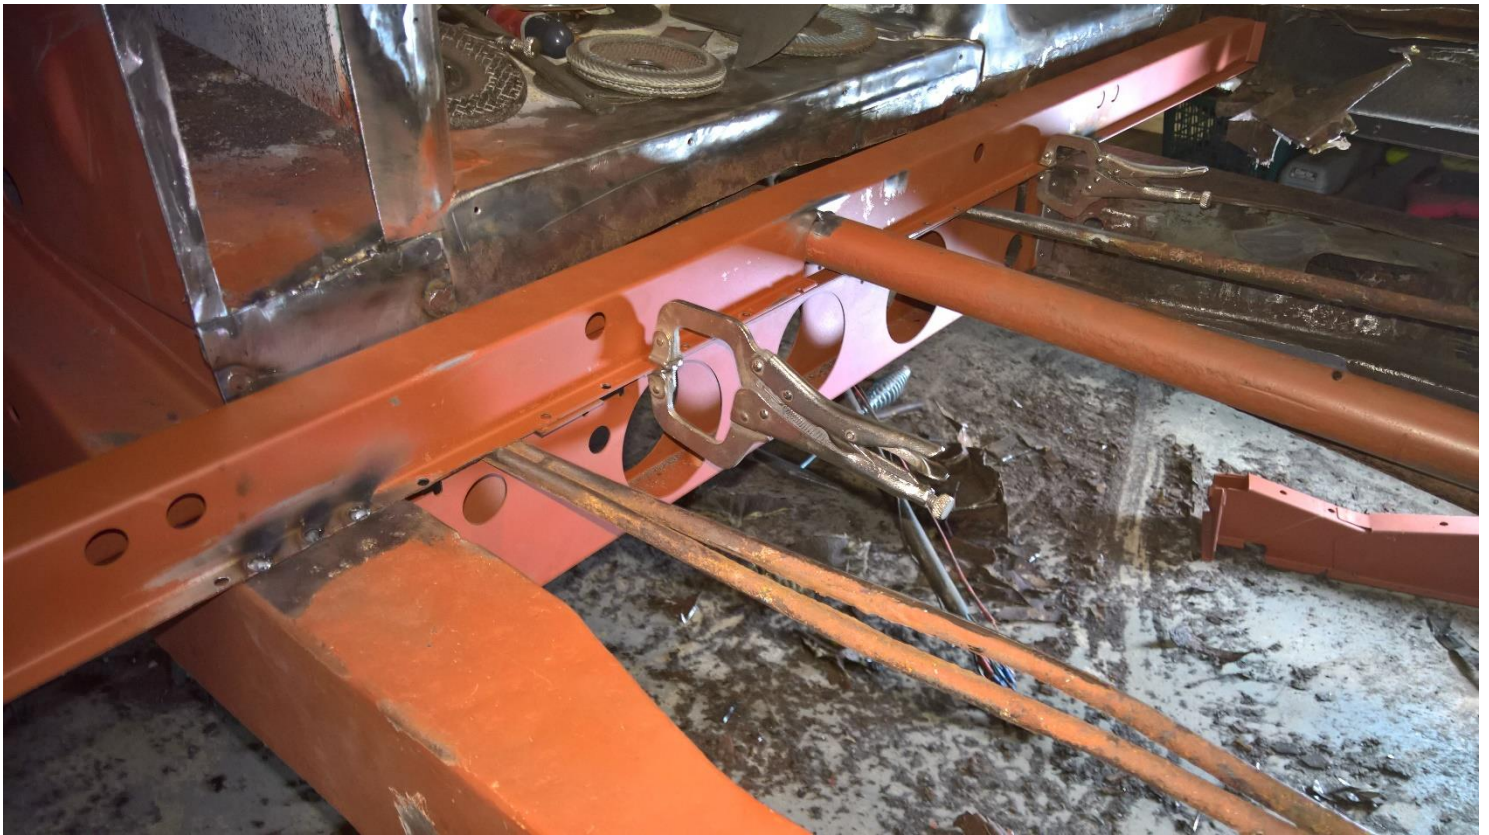
Then the painted support under that new piece welded in.

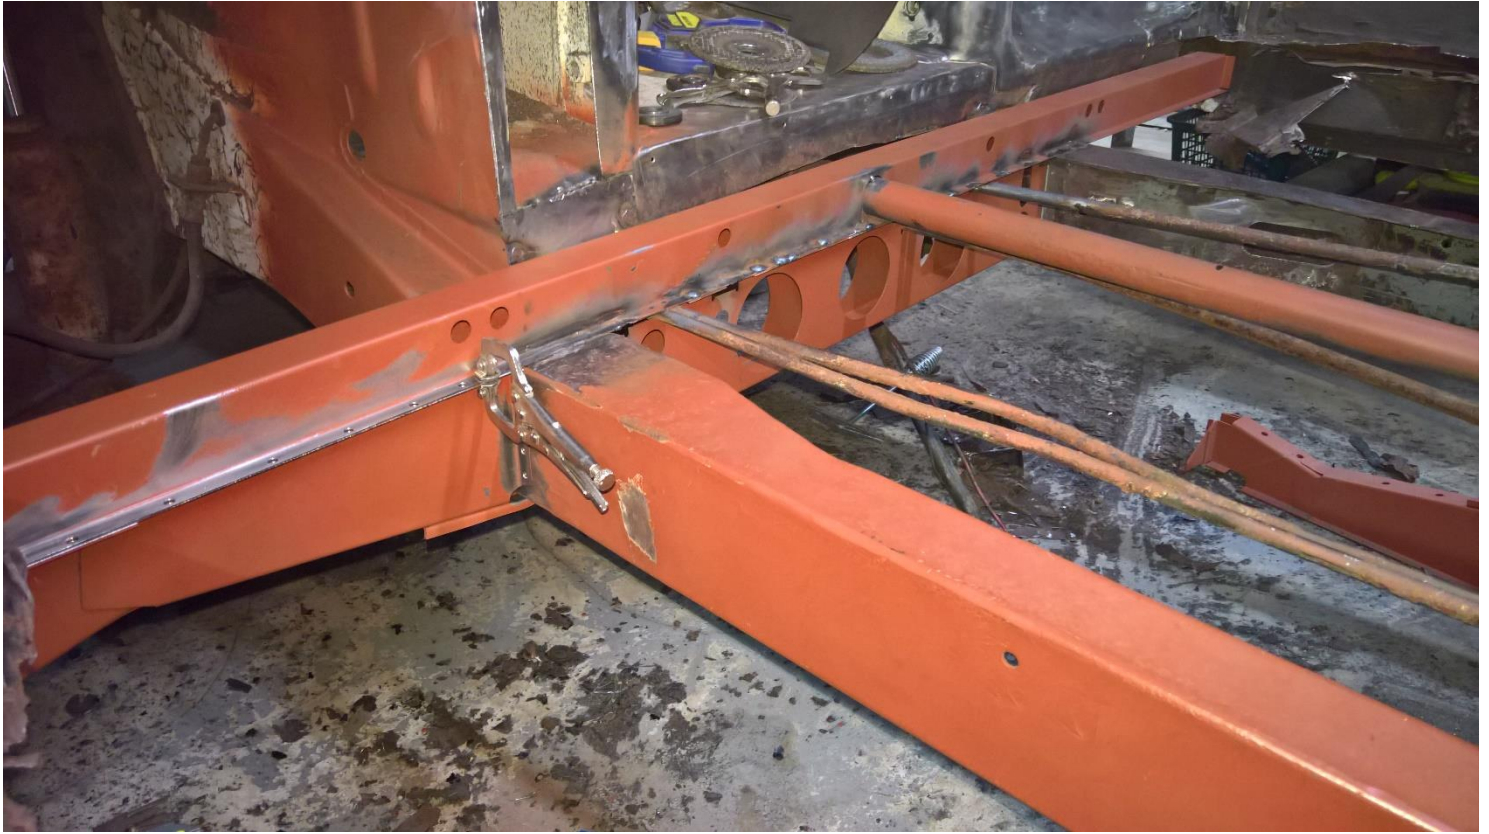
Near side jacking point in.

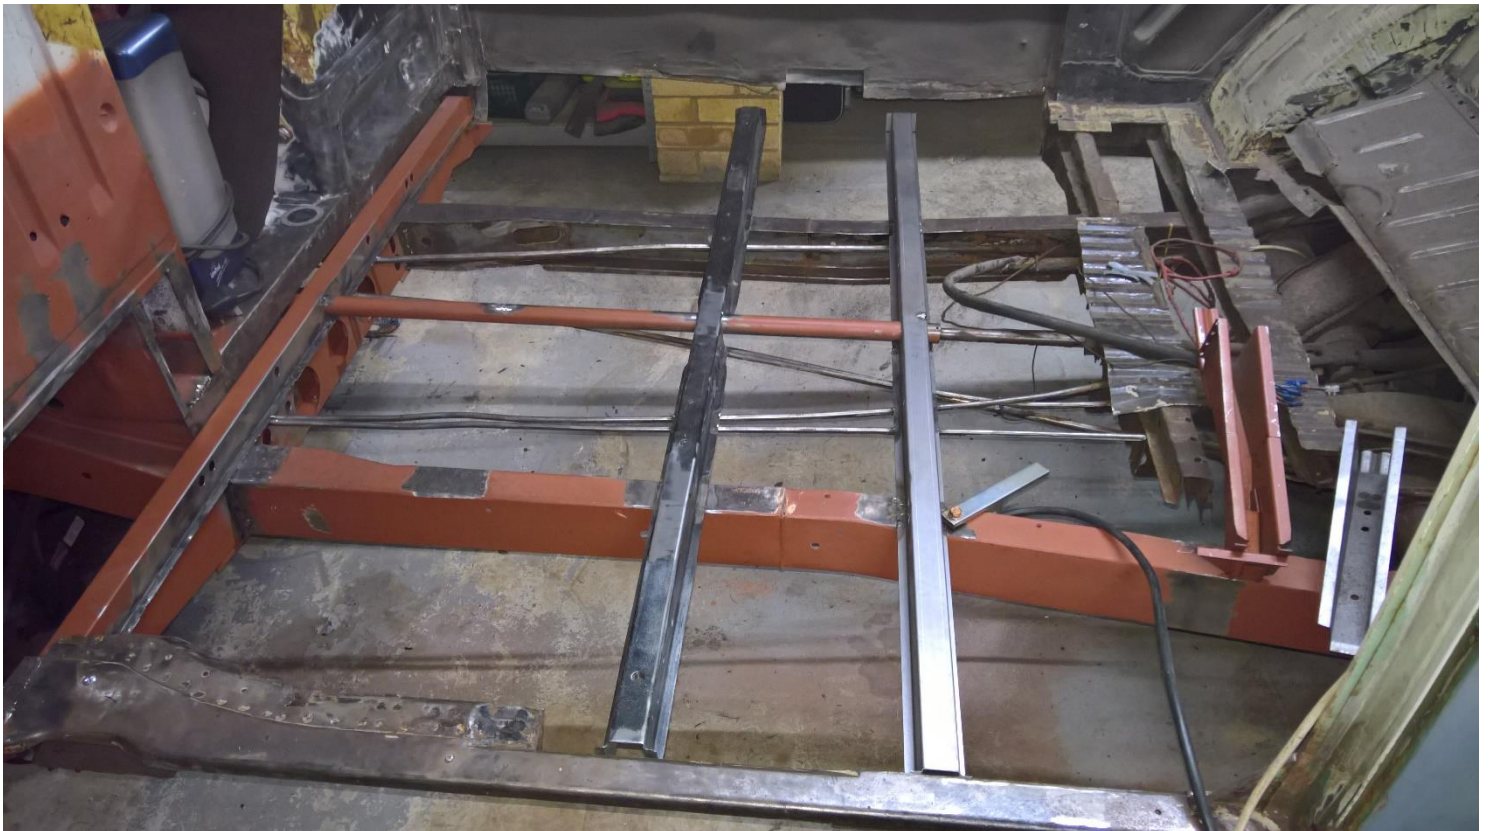
Offside needed the bulge tidying. Progress and pleasure in equal quantities. Now the fourth top hat almost at the back of the sliding door, both of them new and silver from Just Kampers then the third, old but unused, heavy and black that came with the bus, chosen as the middle one for strength under the floor when you step in. Four big supports fitted then welding the brake lines, gear selector and other tubes to these new pieces and tidying up, more sanding of surrounding areas still rusty but not rotten.

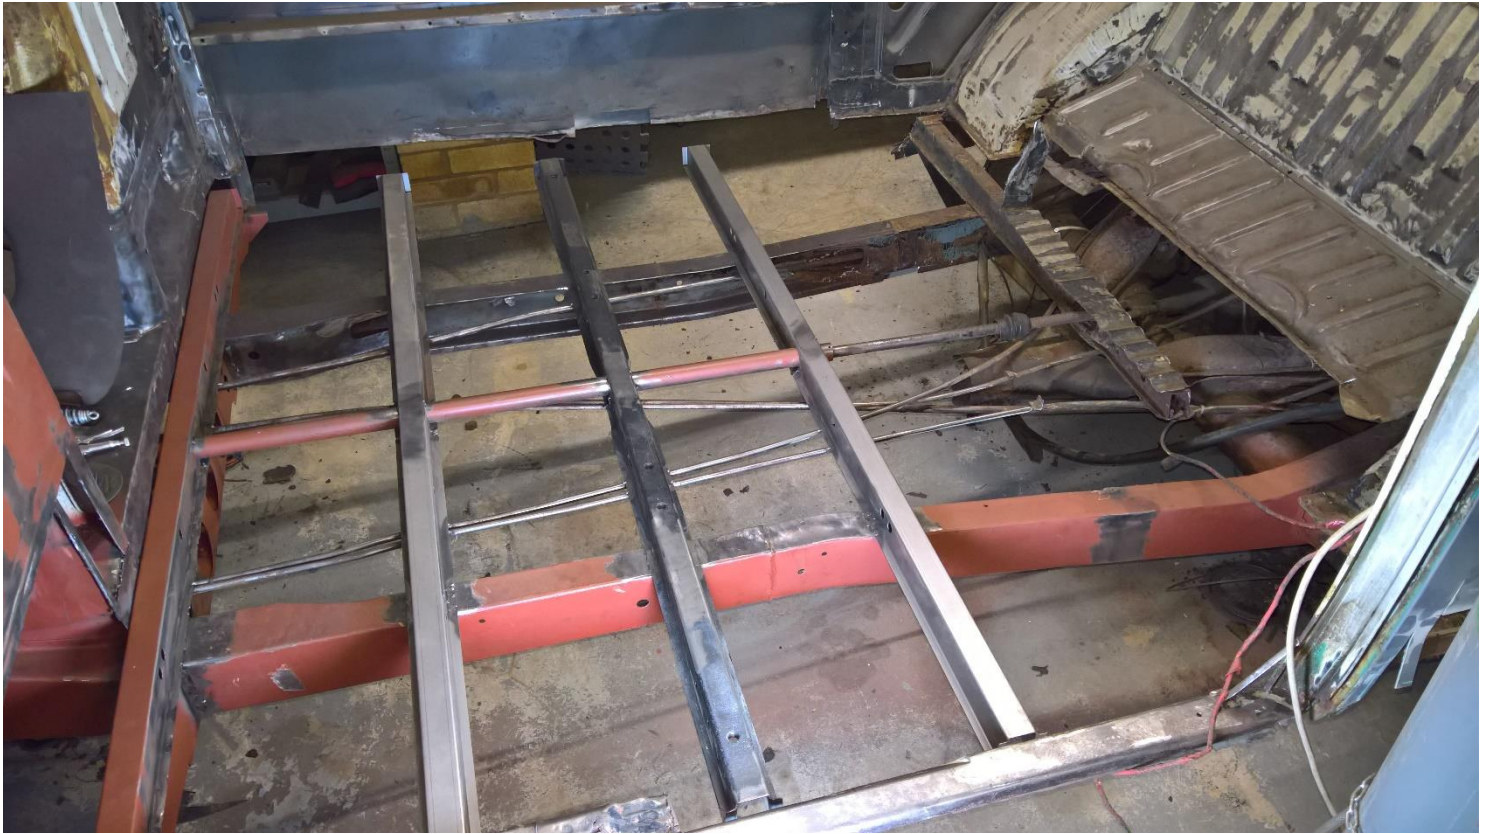
The fifth floor support, its middle support beam under and the offside jacking point also came out ready for replacement. OS rear jacking point had a lot of filler and underseal and you know that from the smell and the speed that the cutting disk moves through it.

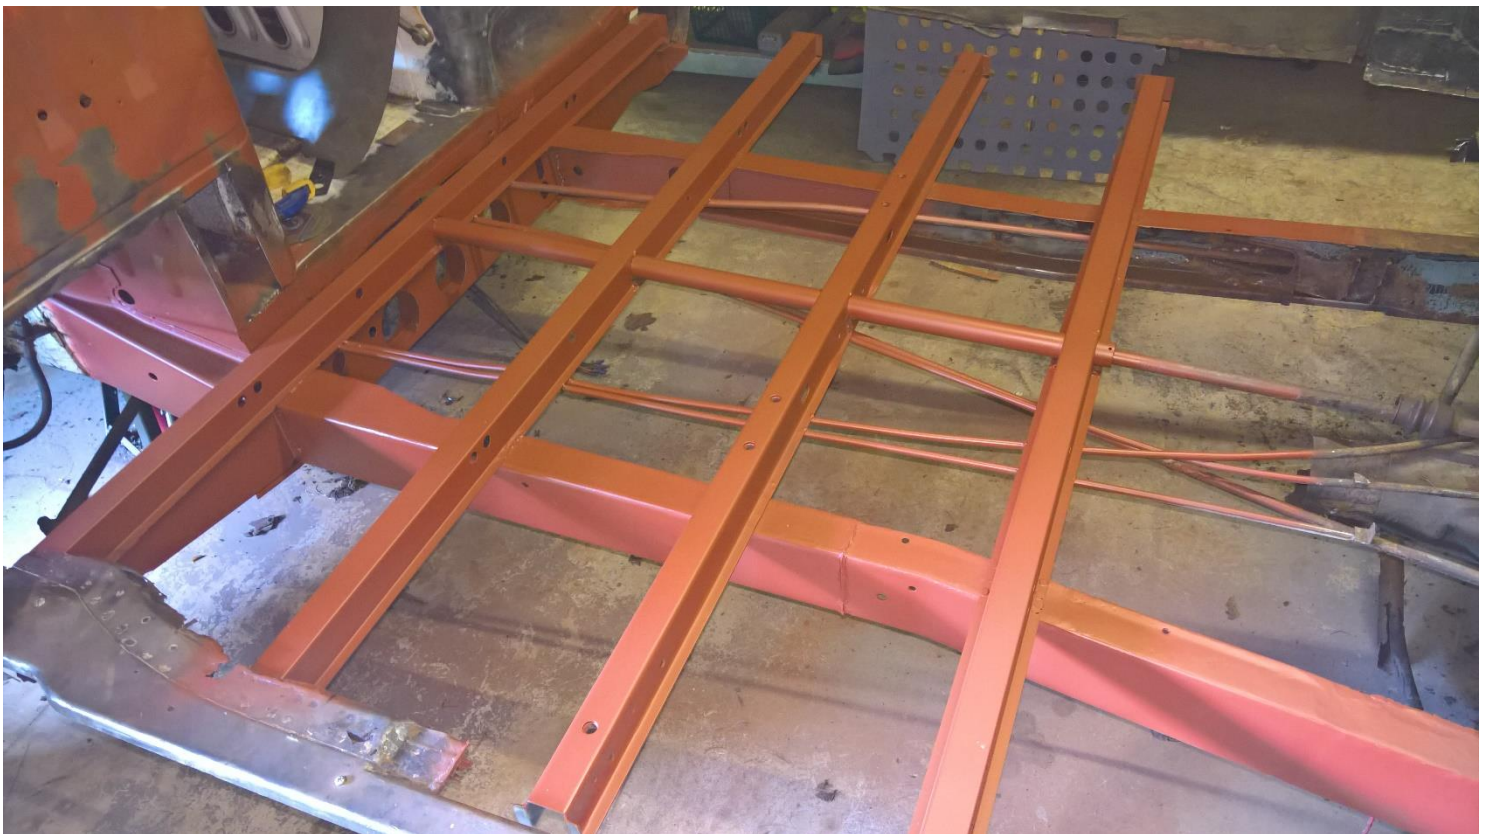
If there are 4 completed, let's get this spraying on the road. My first go at spraying from the spray gun not a rattle can.

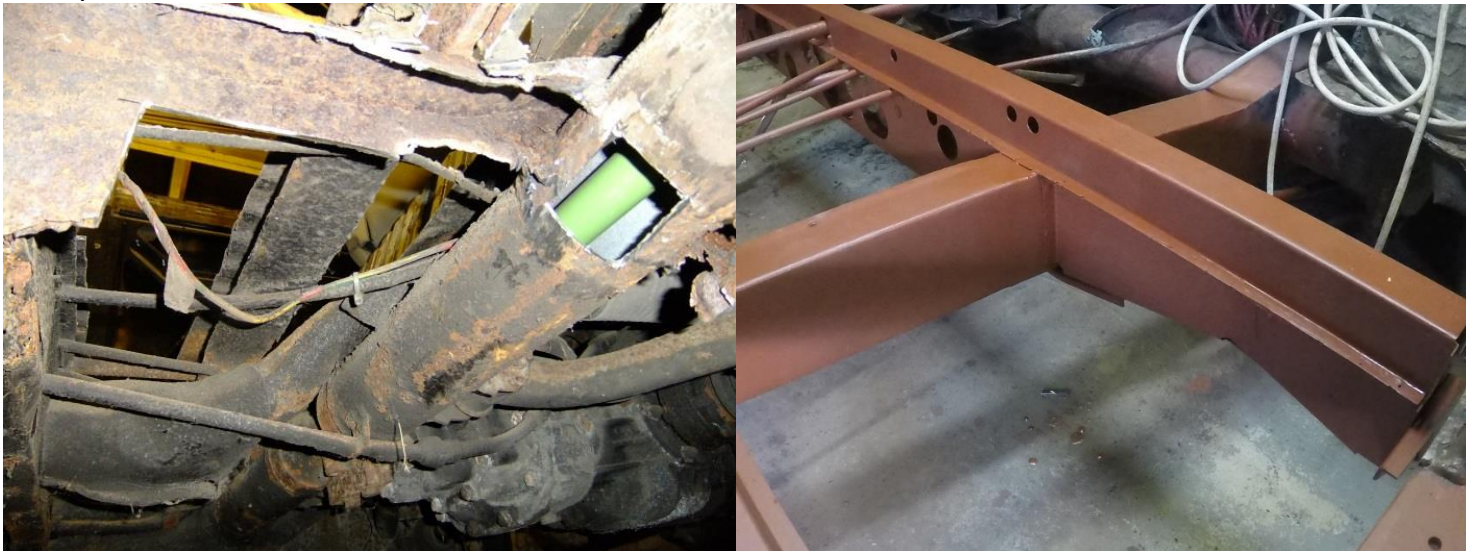
During 2017 I spent 112 hours working on my Bay window, taking things from the before picture of the chassis from below to the shot afterwards taken from above – new metal and you cannot see where we have been. Well, mostly.

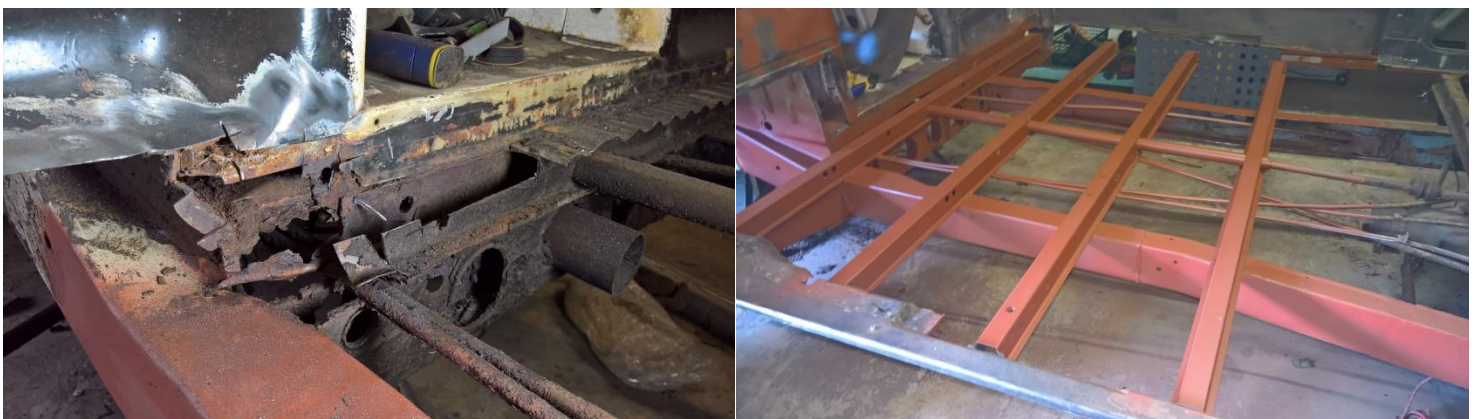
Then the B posts at the back of the driver and passenger doors and if you have them the bulkheads that sit at the back of the seats has a rail along the same line under the floor. See the picture of the rust before and the shiny new metal afterwards. All this takes a great deal of time.

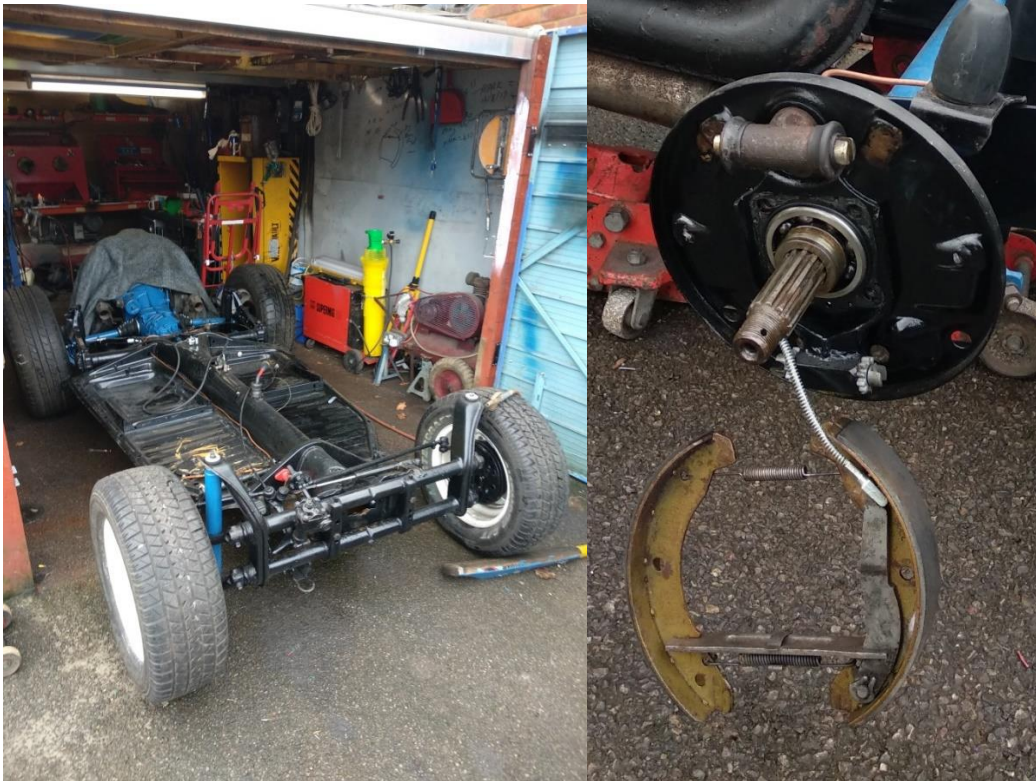
Outside of constantly cutting metal and scratching my head on how to add good metal in its stead, I have also spent just on 50 hours assisting a friend locally on his VW Beach Buggy. The floor pan is now complete, the engine, gearbox and brakes are now in. The steering is mainly installed and the gear lever after a little persuasion is now connected to the gearbox. I have learned a great deal about how much time it all takes and that if you read the manual, have the right tools and ask the Internet on a regular basis, as Volkswagen designed it to be simple, it turns out most things are simple. You may just need to angst and sweat over the complexity of that simplicity for a few hours!
