Eric the Viking – a restoration in many parts – February 2018

Eric the Viking – a restoration in many parts – April 2018

Eric the Viking – a restoration in many parts – October 2018

Eric the Viking – a restoration in many parts – December 2018

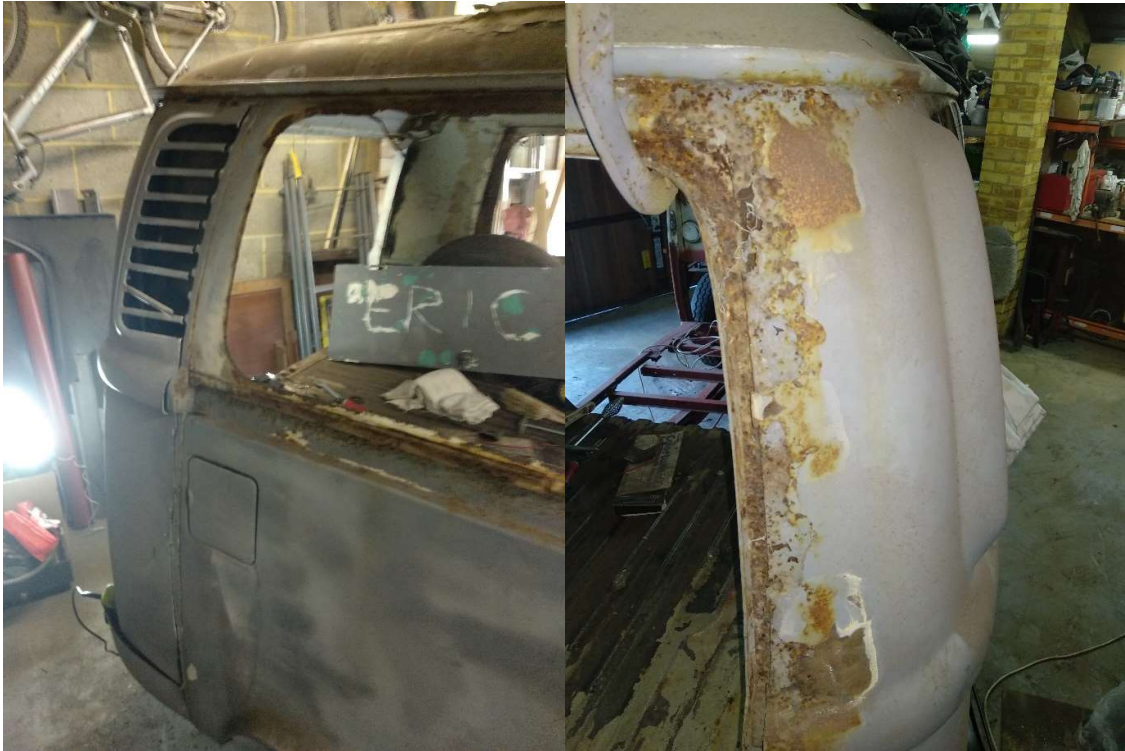
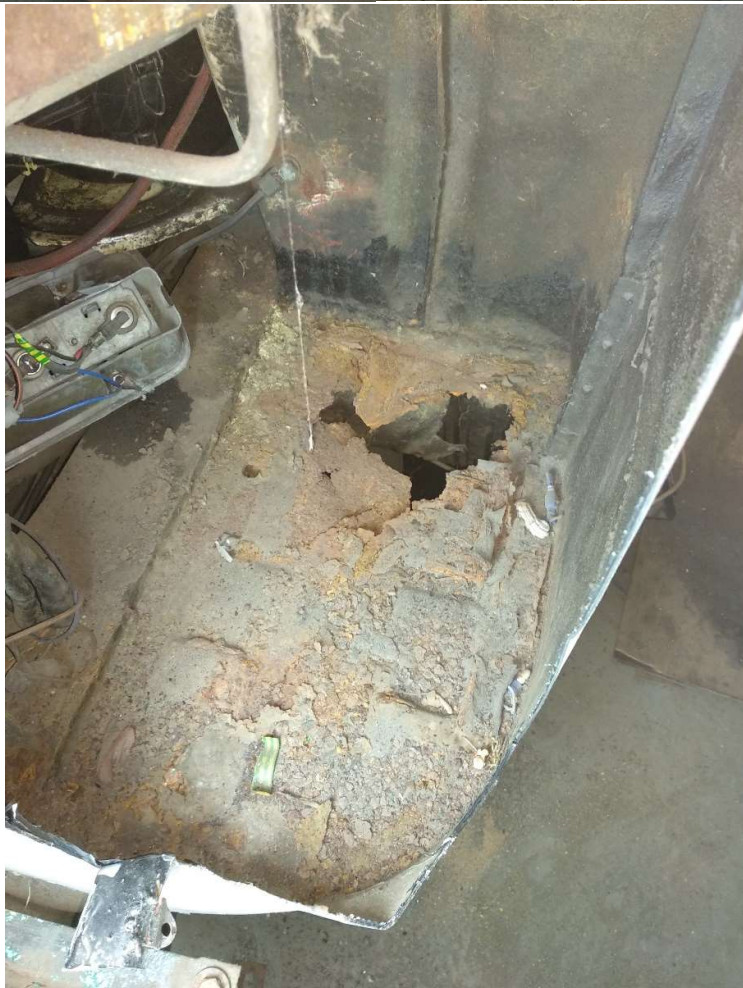
Or is it? Maybe I can get to the tube from behind, all that stands in my way is the engine, the gearbox and the ability to get into the engine bay given the rear brick wall of the garage. Cue a Christmas present of a pair of vehicle turners, effectively skateboards for cars, you jack up the wheel and instead of an axle stand that renders the car immobile, you drop the car tyre onto this little metal skateboard, in this instance both rear wheels. With the front wheels still able to steer, one person can push the rear sideways or any direction, steering as you need and in about a minute, Eric was 45 degrees across the garage. And his bottom in the air on these turners.

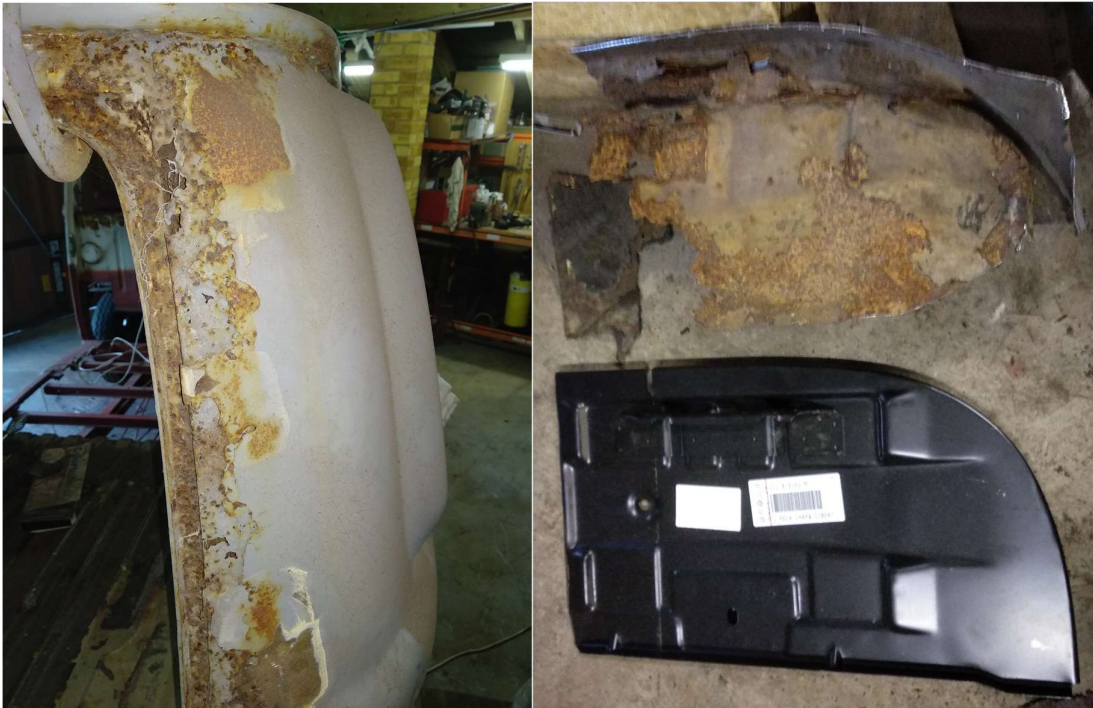
Rear offside outer corner removed completely due to rot.

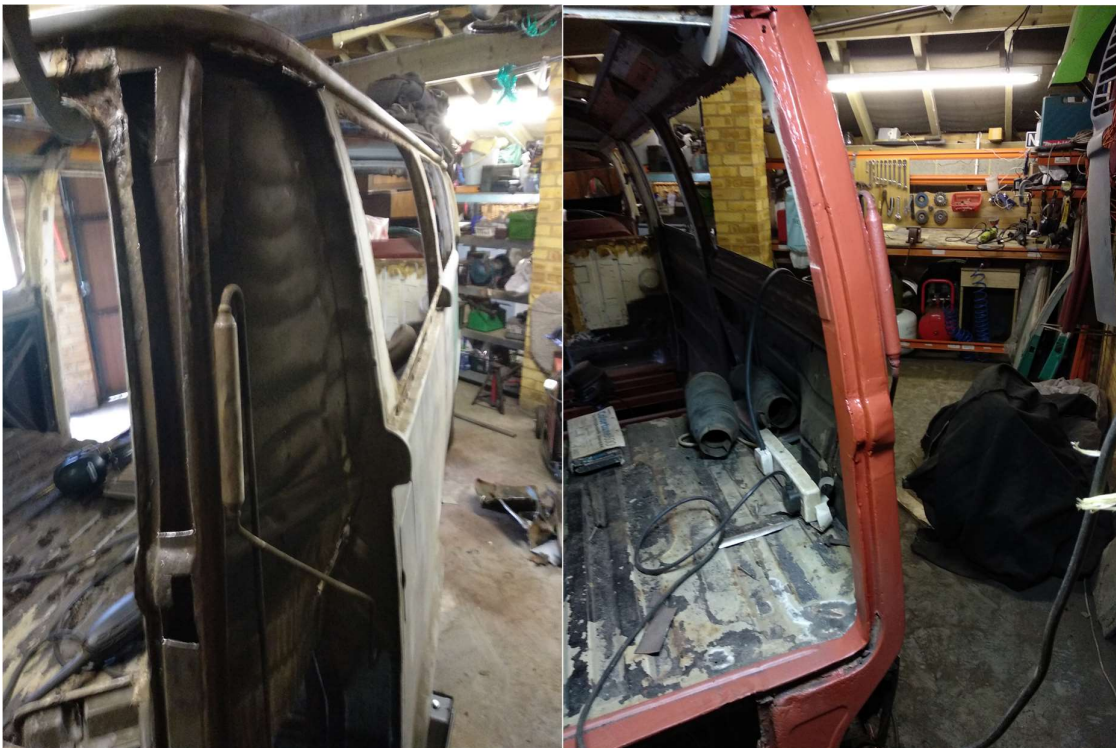
Structural D pillar down the side of the boot lid and engine bay door was badly rotten under the outer panel.

Removing a structural piece like that is above my pay grade, so rot chopped, patches made, welded in and painted after much grinding. One sentence covering around ten hours labour and that was the outer half of that one inner pillar, still have the rear/inner half for another day.

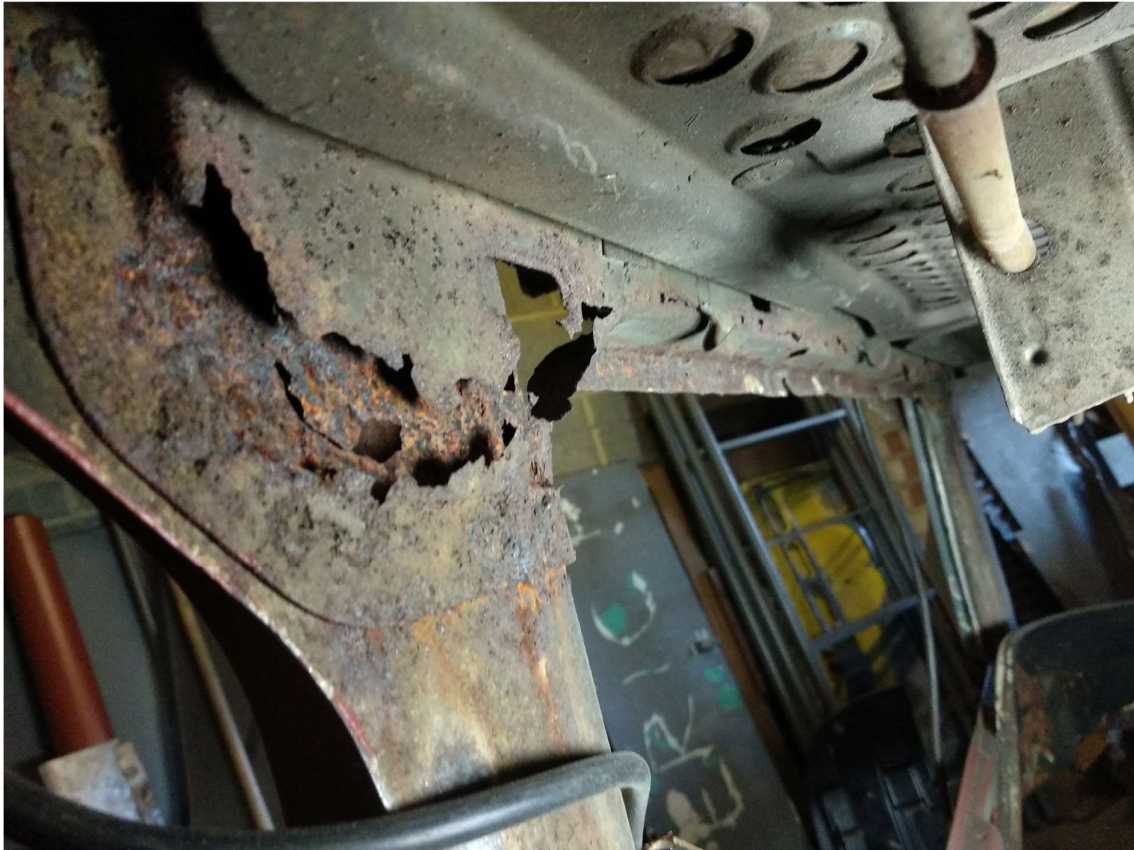
Then I saw the back of that D post I just spent a day welding the front. What do you mean it looks like this?

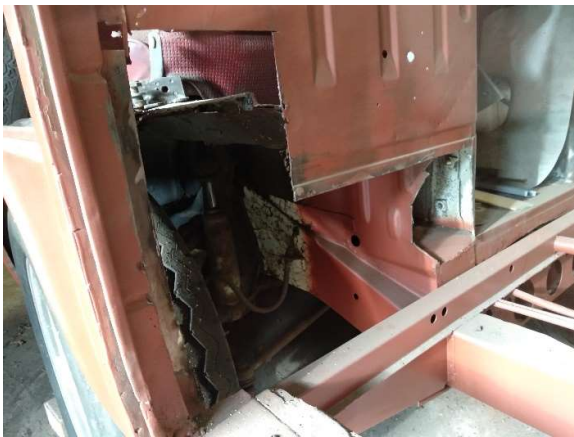
B-post. Behind the front doors and in front of the sliding door / matching other side panel is a pillar called the B post. It is pretty much a hoop of steel that runs from the chassis rail on a T1 to T4 (and maybe later, I have never checked) outwards, up the side of the doors and into the roof. Underneath the vehicle it forms a section strong enough to jack up your vehicle. Maybe. Therefore it all needs to be in good order, made of steel not body filler or rust and importantly needs to be connected at the join from underneath to the side.

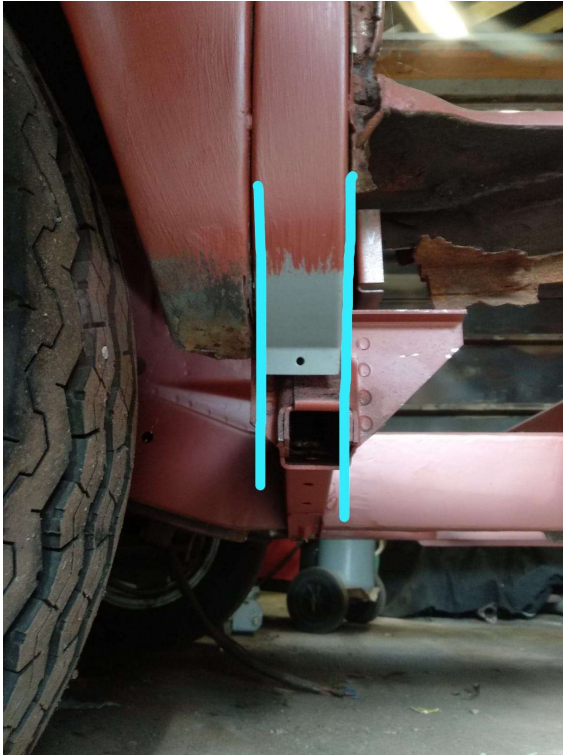
Eric's front cross member that starts this hoop runs across behind the front seats with jacking points below and SHOULD meet the edge of the B post.

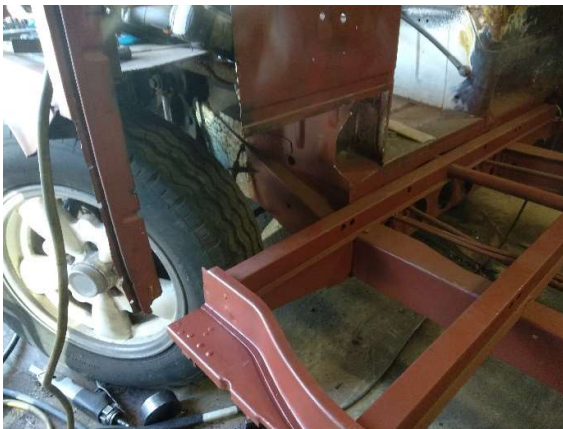
Unfortunately it was 10mm away from lining up and therefore I had fitted the cross member incorrectly. Since that one is parallel to the other 5 cross members, potentially they were all incorrectly placed as well. My heart sank. I enlisted some professional help from a talented friend who just happens to have been restoring VW campers for 30 years professionally and after a good deal of investigating and measuring, we were able to conclude that my cross member was correctly placed. My heart lifted. Unfortunately, my wheel arch, sliding door threshold plate and bottom 12 inches of B post were all in the wrong place. My heart sank. The angle grinder makes short work of removing the incorrectly placed pieces, but that leaves a lot of work to put it all back correctly.

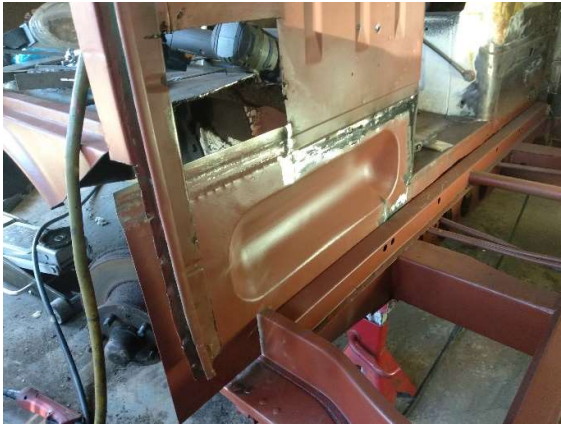
Now that all of the wrong metal was missing, including the heavy angle iron added 2 years ago for strength but in completely the wrong place, we were able to add in some good new metal in the right place. Firstly, we removed the threshold plate that you step on when entering the sliding door, we were then able to add the inner sill, then the middle sill. With those welded in place, the bulge can be fitted.

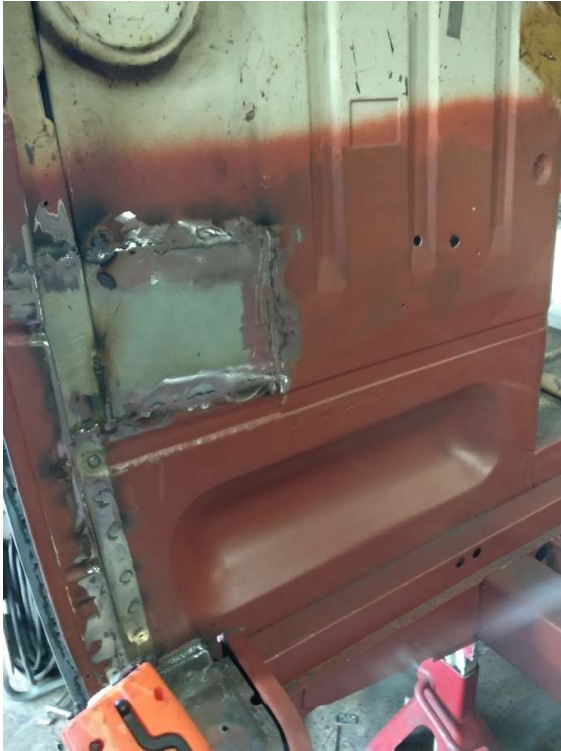
The bulge panel is really just a flat sheet of metal with a dent for the feet of the bus passengers but the bulge does add strength to that panel. That panel forms the front of the B post. Then a “cover” goes on the outside to be visible and the rear side of the square section and the inside piece of the square were fabricated from sheet steel and hammered with the pressings required. Finally a flap coming into the van along the rear of the bulge was folded and this new metal in the shape of a W was welded in. See the spot welds on the back of the bulge panel, attempting to replicate the factory original.

We also filled in the hole above the bulge to replace the previous rot and the top of the bulge was whacked repeatedly to make the pressing just above the bulge. It isn't perfect, but is sufficiently close that once the primer and paint are on, it should not be visible.

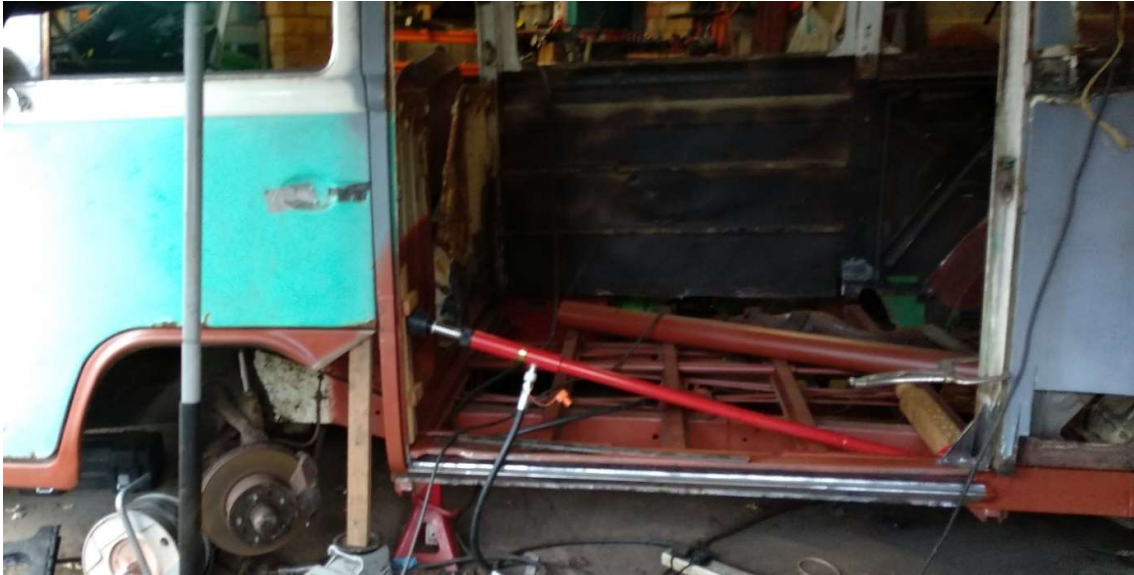
With that metal all looking good, the threshold plate could go back in over the top of the inner and middle sill, the wheel arch could go back in too. Then the passenger seat floor was joined to the back of the seat. All of this was done with a porta-power levering the B post straight from top to bottom as the issue was a sagging van making the bottom of the B post 100mm off true. It is just a big gas ram to hold the metal square as the sections are welded together to stay in shape.

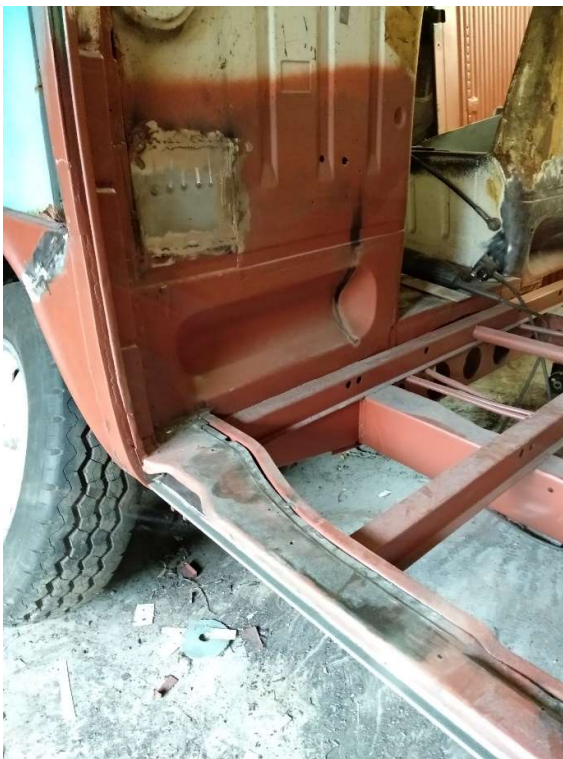
After about 4 man days, the old threshold plate, along with a new bulge, new inner and middle sill and some newly cut and fitted sheet steel are all in Eric, he is a lot stronger and it is all in the right place. 4 man days is a lot less than the 62.5 hours noted at the top, more next time. Stay dirty everyone.

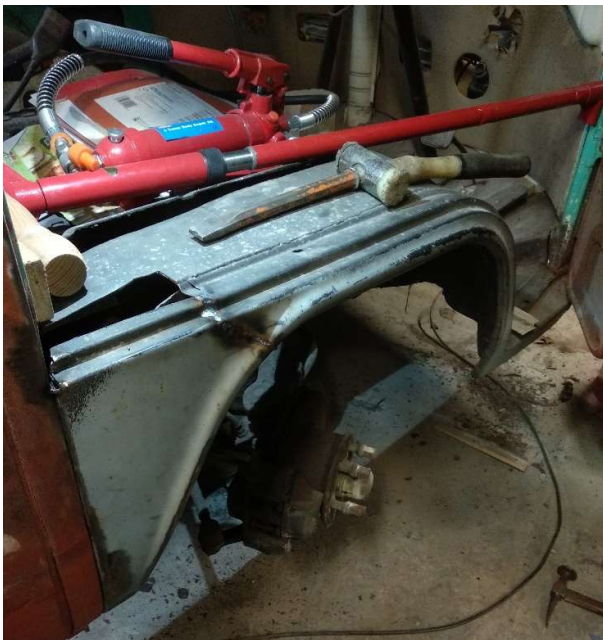
The last picture showed the B post and the toe bulge behind the passenger seat all complete and mainly primed, that has now been primed. We have now finished the other B post behind the driver's seat – another sentence that took two man days to complete! The van had sagged once more and the B post was banana shaped, requiring the Porta Power, removal of the wheel arch and the rotten parts of the seat tub. Rot there is a job for another day. Easing off the metal from the bottom of the step as it hits the A post meant that it was easier to straighten up that side of the van.

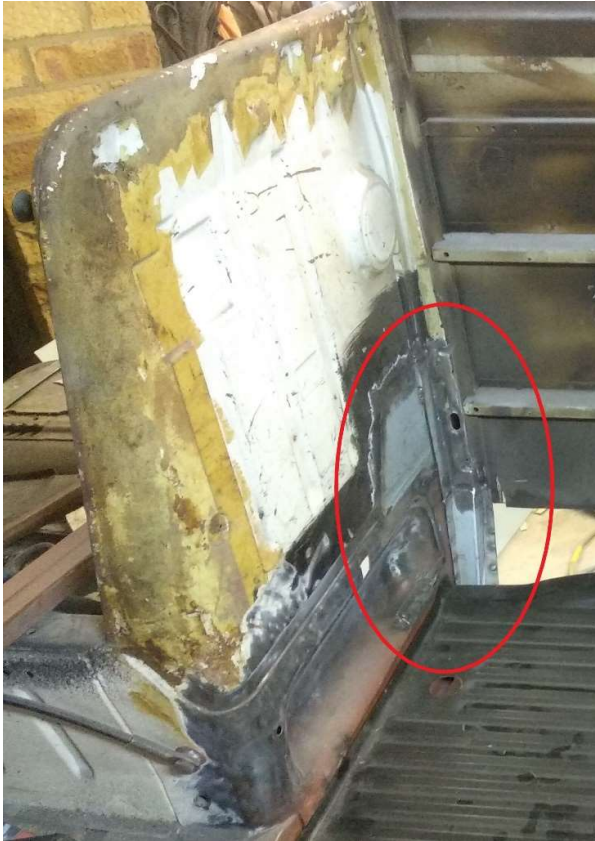
With the Porta Power stretching the door gap to the correct size and the US import door supplied with Eric's purchase making its first appearance, the wheel arch and B post were welded in place to provide strength in that area for the first time in years. Here's the view from inside – the lower 8 inches are new, fabricated inside and a Just Kampers B post outer panel on the outside.

Where the floor was trial fitted, anything underneath will be hidden and received 2 brush-painted coats of oil based rust proofing primer (Rustoleum) inside the sill cavities and around the newly rebuilt B post. Anything above there will be visible inside the van and received a spray coat of Rednox anti-rust paint. Both are red!

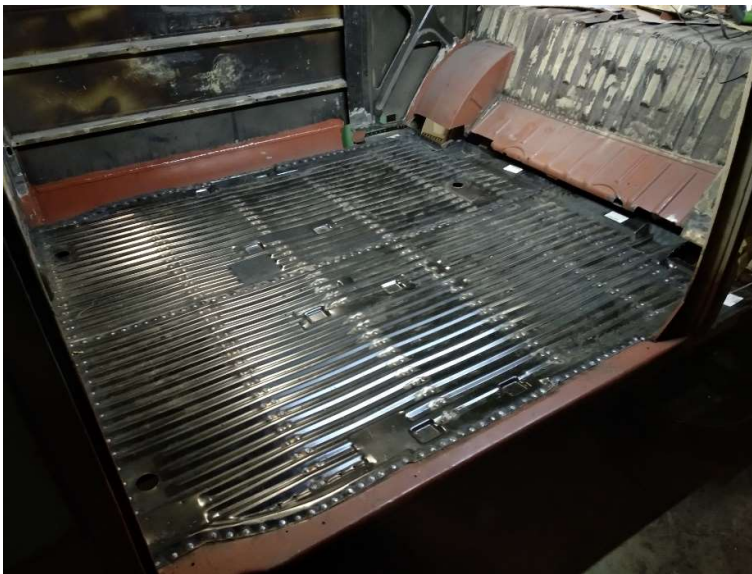
Finally, the floor was welded in.

Welding took around an hour and a half of those same few hundred drilled holes and no grinding has yet happened. Given that they are all in the valleys of the corrugations, they may just get a wire wheel smoothing then some paint! As you can see, around the edges of the

floor, we need to add the LHD to RHD conversion plate on the non-sliding door side to bridge from the middle sill to the body panel – available from Alan Schofield and purchased two years ago. Also need to fabricate and weld in behind the C posts, the bottoms of the inner wheel arches and the rotten edges of the 45 degree panel between the wheel arches. Expecting that will take a couple of days to complete using the latest and greatest CAD assistance. That's Cardboard Aided Design. Template your metal with empty pizza boxes, transfer that to your Zintec lightly galvanized sheet metal and shape with your new hammer and dolly.
