## Eric the Viking – a restoration in many parts – August 2021

Eric the Viking – a restoration in many parts – October 2021

Eric the Viking – a restoration in many parts – December 2021

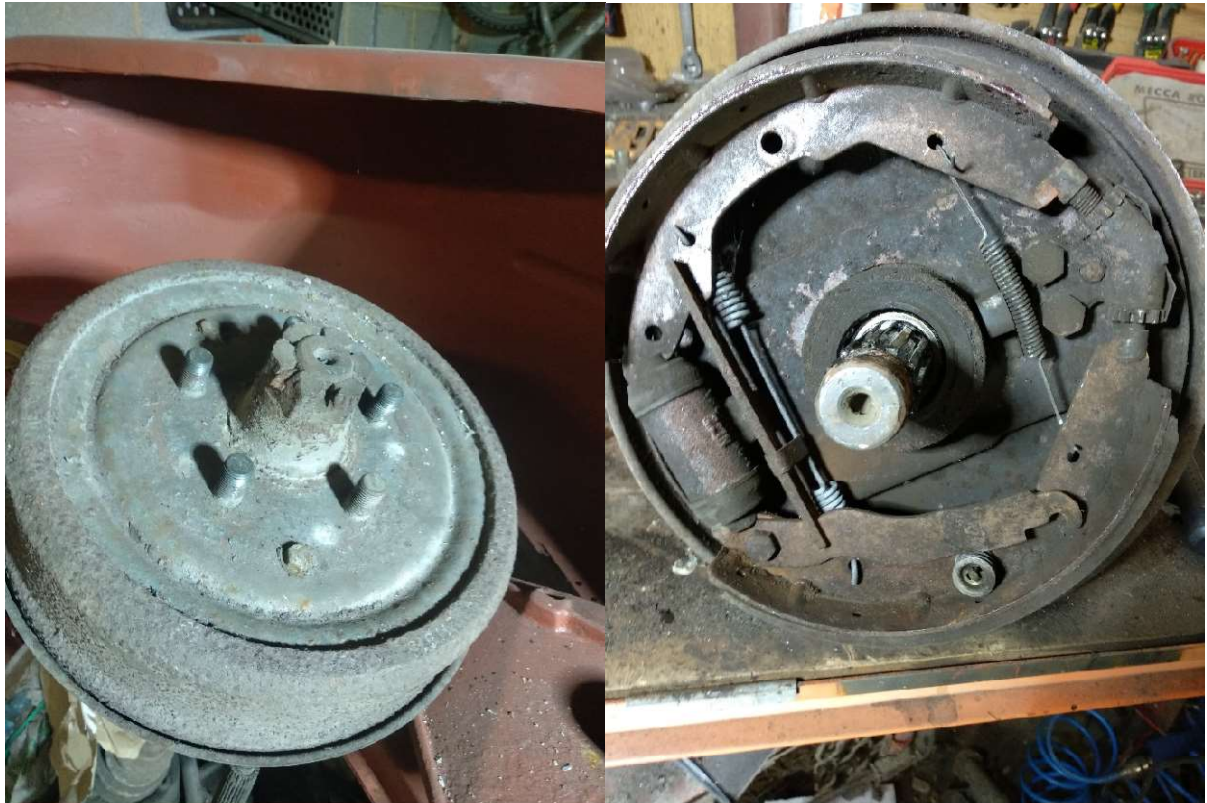
Rear brakes on my Bay are drum, and with Eric spending a lot of time rotting outdoors, they were in a shocking state. The castle nut in the middle of the rear wheel was so rusted to the end of the hub that no amount of leverage would shift it but an hour with an angle grinder got it off in pieces! Then the drum refused to budge until a lot of heat and persuasion on the bench freed it off. Inside looked ok at first but a CV joint bolt was jammed and needed cutting off which meant that I had to chop through the brake back plate to access it!

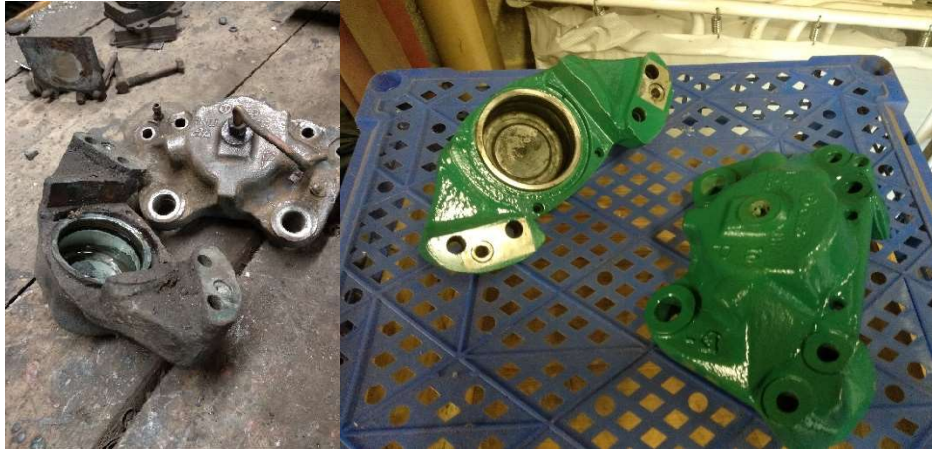
Waiting on parts deliveries from Just Kampers (don't forget your club discount), I turned my attention to the front suspension and brakes. Calipers are expensive to replace and generally only need a good clean, reassembly and new rubbers on the ends of the pistons. I did that job 15 or so years ago on my Matra Bagheera as the only job I really did on it. Quite pleased with the bright green caliper paint finish and you can follow 2 articles on how to do it that are on our club web site (thanks Jonathan!) as well.

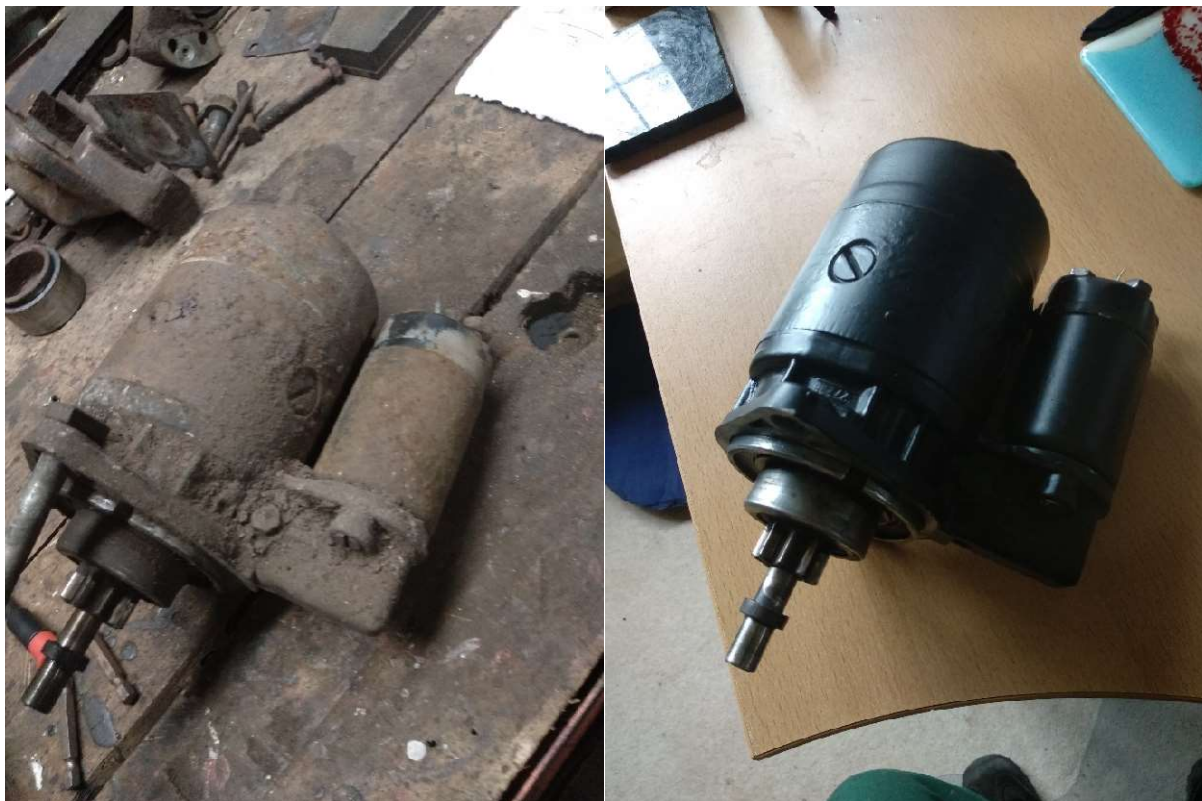
The starter motor was in the way of getting to the underside of the fuel tank to restore that, so I unbolted it, separated the two cylinders and cleaned them before spraying them black.

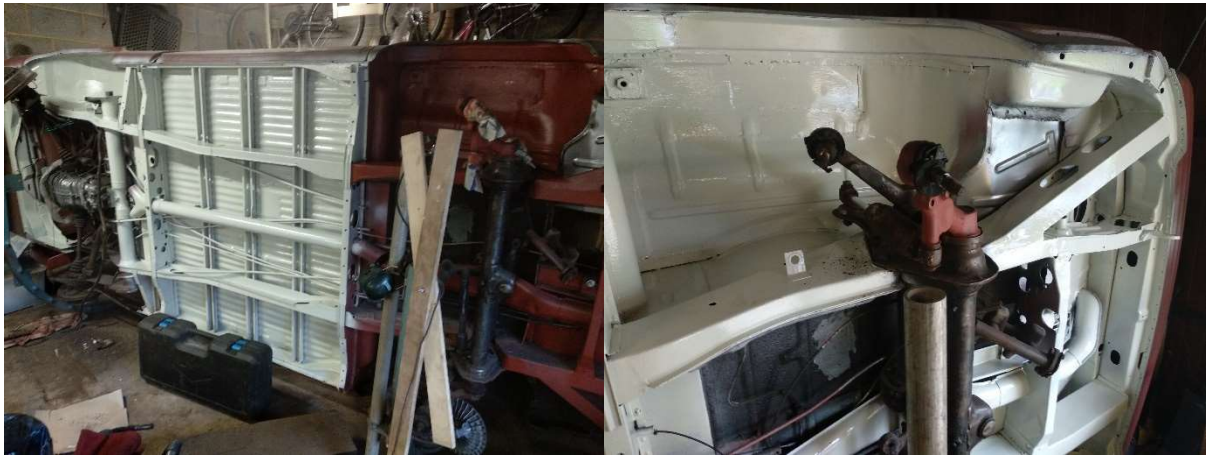
Eric has been on his side now for 20 months and I finally got him ready for the topcoat on his bottom. I chose to use L90D synthetic enamel as I wanted hard wearing and easy to apply since I am a novice.

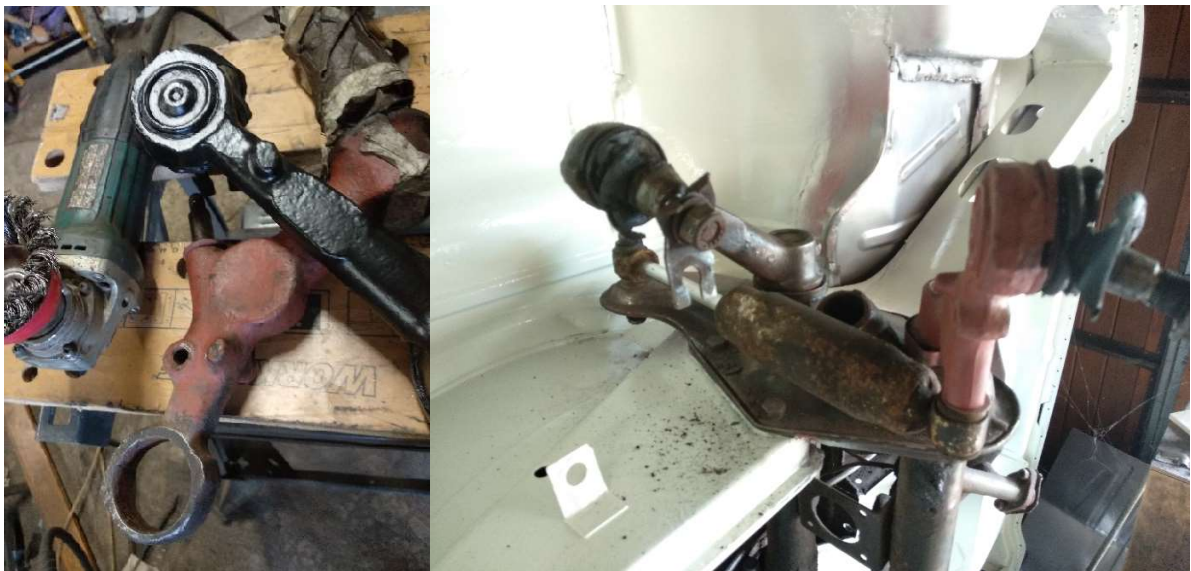
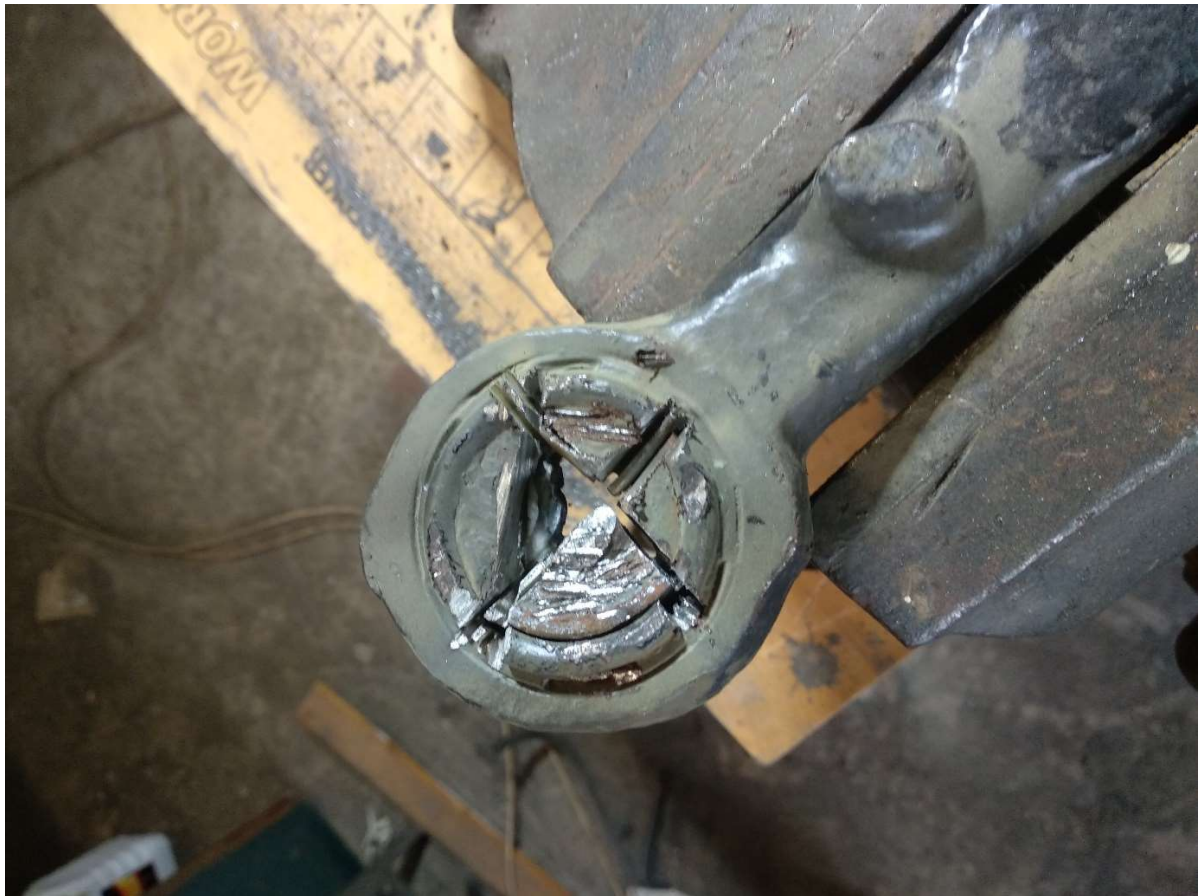
Attached to the front beam are the front suspension arms. Pressed into the tops of 2 of these on each side of the Bus are the ball joints. I dutifully borrowed a ball joint press, inserted the arm and ball joint but could not work out how to press it out. I tried various options, I made a little jig out of 10mm steel railing, I watched Youtube videos and eventually with the help of friends, I found out the trick. The ball of the ball joint sits in the cup of the joint, if you angle grind the shoulders off the ball joint, you can remove the ball, once that is done, you angle grind from the top, cutting just the top of the ball joint and not the arm holding it.

Once the top of the ball joint is ground through into a hole with the angle grinder, you need to cut it with a hacksaw to split the ball joint cup into 4 pieces being careful not to cut the arm at all. It is back breakingly tiring, hot and dusty. Each one took an hour and I have the other 2 on the other side later this year – if anyone has any faster ideas do please get in touch! FINALLY the 2 ball joints were clear of the arms allowing those to be cleaned up ready for top coat and with their ball joint holes ground back of dirt and rust ready for the new ball joints to be pressed in using the borrowed press.

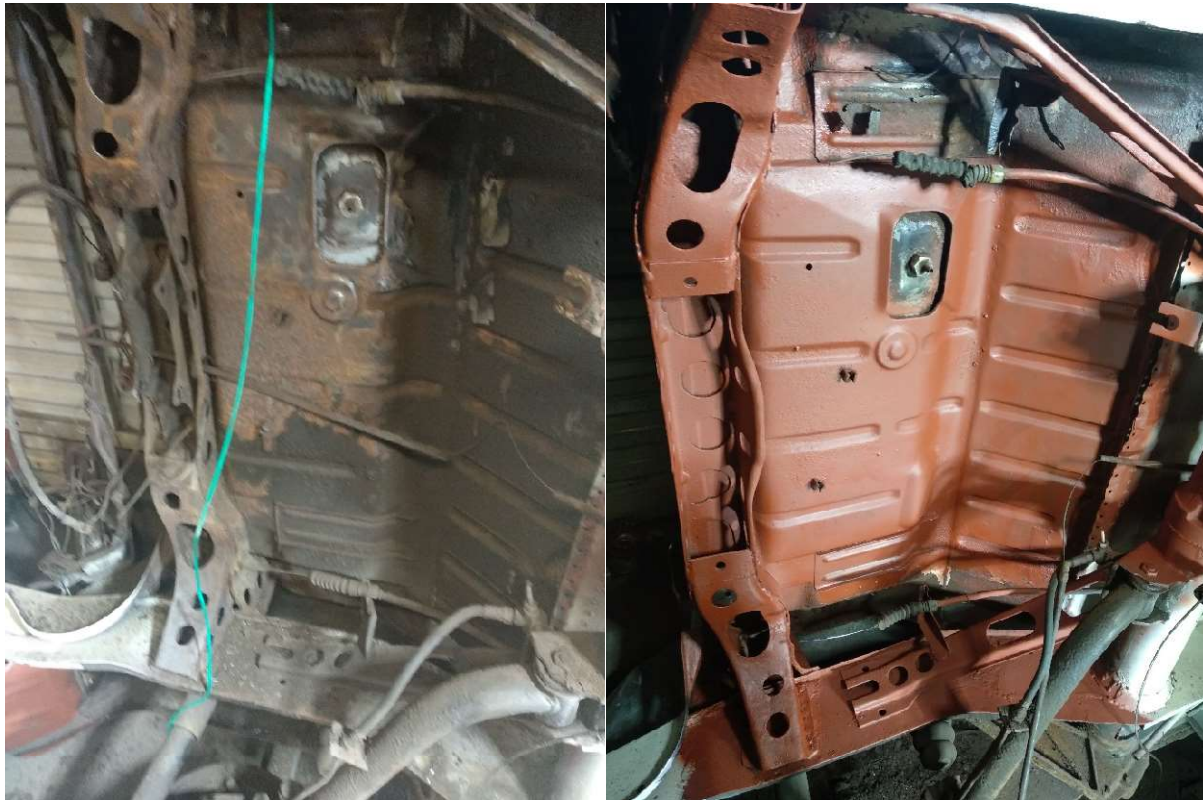
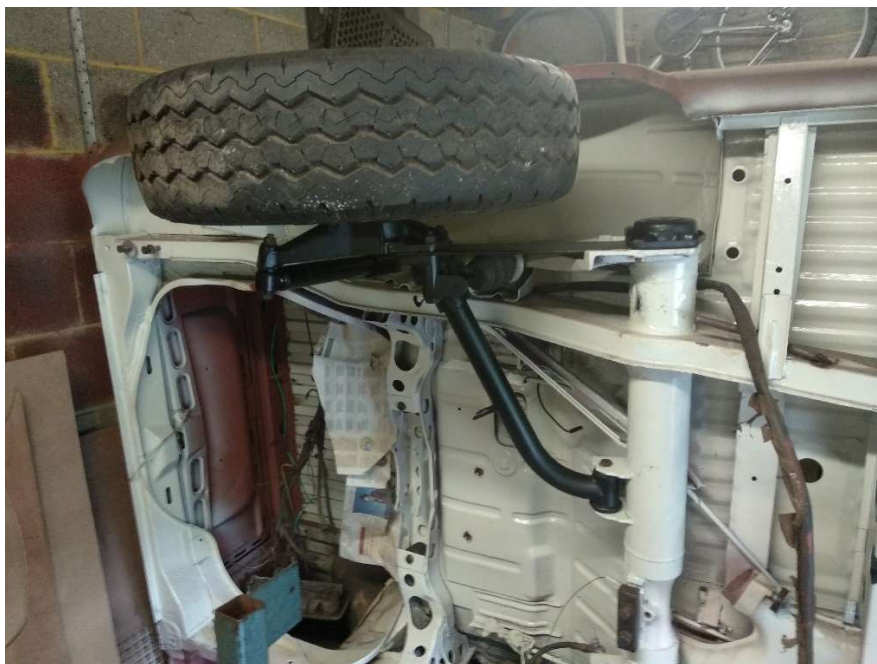
In order: The front suspension and front brake is back together on the offside, the gearbox is out, the underside of the fuel tank was then accessible to get its rust removed.

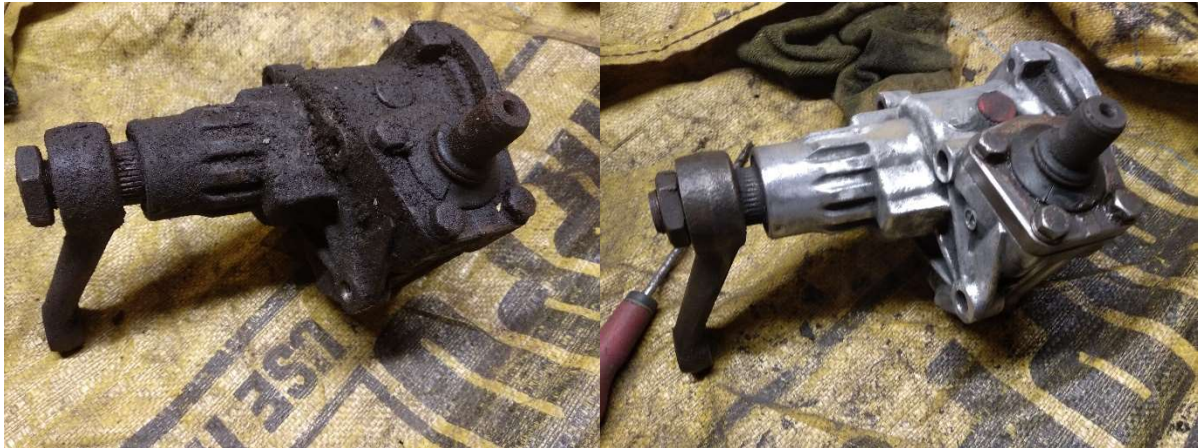
The steering box has mostly been cleaned up, so has the gearbox and Eric is back on his wheels.

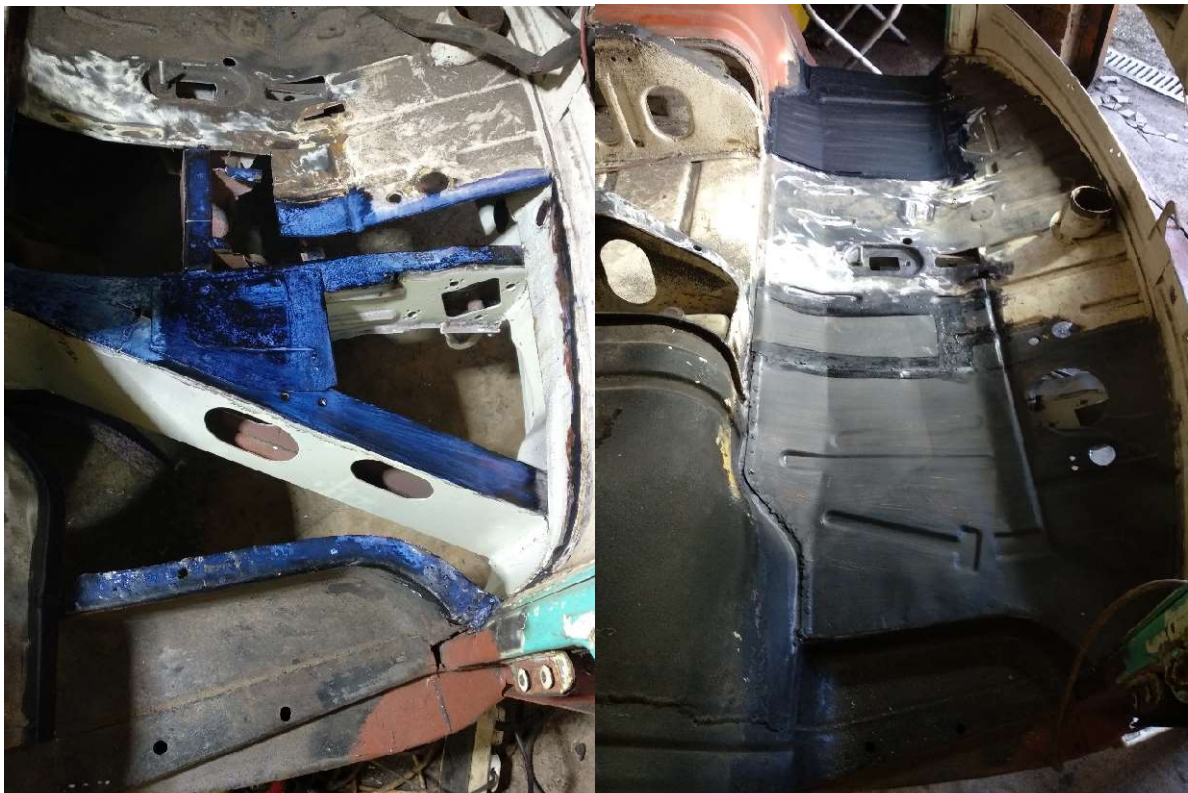
A large chunk of the current work was the cab floor. The driver's side was pretty ropey and the outer half needed replacing. I chose to remove more good metal than was really necessary to give a straight line of seam weld to reduce the visible change. I was also able to rust proof the tops of the chassis rails at the same time. The passenger side was less rotten and was a smaller patch plus a final rectangle in the middle just behind the handbrake and we have good strong metal all welded in.

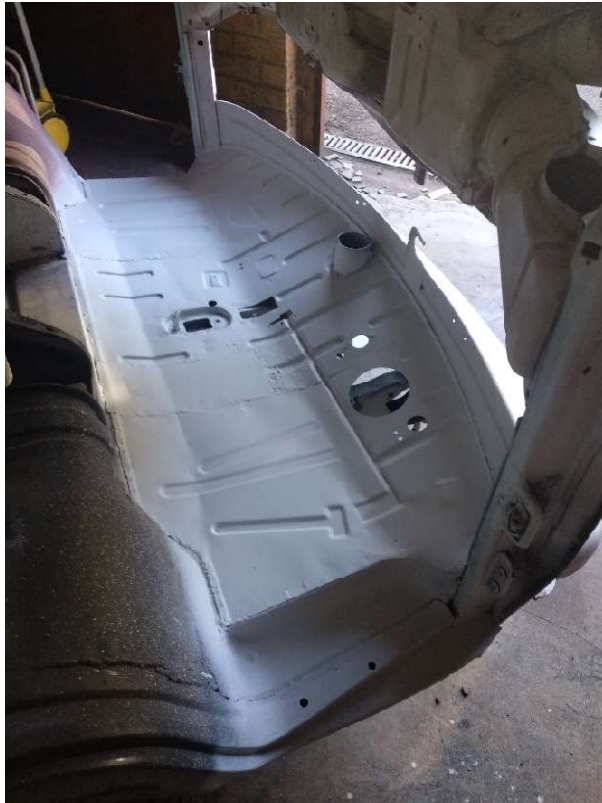
Then primer time but my spray gun had a fault and it looked rubbish and will need smoothing before top coat. Nonetheless rather improved!

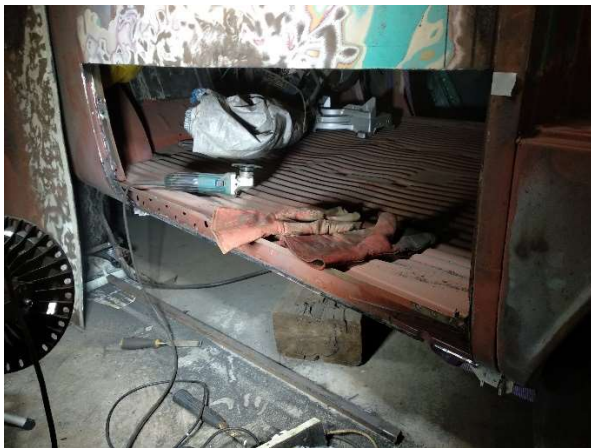
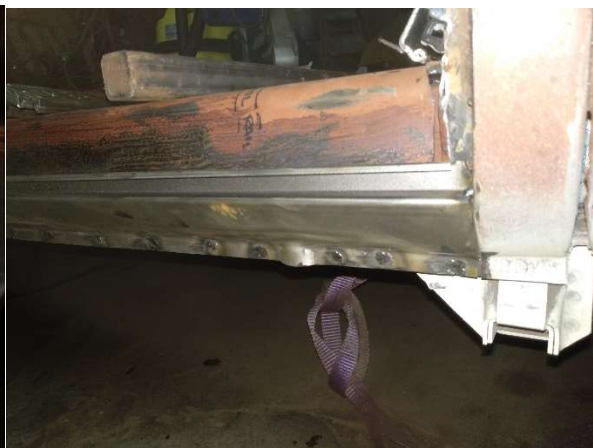
The next part of the project is going to be interesting! The offside middle panel opposite the sliding door is a fixed panel. Several years ago I replaced the lower part of that panel and the outer sill with a cheat panel that is all joined together. It looks ok but the top of the original panel had been damaged in an accident many years ago and there was a lot of filler. I also cut the edge off the lower replacement panel as it was slightly too large but welding that cut in looked rubbish.

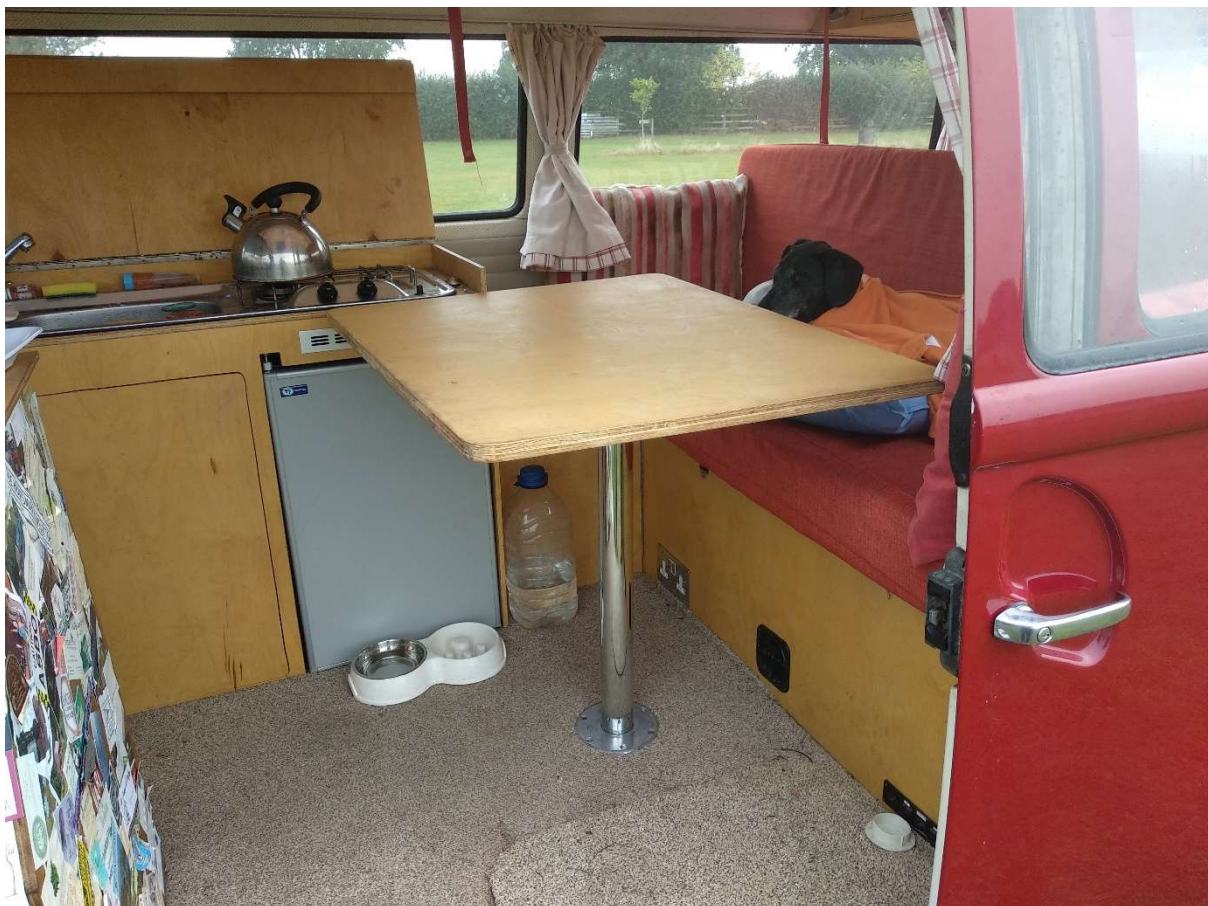
During an evening conversation with a T5 owning friends, he mused that it would be great if our little vans had a sliding side like the huge expensive motorhomes and so an idea was planted. Fast forward several months, a lot of thinking and some hours experimenting in the garage. The non-sliding door panel can be seen in some models as a traditional sliding door, sliding backwards and called a double slider. Therefore, Volkswagen are happy that this does not impact the strength of the vehicle and that

is good enough for me. As noted in the last write up, Eric's non sliding panel has seen some accident damage and the repair was not great by me a few years ago and was removed. With that composite side panel and sill gone, I added a new outer sill.

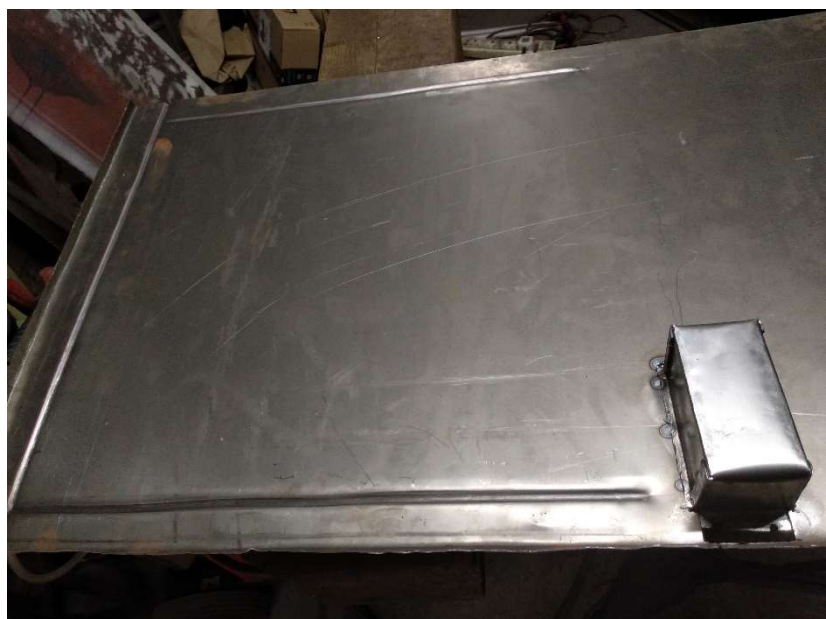
The two outermost runners are within an inch of the B post and C post to give strength at the edges. Then a further pair on the van floor between those runners but only six inches apart which means that one is just under the other side of the fridge and the other is just under the corresponding place for the other cupboard. Under the centre of the whole unit will be this actuator to push and pull everything. The slide out tray then received a little box to hold the worm screw of the actuator plus the whole tray had some strengthening lines pressed into it and the sides folded up to attach to the pod sides in due course.

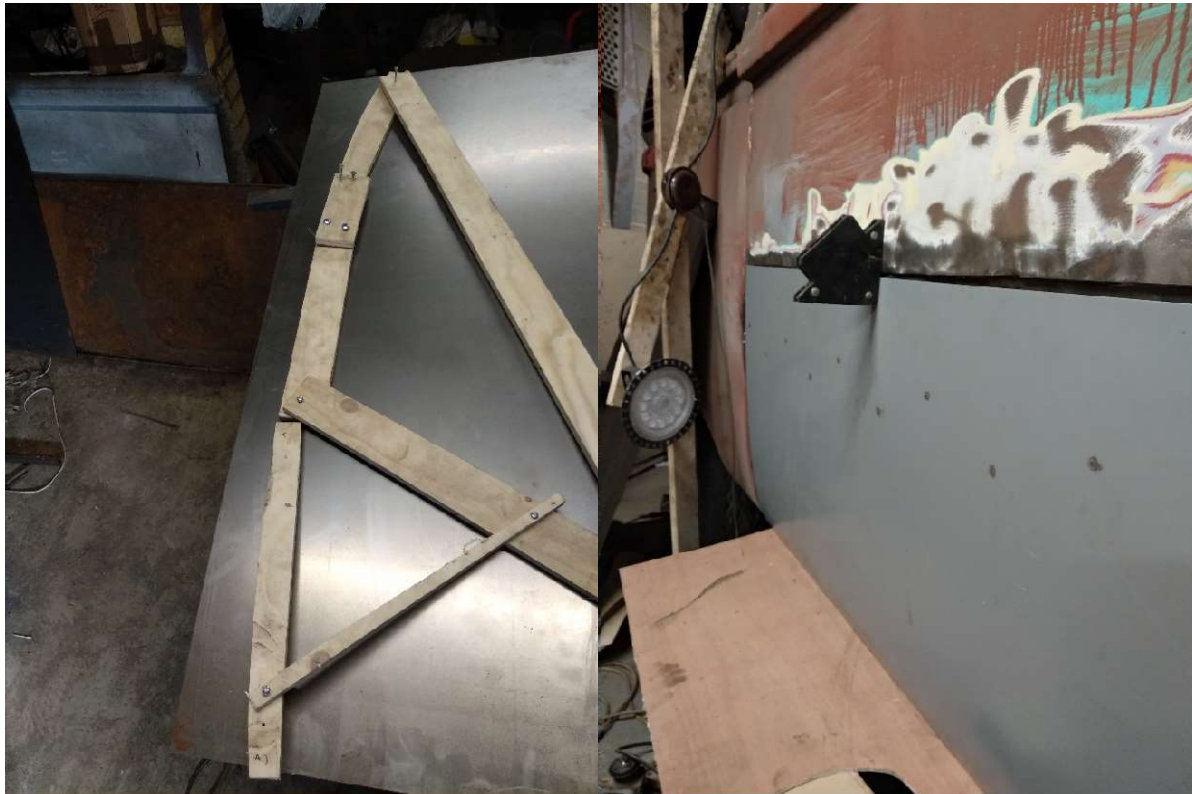
Now we have a working plan. A tray sits on runners and slides out of the van. Attached to that is the outer wall of the van complete with the window. Attached to both of those are vertical sides either side of the window and the whole thing has a roof that will be inclined not flat, to help water run off.

The tray is the easy piece. Finding exactly where it does against the outer wall when the outer wall is not fitted is a little trickier.
