Eric the Viking – a restoration in many parts – February 2022

Eric the Viking – a restoration in many parts – April 2022

## Eric the Viking – a restoration in many parts – August 2022

Eric the Viking – a restoration in many parts – October 2022

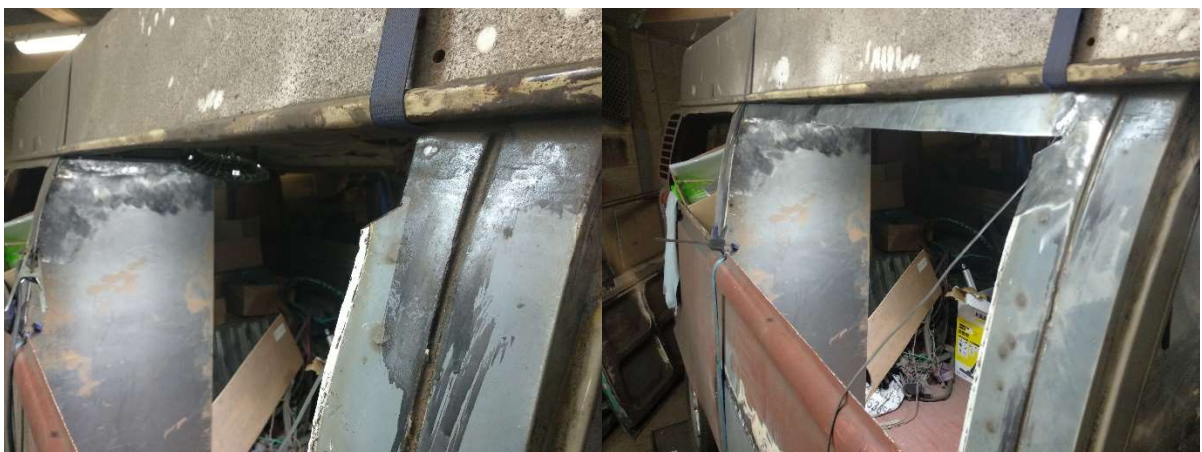
With the sides on, we now have the beginnings of a box. The top of the outside panel however has no metal above the window as the roof was cut off due to being rotten (Pic 2 – Window top missing). This means that once the outside panel is cut off, it will be weak up there with the potential for movement / flexing. I did not have steel long enough, but was able to cut two rectangles of steel and weld them together then weld above the window hole (Pic 3 – Window top added).

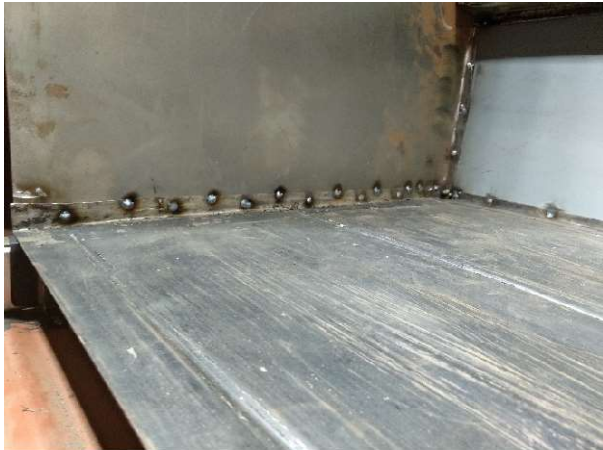
Now that 3 sides are on and the base / floor / tray is square, after a little adjusting of the tray where it joins the outer wall, the tray was welded to both side walls and the outer panel. My spot welding is now of sufficient quality that I am no longer grinding them down! (Pic 4 – The floor goes in)

Notice the grooves running side to side on the tray – they make it flex less by providing strength and were made using my Christmas present from my wife, a metal swager.

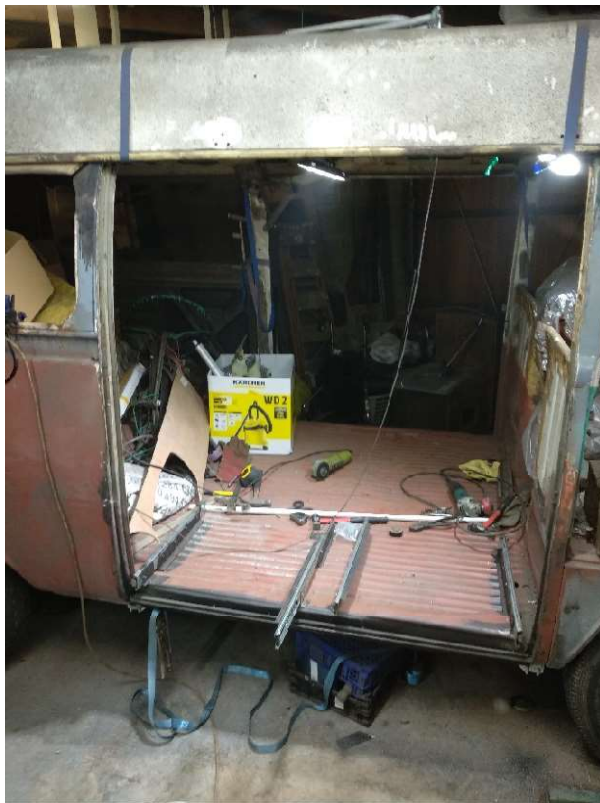
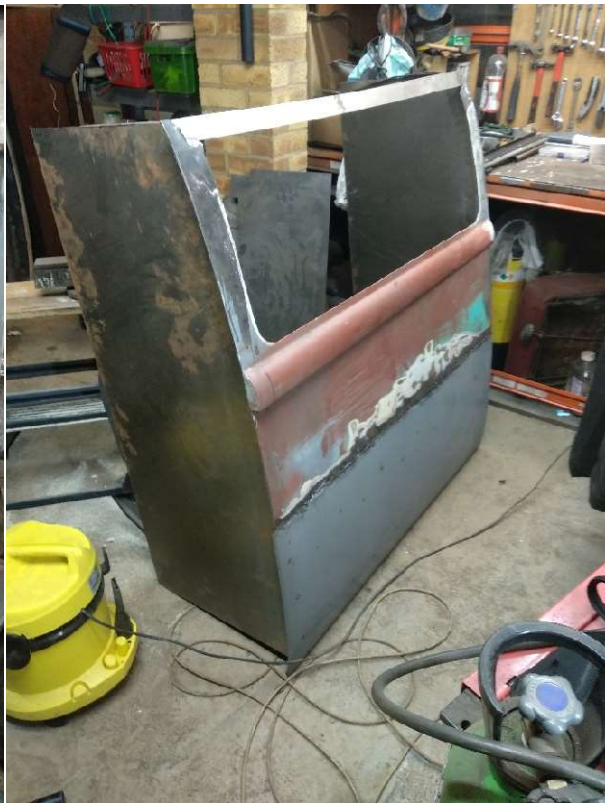
(Pic 5 – No side panel) and (Pic 6 – The pod is on the floor)

Then came the scary bit – cutting up the sides of the outer panel to separate it from the vehicle for the first time in nearly 49 years. Now both sides of the van are draughty!

Finally, the pod was bolted onto the runners and the actuator arm, and at 7.04pm on a Tuesday evening (I know because I had agreed to go indoors at 7pm for dinner!), I took a video of the pod electrically gliding out of the van with the remote control. It was quite emotional!

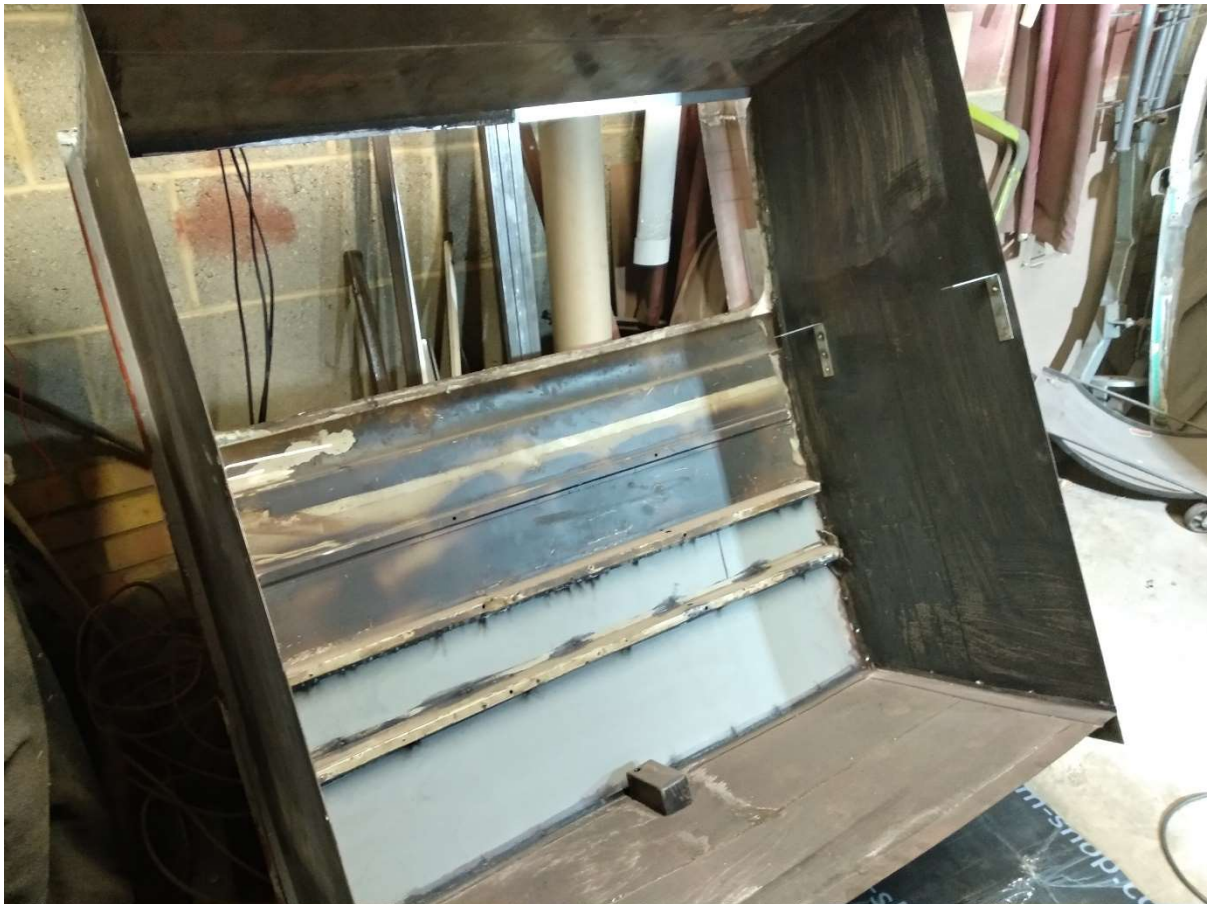
Last time I had taken the slide out pod and got it vaguely running electrically out from the van. The amount of space regained will really pay off, but it is a lot of hard work planning, fabricating and testing. The next part of this puzzle was the roof of the pod to make it watertight and therefore warmer when open. A sheet of steel is actually not very strong but my new swager helped – adding grooves along the long length of the roof rectangle made the sag of the sheet reduce then each edge was folded over to attach to the outside panel and the new walls.

Now the box has a straight edge on the inside of it for the pod floor, roof and sides. This is where the kitchen parts will go but the unit itself will sit slightly farther out of the van meaning that I must add a skirt all around. This was planned as the additional sections would be spot welded and joggled adding strength along the length for minor extra weight. The curved edge of the sides allowing for a door rubber to seal the edge of the pod to the edge of the van when the pod is out.

This took quite some time even using CAD (Cardboard Aided Design) but I got there in the end. The roof of the pod was still a little saggy in the middle even with the folded down lip in the inside long edge and I was not confident that the apron would provide enough extra rigidity. Fortunately, one of the steel lengths that I had used for bracing was part of a bedhead that I had been given – rectangular 1cm box section steel, strong and lightweight and after cleaning it of loose paint, that went onto the inside edge of the sliding pod roof, reinforcing the front lip. Then I was able to add the roof apron of

14cm front to back of steel with its folded over edge used to join to the rest of the roof. Now it does not bend. A little seam sealer along all the joints created should minimize water ingress to the seams that would cause premature rusting.

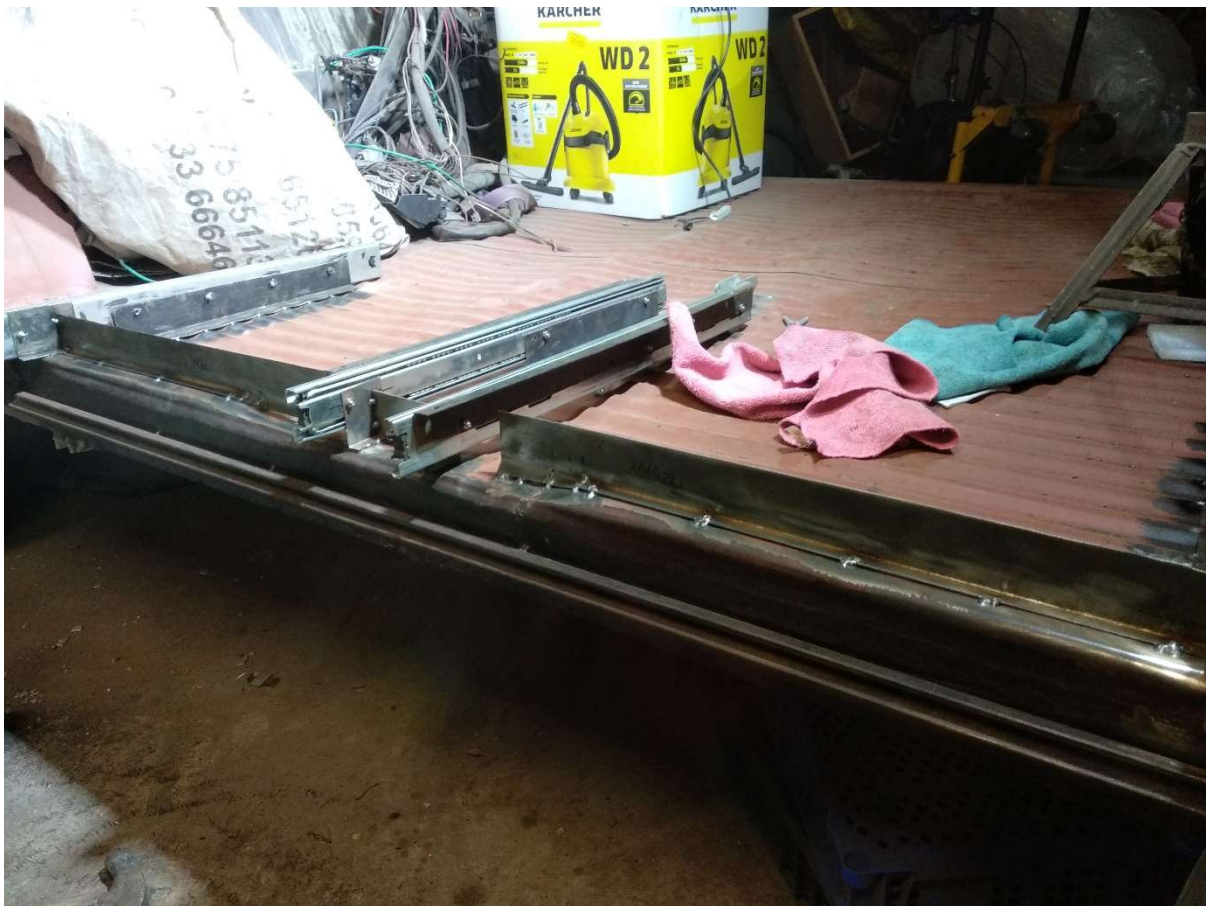
With the inside of the van having 4 runners at the bottom, I next moved to the spaces between the runners. I want these to flex enough for the pod to glide no matter what the ground does to twist the chassis, but I also want to reduce gaps to insulate the inside.

Some offcuts of steel from the pod apron proved to be an easy trim and were mounted. Note the space outside the new steel allowing a small amount of space under the pod right by the outer panel. This will be for water inlet pipe, grey water outlet pipe and potentially the above noted stand.

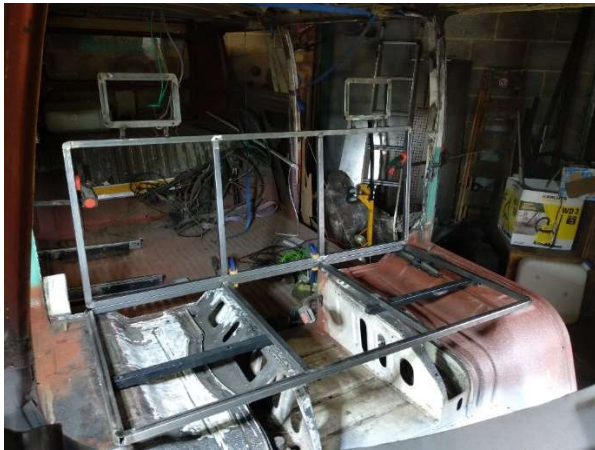
Bench seat frame

But why go to that length? The base is hinged, and I then made some blocks to go at the rear of the base. This makes the base inclined slightly the opposite way. Then I made “arms” for the back rest and after much mocking up with corrugated cardboard, the offside and nearside arms and their brackets were fabricated from 2mm steel plate. These arms support the back of the seat allowing you to drive in comfort. Once you get to your destination, the arms can be repositioned allowing the seat back to face the opposite direction. With the base also inclined in the opposite direction, Eric should end up with a sofa facing backwards. That cannot quite be finished yet as the back rest height is determined by the height of the seat base. Following the standard seat design, I welded some coil springs to the base frame down the sides of driver and passenger. Then I welded some serpentine zig zag springs front to back in between them. These sit on little bits of serpentine spring blow torched to bend to the right height. This now looks very like the original seat, and I added a steel string of 3mm diameter all around the outside to help the fabric sit correctly. Two front seats with metal as per the original for long distance comfort. Hopefully.

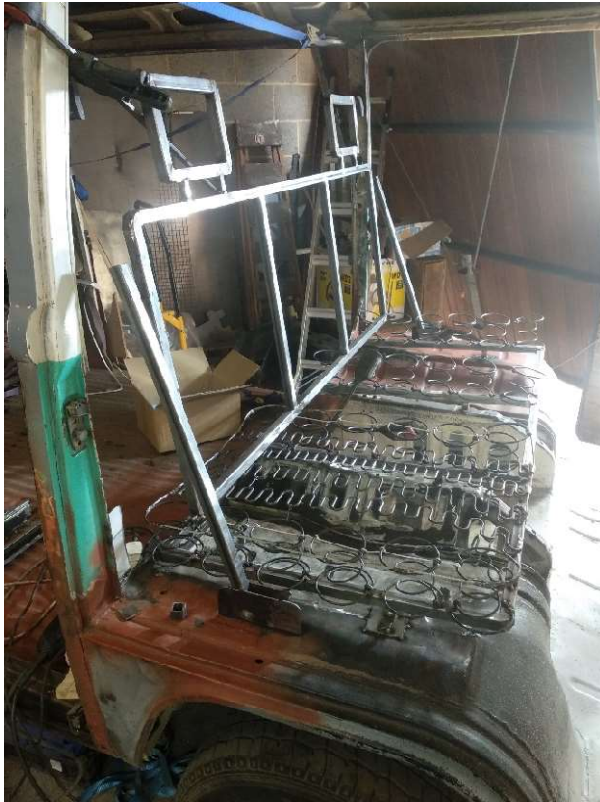
Serpentines, coils and outer in place

Next up, I need to add serpentine springs to the back rests for driver and passenger per the original design and work out exactly where the back rest will sit, then attach it to the arm.

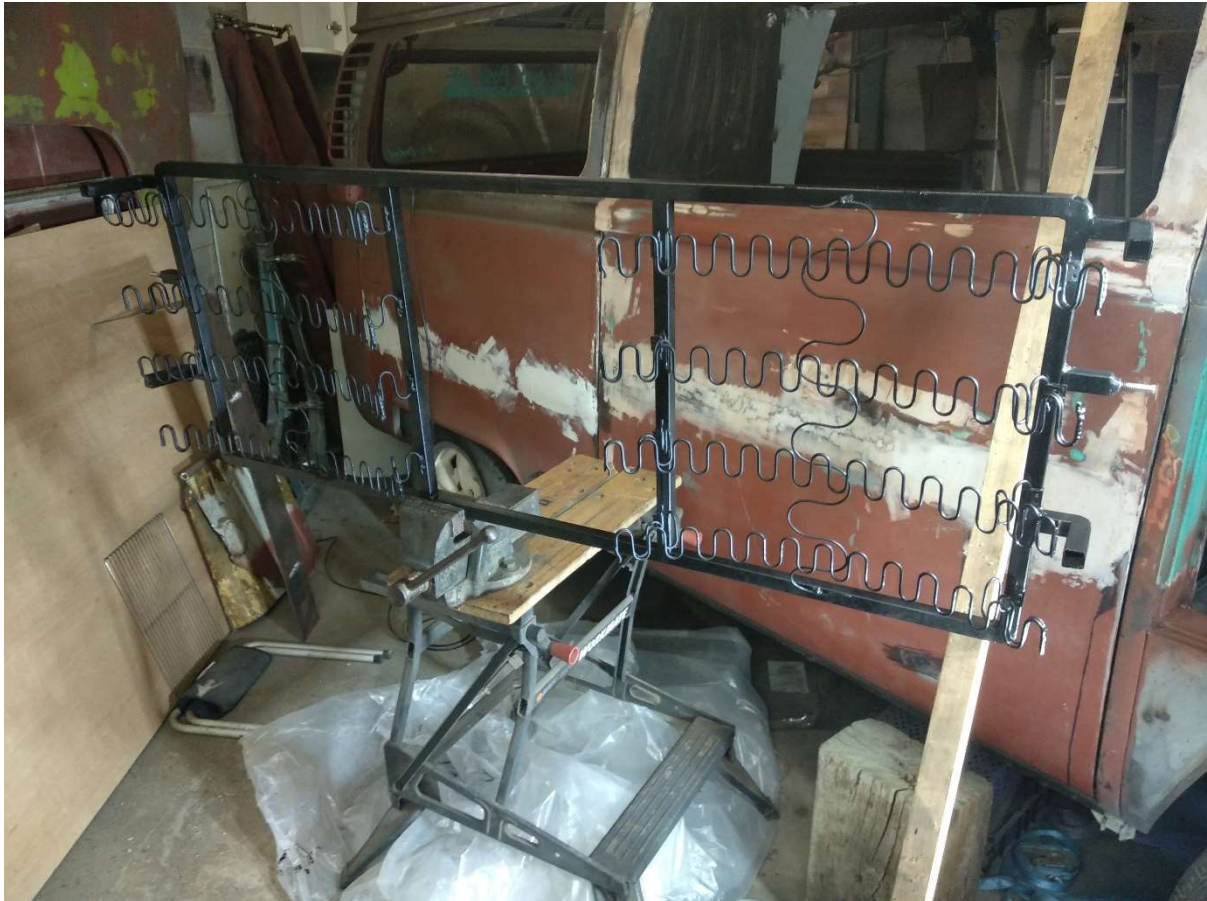
The serpentes arrived – wavy bits of metal that provide the suspension for the seat backs. Initially I used the clips that came with them, but it was all very loose, so each serpentine was welded to the next one. At the sides, I used shortened sections of the serpentes bent to 90 degrees and welded in place as that seems to be how original seats are done – I was able to use the crème brulee torch that I bought about 15 years ago and had never used except for lighting the fire! It all looked fab and received rust proofing paint, primer, and black topcoat. Then I added some plungers purchased online to allow the seat back to lock in place for either driving or camping, sadly I put them in the wrong place and had to do it again the next day!

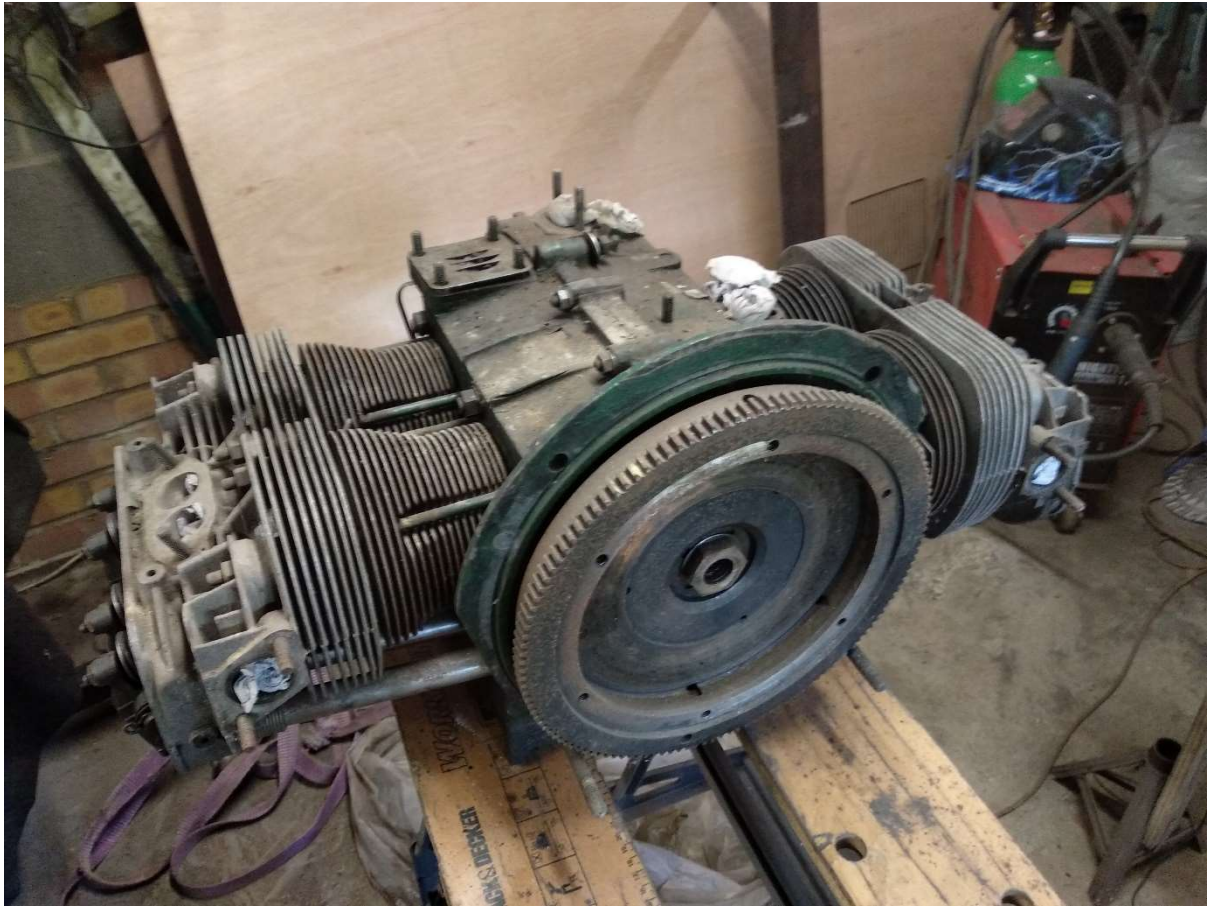
Following an email chat with a race engine builder in Warwickshire, I put restoration on hold and stripped an engine for the first time. My wife's 1972 crossover Poppy had an engine replacement in 2015 when the case was found to be split, tipping oil everywhere and the engine had sat in the corner of the garage ever since. I bought a 1776 Mexican case online that was drilled for full flow (external

oil cooler ability), but I did not really know what that meant. It took me just over 5 hours to strip the engine from the rockers inwards. From this “long block”:

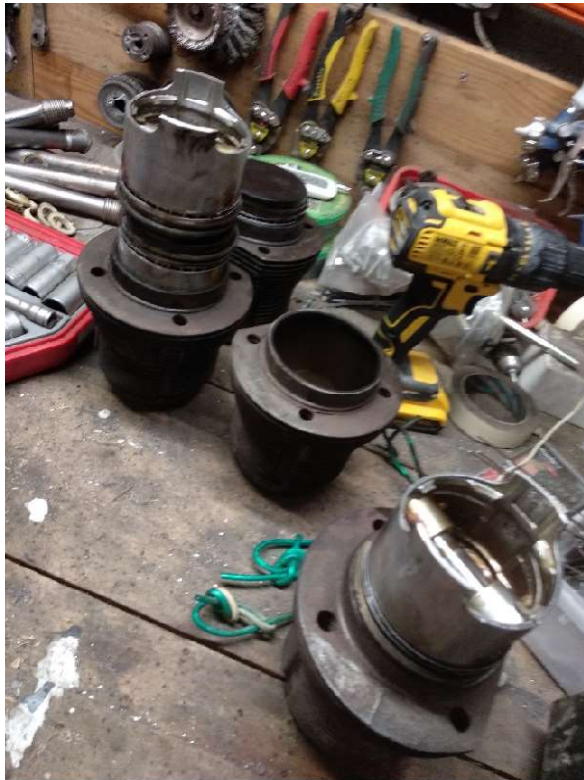
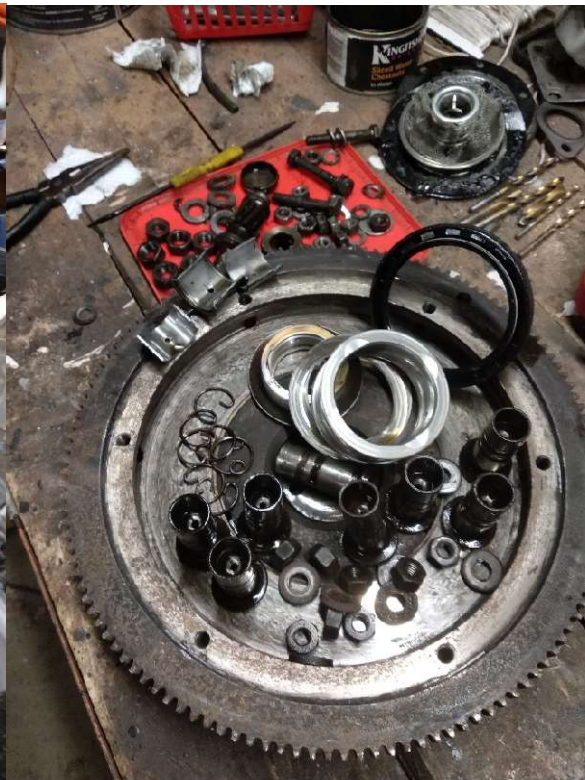
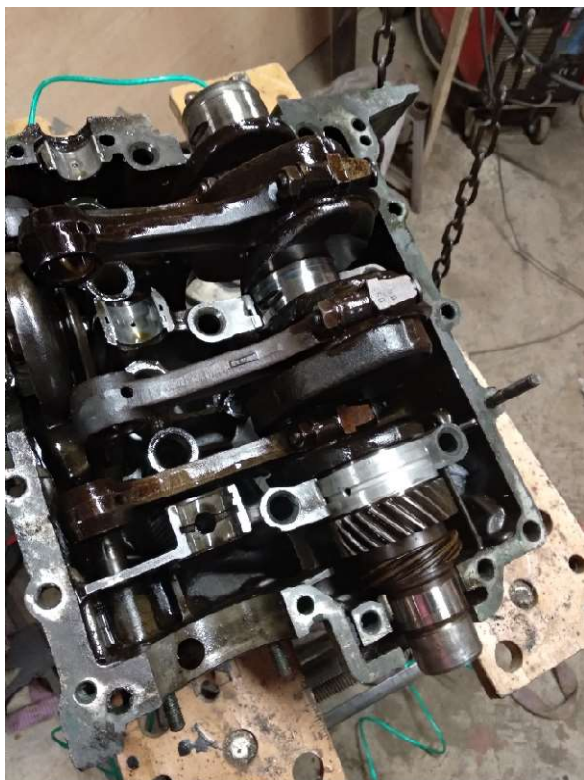
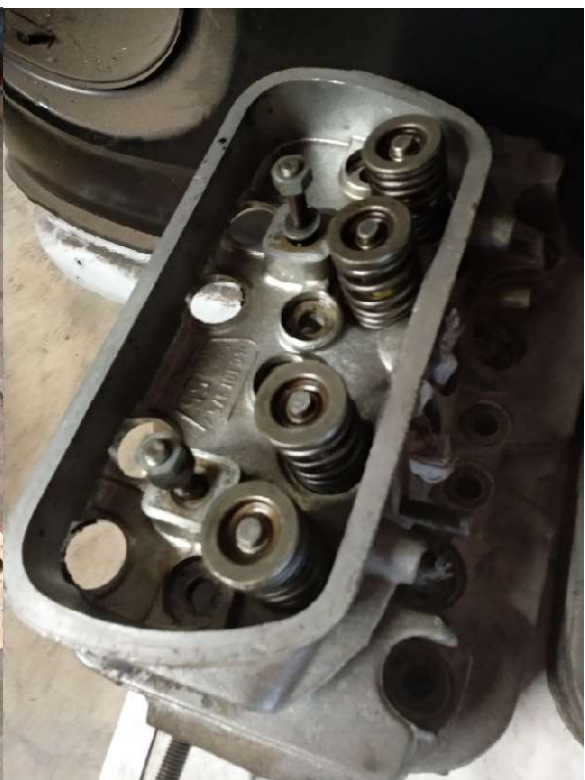
And down past the barrels and pistons to piles of engine bits!

The case that I had purchased online was a "good Mexican case" which turned out to have case saver studs, corrosion, had already been align bored and signs of very bad treatment. The drilling for full

flow / external oil cooler had been done badly and is for a Beetle – the mounting bar (aka moustache bar) for a Bay window means that those holes cannot be used. Sadly, this is becoming increasingly regular as the cases are old and have not been made since 2014. Never mind he said, I will see what I can do once it is fully cleaned, tested, and measured. Which costs money and might end up as unusable anyway.

Next, we turned to the crankshaft. It has been ground several times and is very worn. He will polish rather than grind and see if it allows it to be used. Which costs money and might end up as unusable anyway.

He looked at the heads and gave them back to me. Totally shot, not even worth trying to resurrect. New heads required. Which costs money.

Finally, he looked at the flywheel. It needs to be 21mm deep between the inner and outer levels and was 20.34mm and the milling to that height had been done badly. New flywheel required. Which costs money.

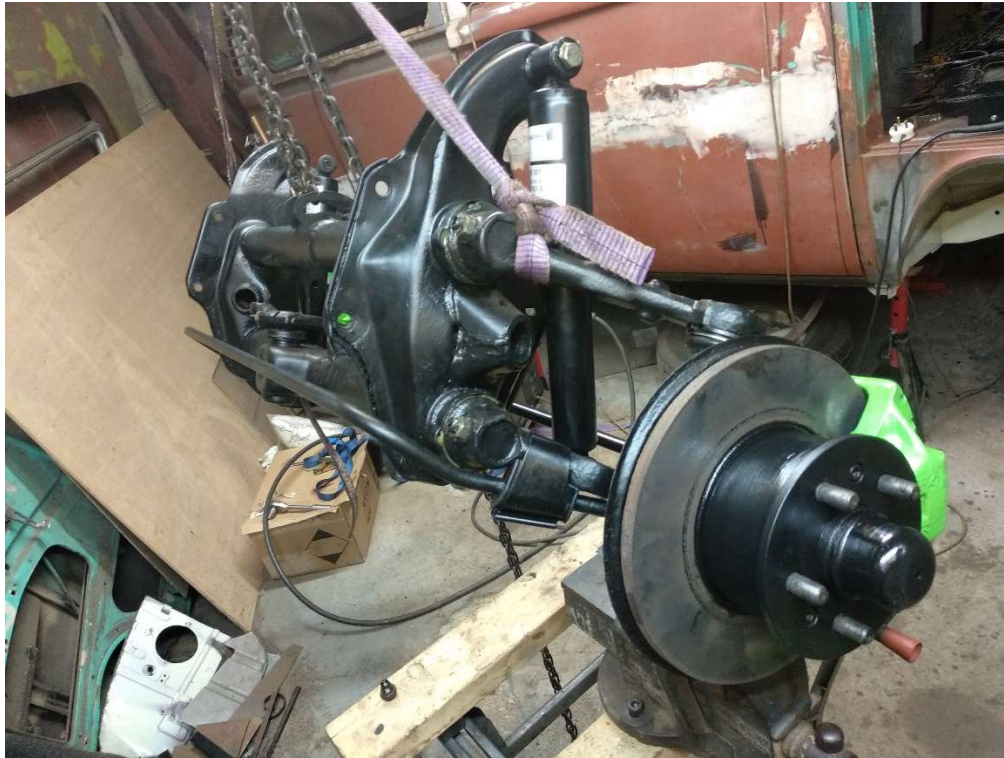
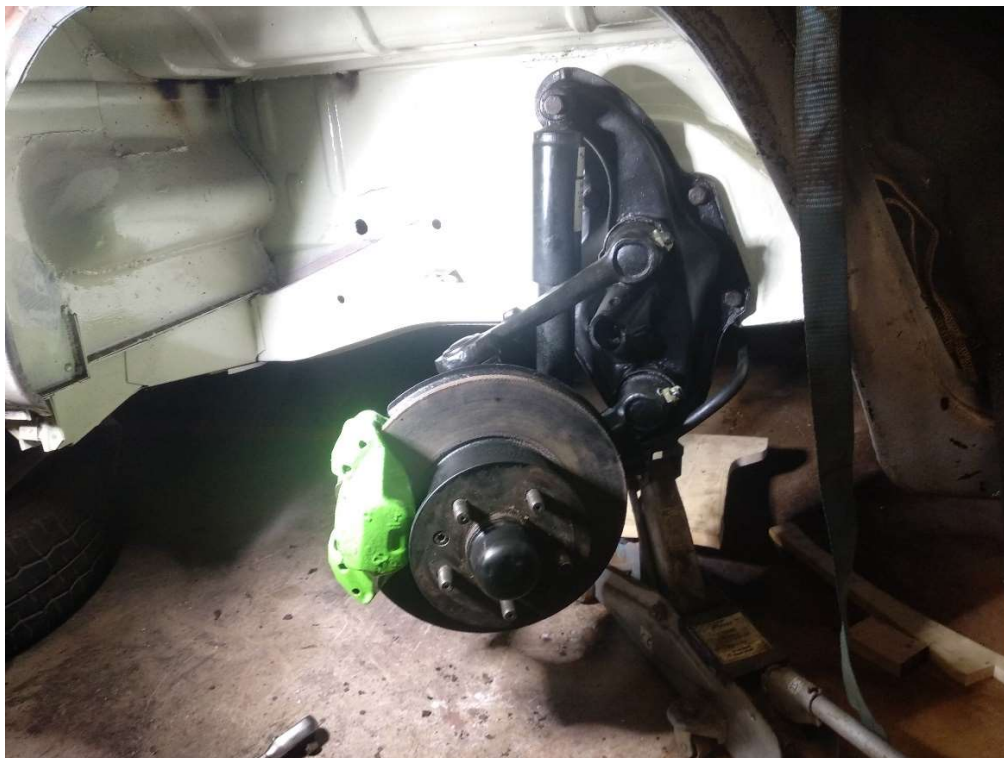
Once finished (first picture), and with the anti roll bar back in place complete with the new rubbers and mounting brackets, it all got a final check before calling on a neighbour. The recommended way to refit a beam is to get it under the van and jack it up on a trolley jack, keeping it horizontal and continue lifting onto the chassis rails.

I had a brainwave and for once it worked out well. We wheeled the finished beam to underneath Eric, ensured that it was approximately as vertical as needed. Eric was on the block and tackle to get it high enough for the beam to go underneath, then we simply lowered Eric onto the beam, which was therefore completely flat and the sheer weight of the van helped press the chassis rails into the beam. A few little wiggles and we were able to get the first bolt on each side before a little further wiggling could get the remaining bolts into the chassis. From the beam being up on the block and tackle, to moving the beam, lifting the van on the same block and tackle, lowering the van onto it and aligning all bolts took 45 minutes. We felt that was a big result! Picture 2 shows the offside front wheelarch, all painted in white with the beam in place and shiny green calipers.

The front beam has been dismantled, removed from the van and was hanging on a block and tackle for ease of movement. It is an adjustable beam of unknown origin that came with Eric. The bottoms of the clamshell sections that form the chassis mounts were both rusted, but were by no means unsalvageable – cutting out the minor amounts of rot and replacing it properly with butt welded sections made for a great look. Much easier and more satisfying than the work on the vehicle that has been rather worse hit by rust!

Each component of the front suspension, steering and brakes was removed and either stripped, painted in anti rust treatment, primed and painted or was replaced. The brake calipers have been painted in 3 coats of bright green Kawasaki high temperature paint and all other components were top coated in John Deere tractor paint in gloss black. This was a recommendation some years ago and the colour and protection are great.

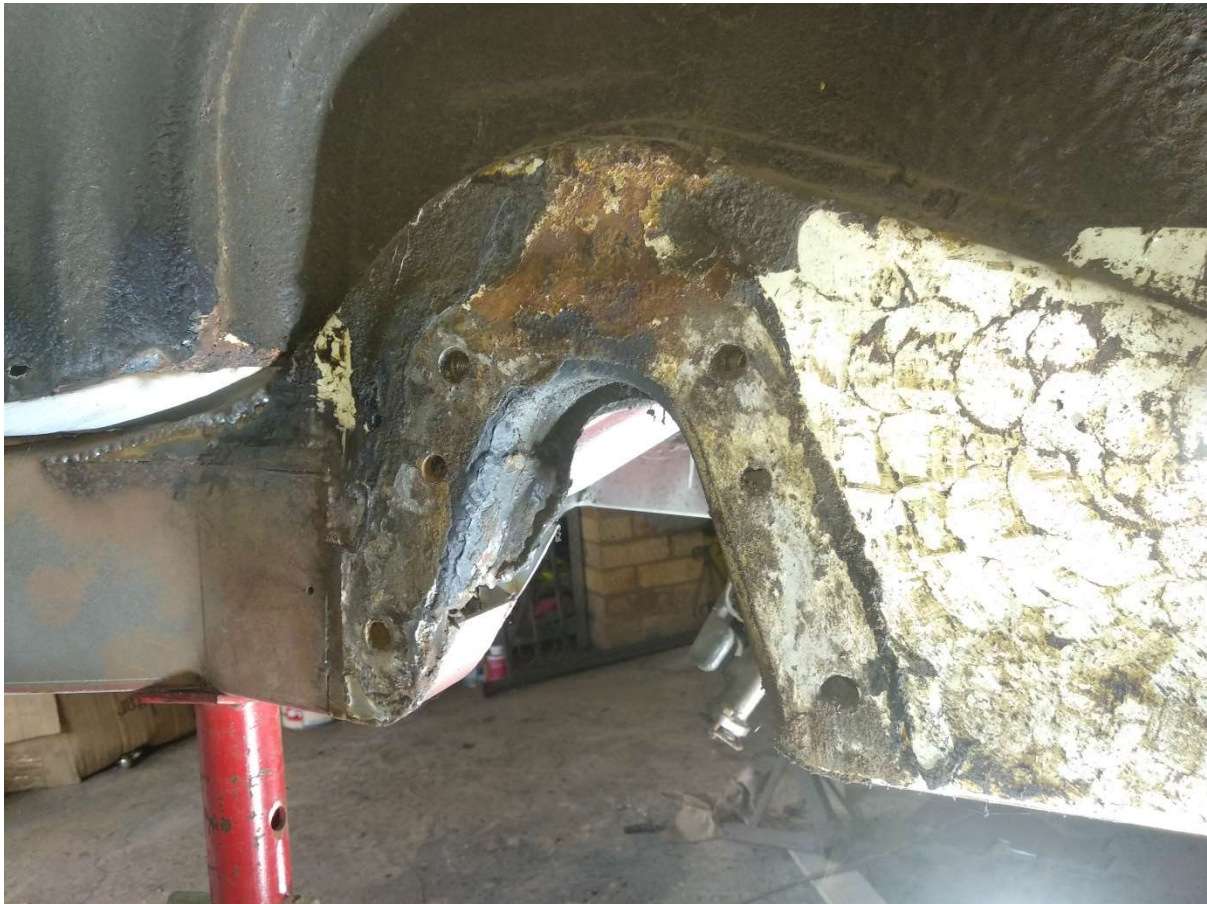
Picture 3 shows the chassis under the beam, the lumpy underseal was hiding some gremlins but new steel sections have made it all strong again. With the chassis rail opened, I have been able to add rust proofing paint to the insides of the rails in a lot of places and will follow that up with underseal in due course.

Then with the beam off the van, I was able to tackle the chassis rails in the sections that had been hidden by the beam. As this was only about a foot on each chassis rail, it did not seem like a long job however, the access is only by laying on the ground and understandably, 50 years of water, mud and rust had accumulated to rot out a large chunk of this. New sections in 2mm semi-galvanized steel were fabricated up and welded in place, and with new thick steel onto nicely tidied chassis 2mm steel, this went in smoothly and with minimal grinding required. Once fully smooth, again this was rust proofed

and primed but top coat on the chassis / underside is the original L90D pastel white. I am using synthetic enamel for its hard wearing and easy to apply properties.

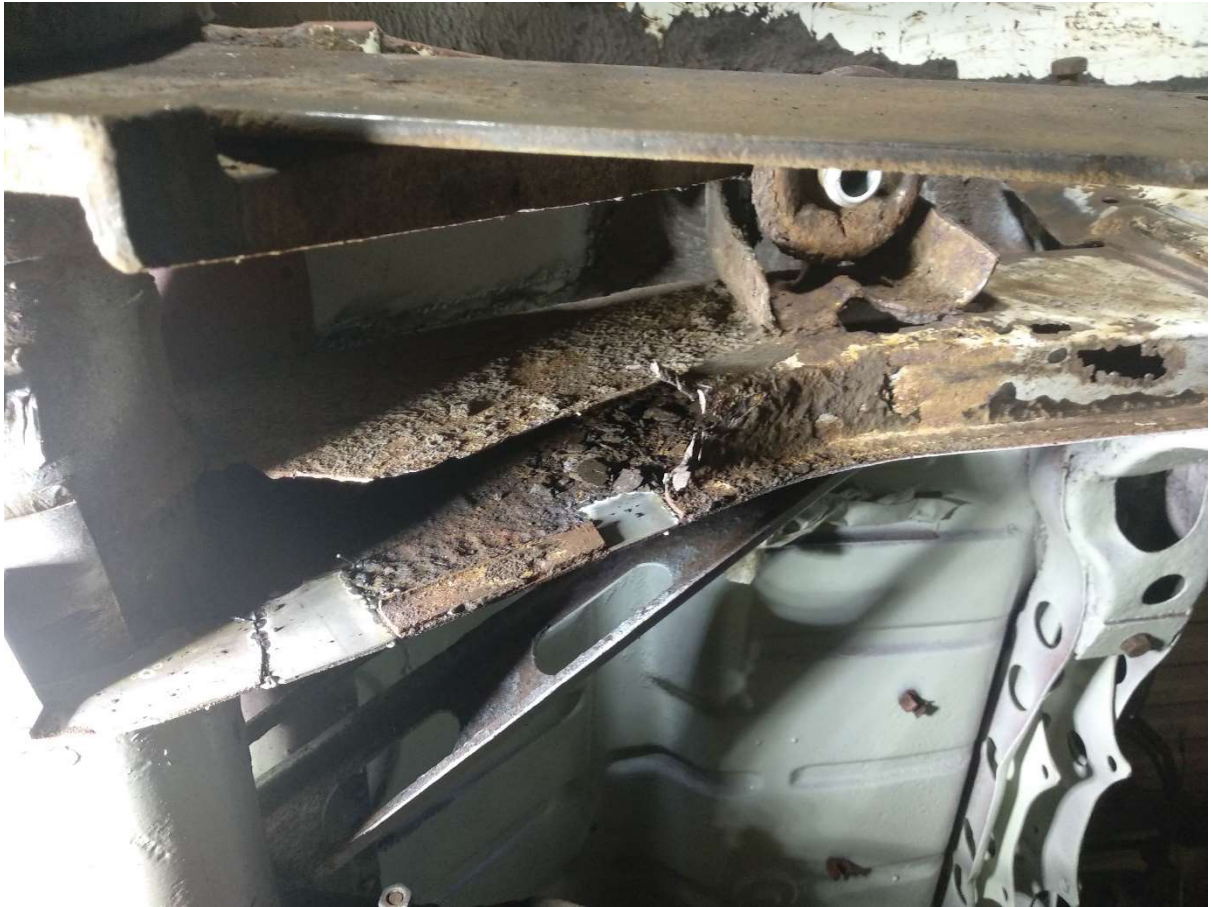
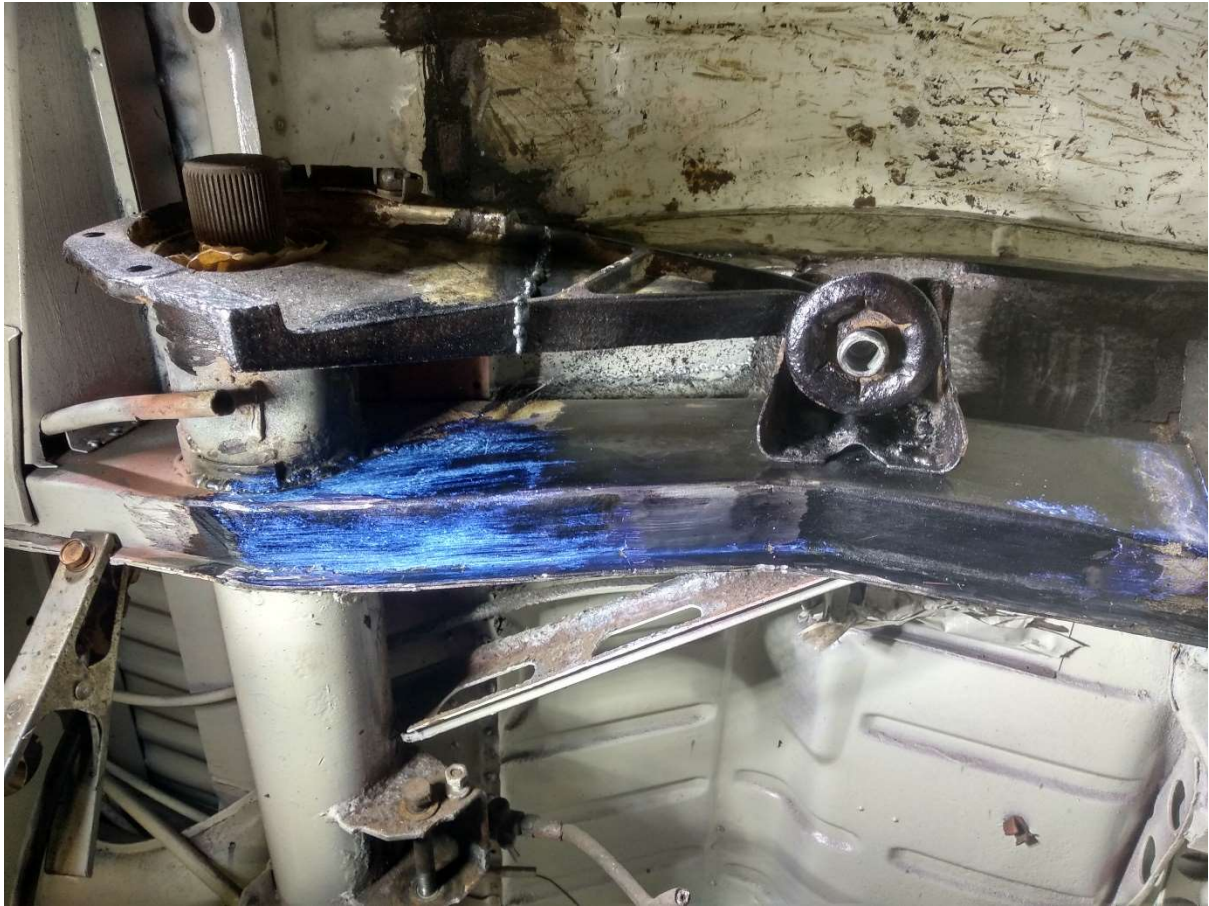
Once that was complete, Eric had a beam with which to roll him over. The garage was suitably tidied and emptied, Eric was turned nearly 180 degrees (not easy in a double garage) and the offside wheels removed. The rollover jig was bolted in place of the wheels and Eric was laid onto his off side. This allowed me to get to the underside to work on the sections not easily accessible when he was on his other side a year or so ago. The key section here was the nearside rear chassis rail. Picture 4 shows the remains of the chassis rail – I knew this was bad when I did the other side of the same section. If you have a box that has seen better days, replace one side then the other – more reliable for positioning than replacing it all at once. Just behind the torsion tube was about 30cm / 1 foot that needed a significant section replacing and as it was curved, this was done in 3 sections, again rust proofing the inside as it became accessible. Anything rusty was cut out. The mounting bracket of the

bump stop was removed as that was very bad, new sections fabricated for that before welding that back on to fresh steel.

It looks much better with steel instead of holes! Picture 5 was when the rust proofing paint was still wet, once dry it goes purple and then the primer went on twice and several coats of L90D top coat as well.

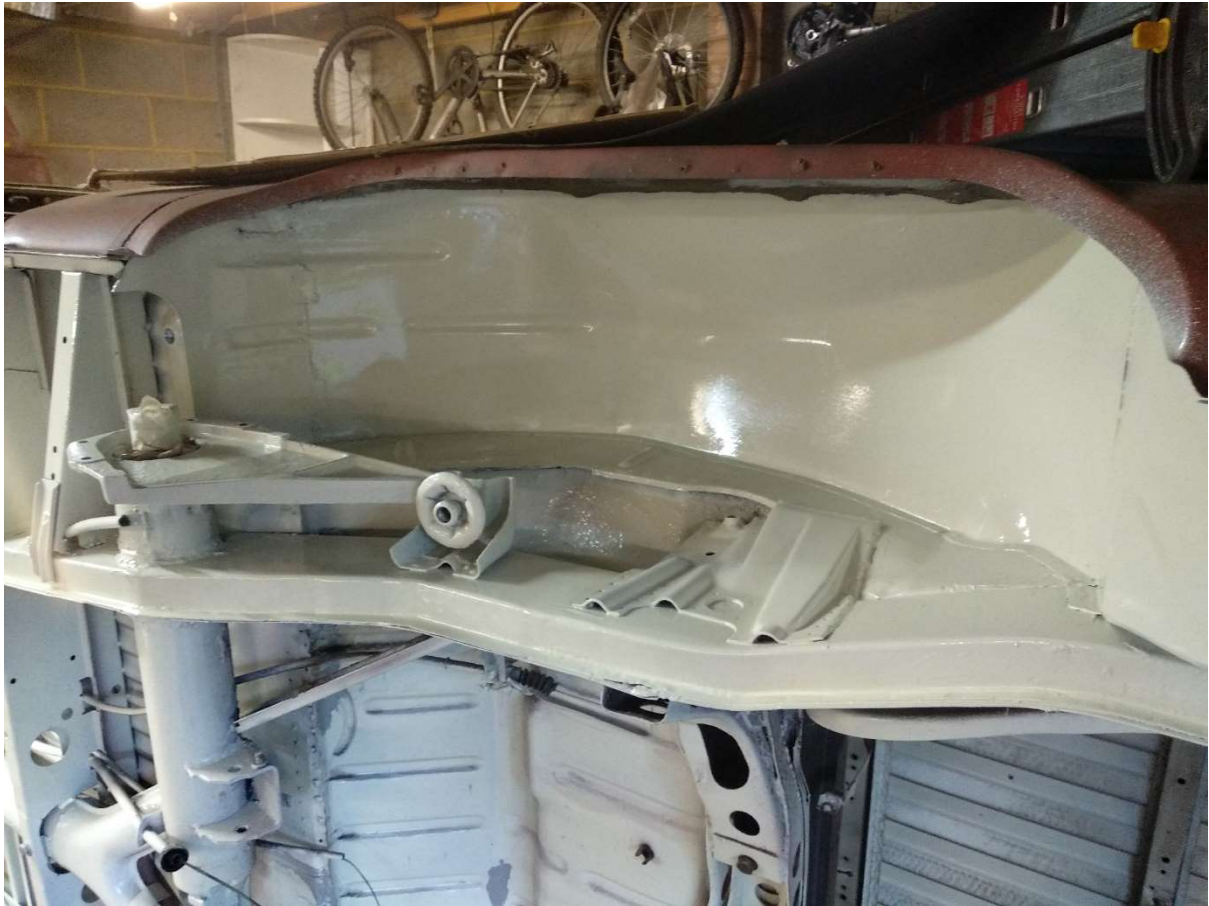
A similar story on the offside rear wheel arch – remove buckets of underseal, get visibility on the metal, remove the paint unless it is looking great. Remove rust, add new metal if required, rust proof, prime and paint. Once all of that was complete, the majority of the underside is now done – just minor bits that were missed plus the underside of the fuel tank to go then it is build up time. Picture 6 of the offside rear wheelarch and bump stop all clean and white made me feel rather good!
