Eric the Viking – a restoration in many parts – February 2024

Eric the Viking – a restoration in many parts – April 2024

Eric the Viking – a restoration in many parts – August 2024

Eric the Viking – a restoration in many parts – October 2024

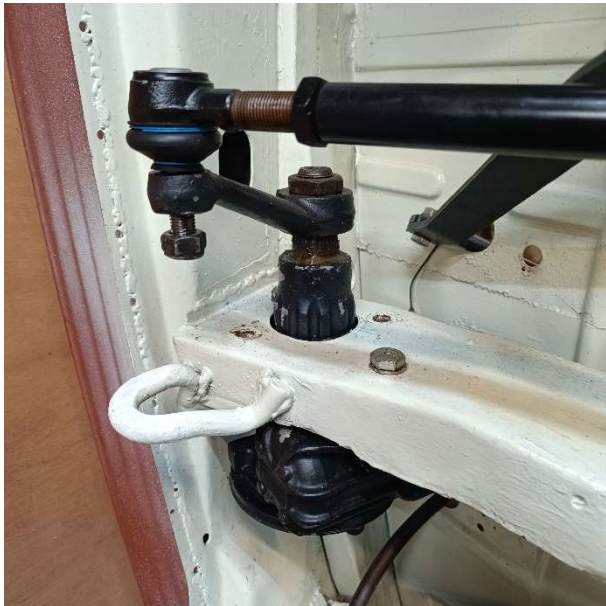
Whilst sorting the workbench, I came across a trapezoidal piece of steel with a lip all round, covered in 50 years of muck. It is the steering box strengthener plate that goes between the box and the chassis rail. I had been looking for it last year when I fitted the steering box back onto Eric. Annoyingly, I had put the steering box on, the drag link, greased everything and it looked great.

Drag link nut came off easily but the ball joint (top of picture) steadfastly refused to separate from the Pitman arm (arm at an angle under it). After much hammering and swearing, I explained the issue to a

Once the drag link was off, it is possible to remove the steering box of a late Bay with the Pitman arm still attached, which is a good job as the arm will not come off the box so it is staying there for now! With the steering box on the bench and the strengthener plate being stripped to bare metal for a repaint, I was unhappy with the paint on the steering box so that was stripped again. 3 coats of etch prime and 2 coats of John Deere top paint in matt black to both and they looked great once more.

Seam sealer to the join between chassis and strengthener plate (it is horrendously messy stuff) and reassembly went smoothly. At the same time, since I had the etch primer and the topcoat, I grabbed the box of tin ware for the engine and did that as well – I had stripped it last year and rust proofed already. Looks much better.

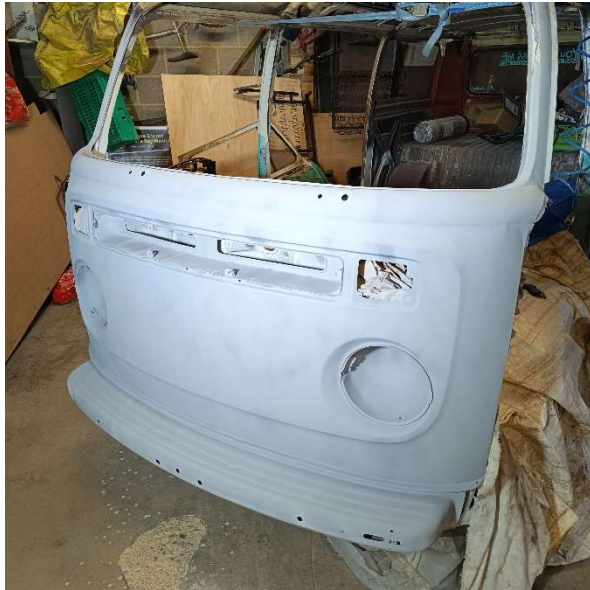
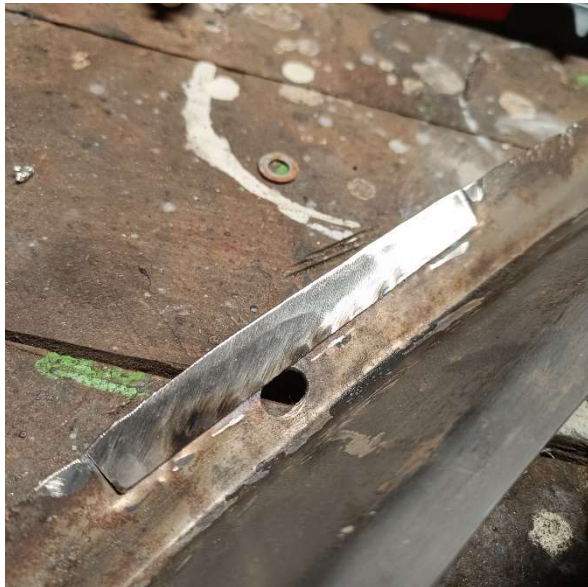
Next up is the dashboard. The dash is made of the metal front, a softer rubber style grab rail in the middle and then the metal for the dials, radio and switches. Separating the 3 components was

straight forward, although the nuts would have been tricky without my trusty impact driver. Everything was stripped to bare metal before dealing with the inevitable rust on the front lip.

This was chopped out and a few sections of new steel let in. I was quietly pleased with how smoothly that all went on!

Once stripped, I then rust proofed it all, etch primed twice and top coated twice with John Deere matt black tractor paint that is my go-to paint for black parts and it goes on wonderfully well. I also emptied the box of other metal to be painted black as well – dash, front of dash, steering column, steering column surround, foot pedals, steering column support bracket and closure panel on the floor, and finally the air vents that sit on the front of the dashboard.

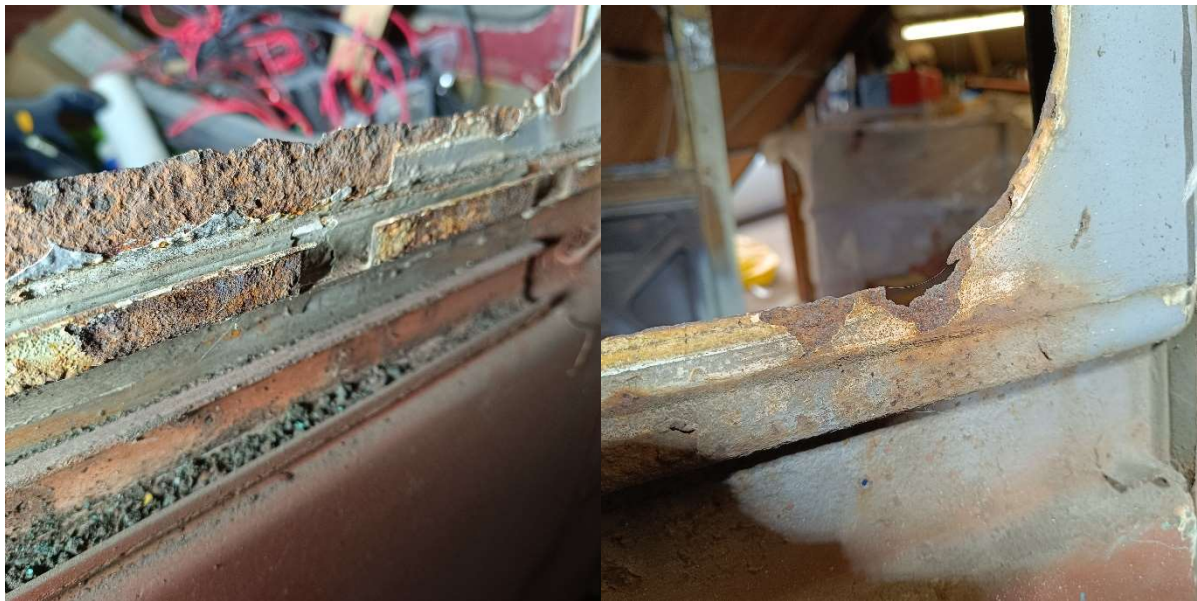
The rear windows had also seen better days and needed some attention – very frilly metal was removed, new sections added, and welds tidied up. The external covers on each side sit on clips nearly a metre long which had also perished and have been removed. New ones are a continuous U-shaped steel section, the old ones were more like fingers which makes them very fiddly to make. JK came to the rescue (with club discount) supplying the simple rectangle of steel folded over. There were no mounting holes either, so I drilled holes ready to weld them to the body.

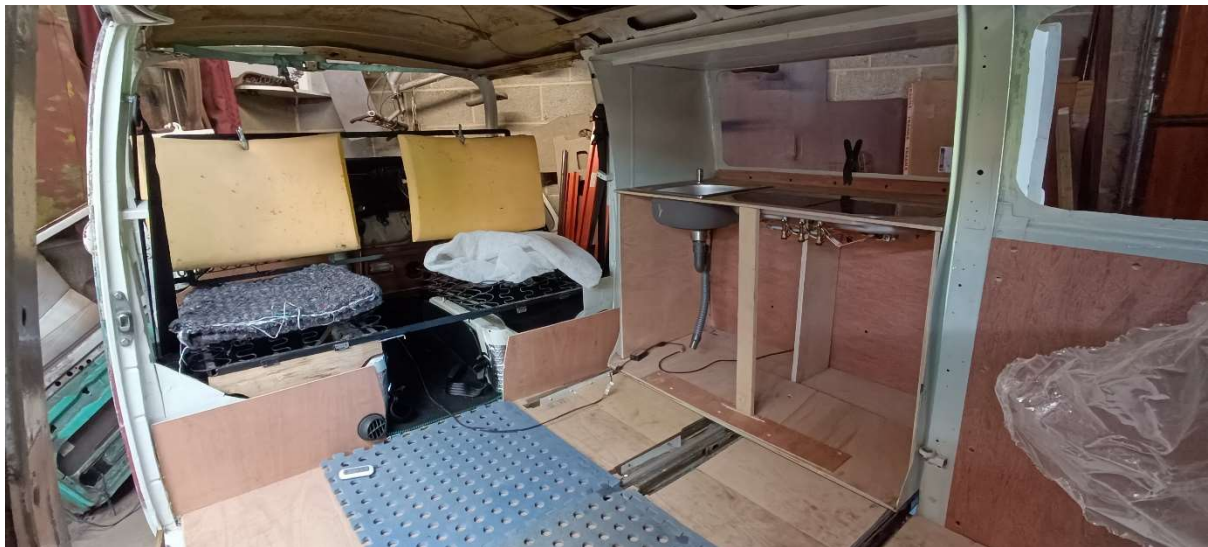
kitchen pod I used 5.5mm ply to keep the weight down after adding heat insulation there as well. With the slide out hinges all cleaned of dust, dirt and metal grinding dust from several years, I applied new grease and bolted them in place. A friend came over and we lifted the pod onto the runners, bolted it in place and slid the pod into the van. It stopped 6 inches short and refused to budge. The nuts protruding were thought to be the issue and were swapped for rivets which popped off during the next trial. Nearly 10 hours were spent on diagnosing this and it turned out that one of the runners was just under 3mm from where it should be stopping everything from sliding home. I could have ground off the bracket from the cargo floor, welded it, repainted around it and under the floor where the heat would have inevitably burned off the paint. Instead, I added 3 small washers to the bolt and everything slid home, albeit with the grinding noise of metal against metal – the side of the pod rubs on the C post now! Grr.

I was planning it anyway, and the fix was to add a guide wheel on each side of the pod to maintain the distance between the pod and the B-post and another guide wheel on the C-post. Now the metal of the pod stays parallel. To improve the strength of the pod that is effectively a box with the inside face missing, I added the kitchen worktop and wooden sides underneath for the cupboard. Once the front goes on and is glued and bracketed in place, it will be a lot stronger. I even managed to cut out the worktop holes for the sink and cooker unit.

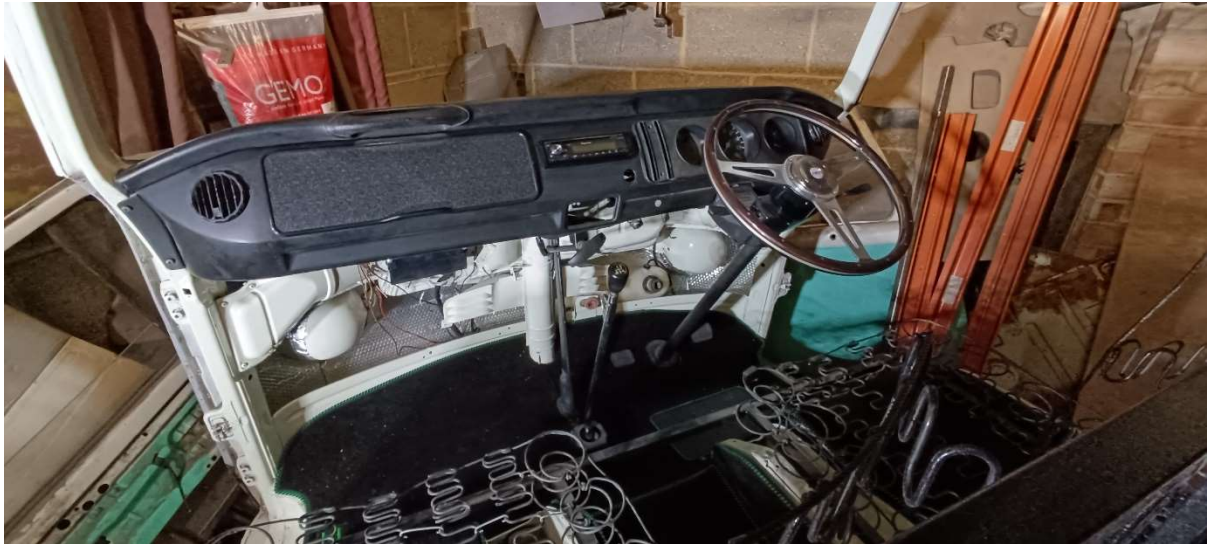
With my parents coming to visit, I cleaned the dashboard, mounted the car stereo and the glove box lid, dismantled the instrument panel, washed it in the dishwasher and put it back together with clean glass and put it in. Looks fabulous and much more like a van now!

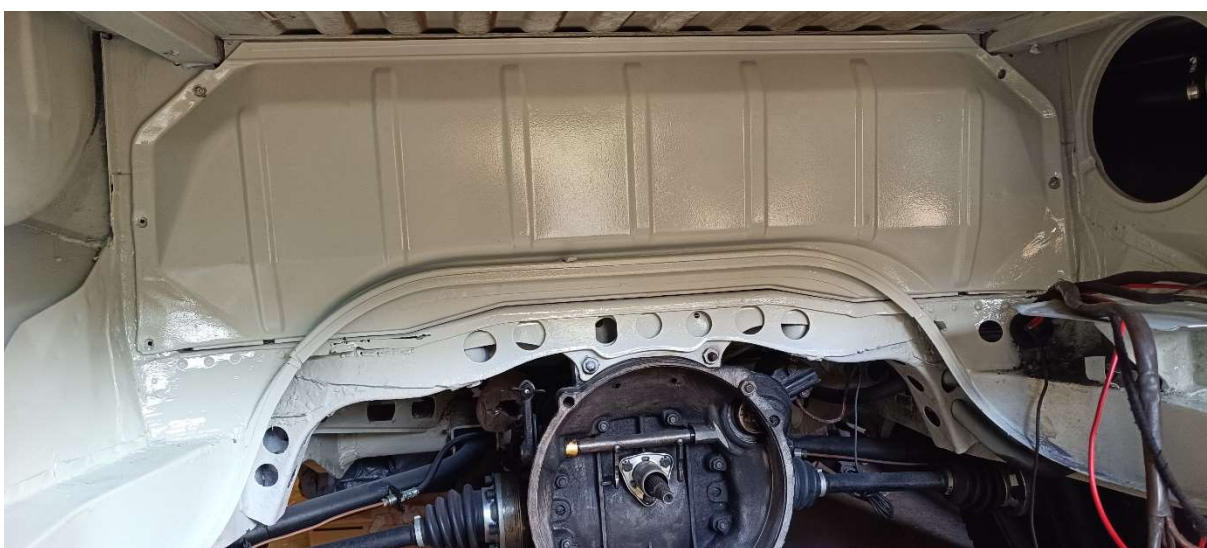
With everything out of the engine bay, there was some remedial welding needed in a few minor areas, some smoothing out, rustproofing, priming and top coating again in L90D. I also did the firewall and the inside of the engine lid as well.

What a transformation!

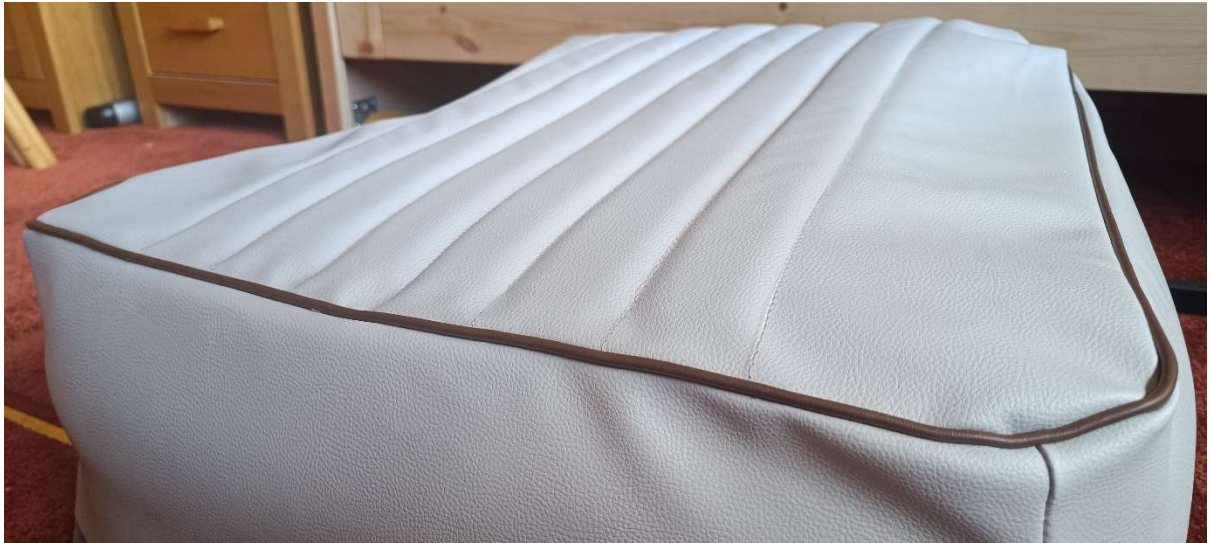
With my top and my sides made, I then ran a pencil line around the top where I wanted the piping, put on my big boy pants and set to work, the machine now sewing through the top, the side and both pieces of material that form the piping. Once the tension was adjusted high enough, the machine coped – the corners were a bit fiddly but went well. Eventually, I had a cover and once on the metalwork looked rather nice.

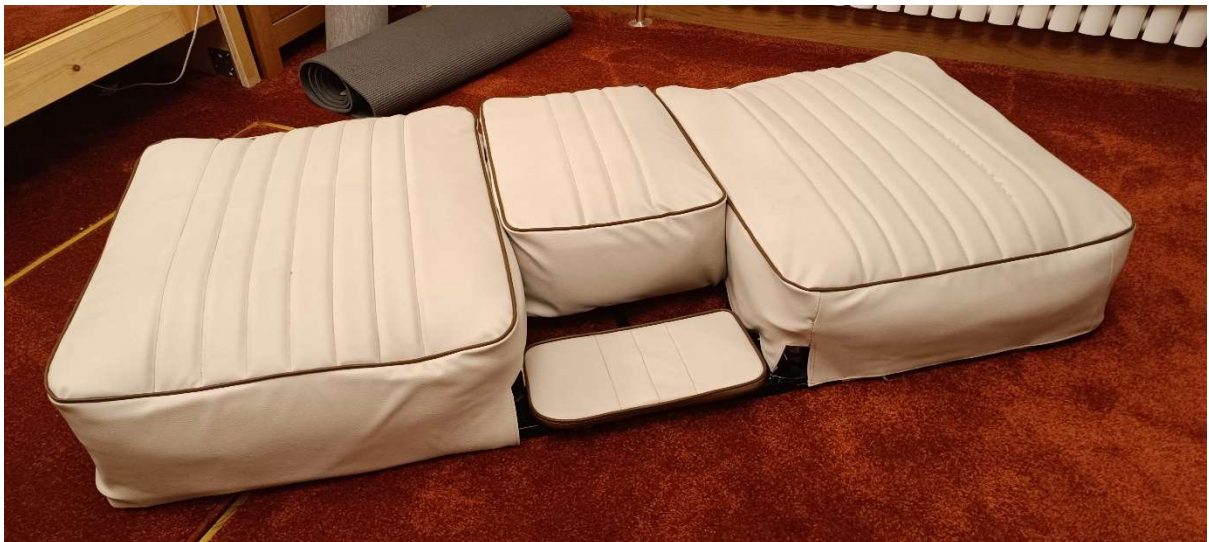
Rinse and repeat for the other front seat and already the pleats are coming out more defined and straighter as I get my eye in. Then a middle seat / arm rest / dog seat that is mounted on board and goes from the front to just in front of the arm rest so that the seatbelt buckle can emerge and a small upholstered flat piece for a drinks table when you are facing backwards.

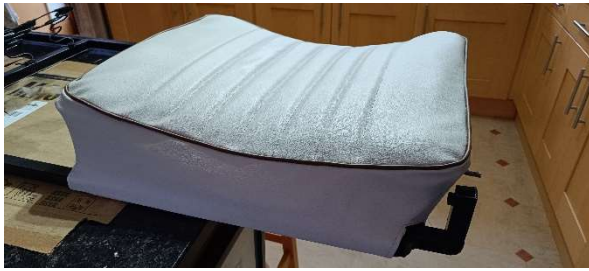
The seat back metalwork is more sculpted to curve around the back of the user, which presented the issue of how to get the material sewed correctly to avoid and bagging. The main piece was made as previously with the foam underneath. The rectangle for the side similarly and the piping similarly as well. The piping was sewn straight for the sides, and in a curve at the top and bottom to match the curve of the metal. Once that had been worked

out, it was then a case of repeating the attachment of the bib to the side piping and sewing up the start of the side to the end of the side.

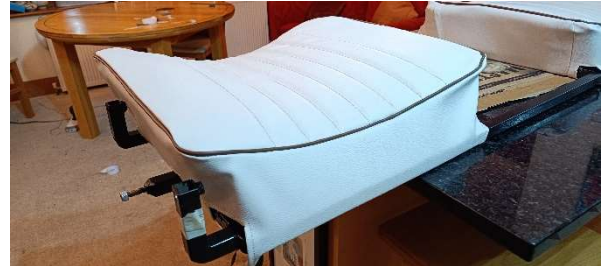
Each of the covers has to go around metal in places which needed careful cutting and seaming.

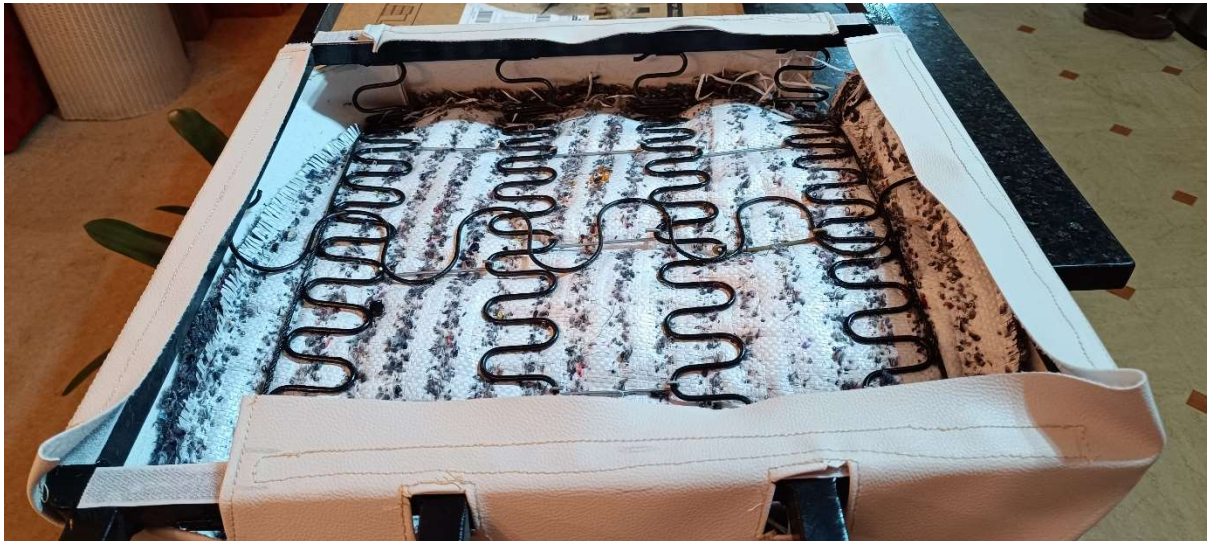
And then the padding can be smoothed out, Velcro added to the metal (self-adhesive) and to the seat cover (sewn on for strength) and get a final trim.

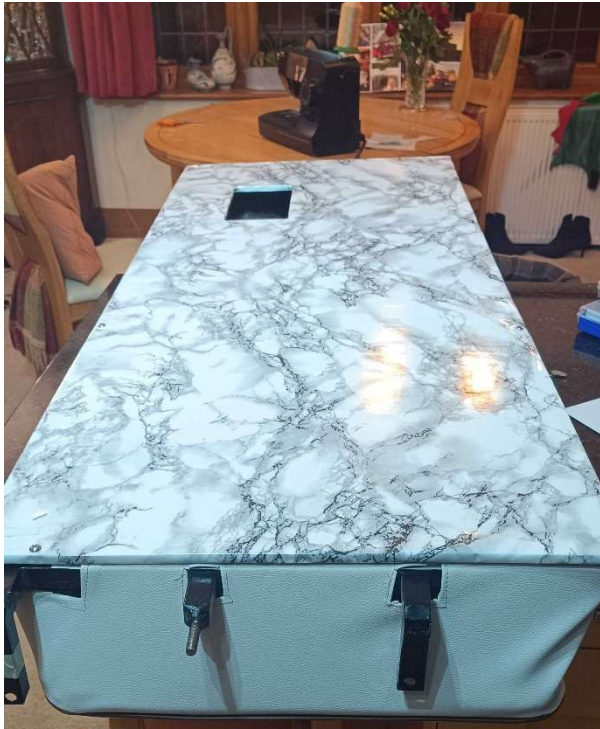
I was rather pleased with the result. This configuration gives me seats for driving, the same seats facing backwards for camping and a table for storage / dinner prep.
