Eric the Viking – a restoration in many parts – February 2019

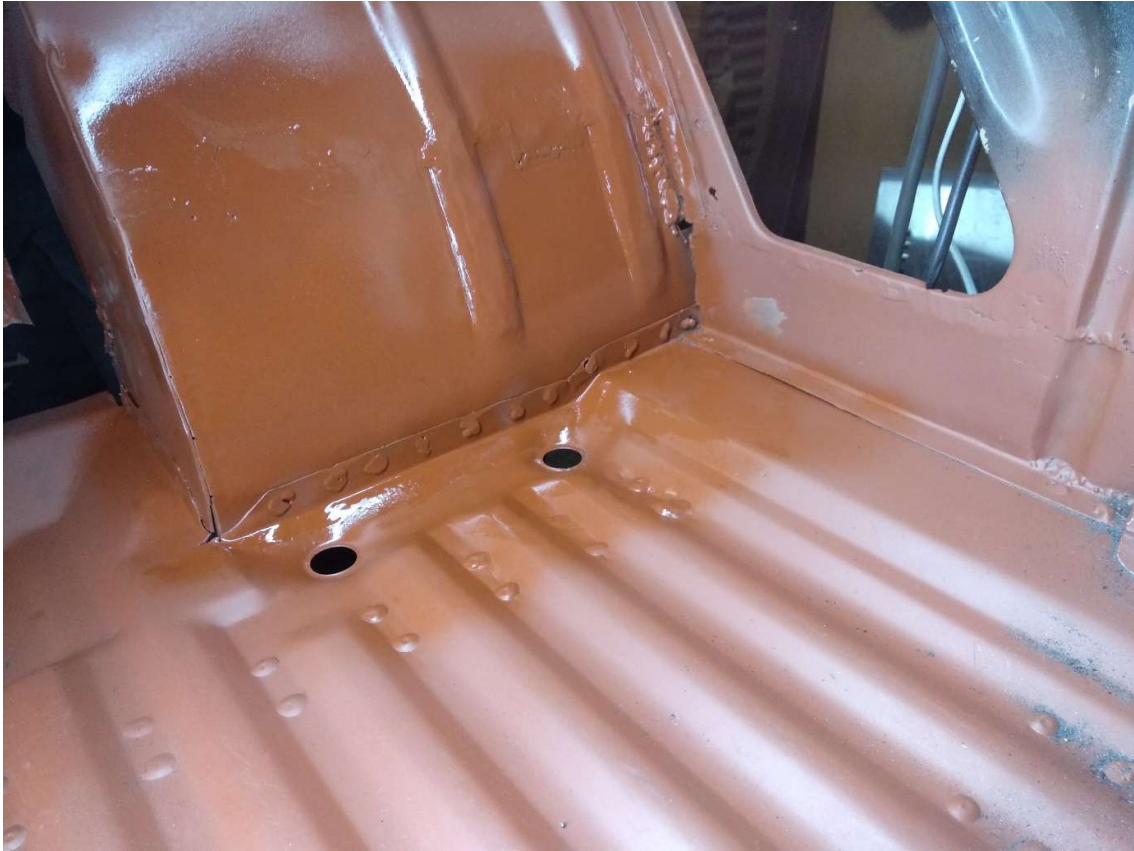
I knew that the C-post that separates the sliding door from the rear window was good down to nearly floor level and was entirely missing below that where it needs to join solidly to the middle sill. This is a structural piece and needs to be strong. Two pieces of roughly quarter circles were welded in and a cover bent around their outside was added. Very pleased with the results!
