Eric the Viking – a restoration in many parts – June 2023

Eric the Viking – a restoration in many parts – August 2023

Eric the Viking – a restoration in many parts – December 2023

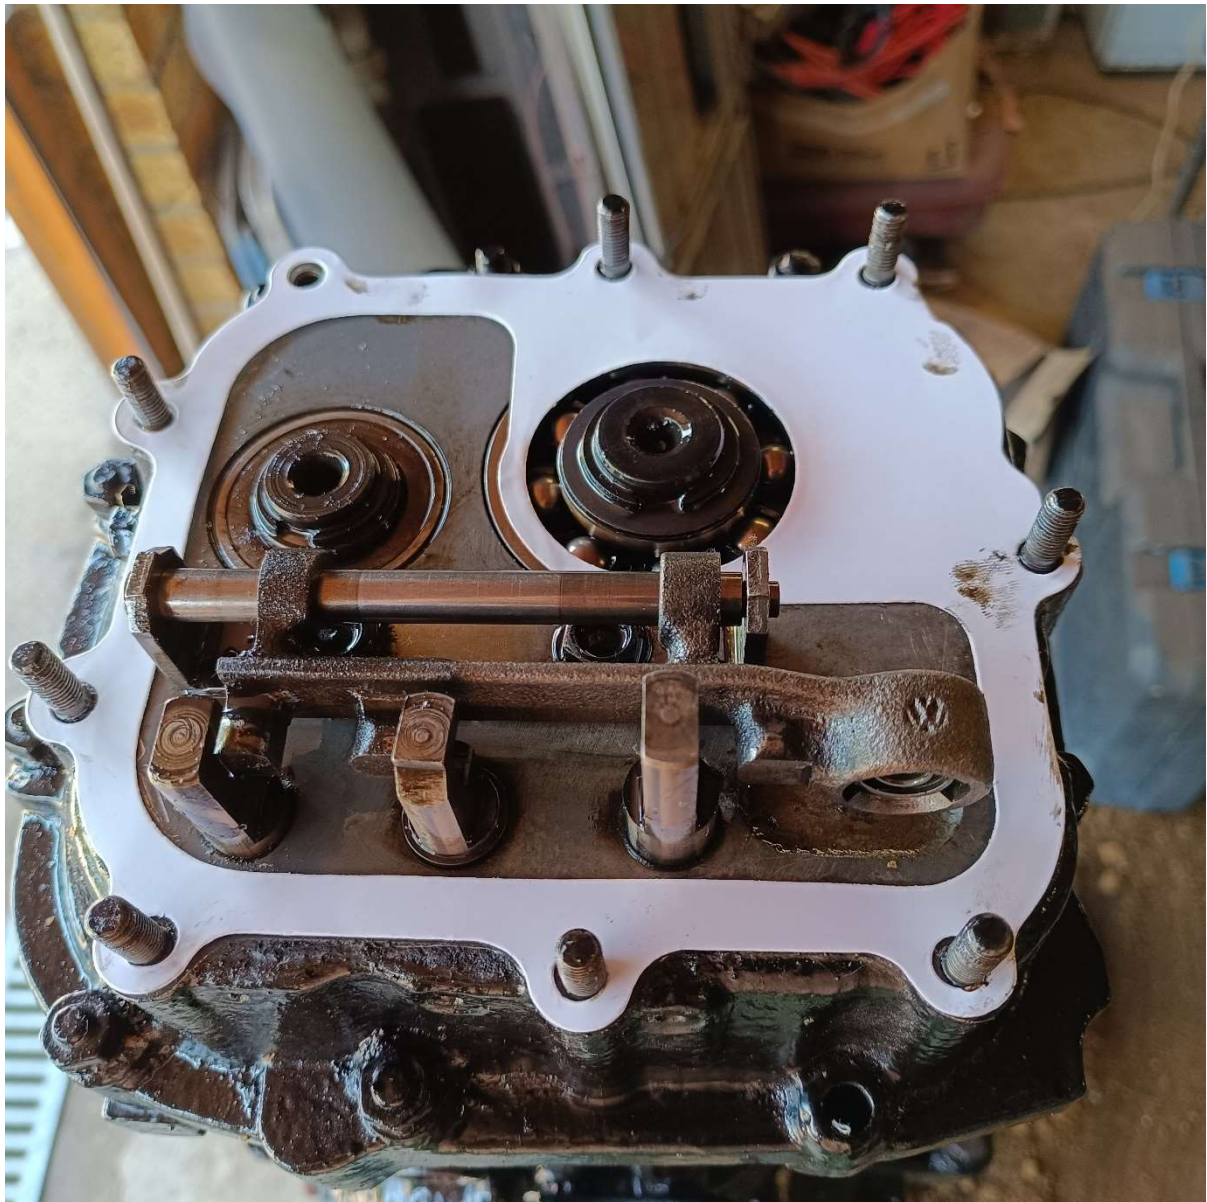
First, the easy job. Having mostly cleaned the outside of the gearbox last year, I did a final clean, then anti rust paint mainly as a habit. On top of that was primer and my preferred top coat of John Deere black paint. I also took the opportunity to take out the ends of the driveshaft section and clean behind, changed the gearbox oil and degrease the inside of the bell housing. As a word of warning – do not empty the oil from the gearbox until you can verify that the filler plug can be removed! With the gearbox on the bench, I also removed the

nose under guidance from the restoration manual and changed the gasket there that had perished and cleaned the “hockey stick” that operates the gears.

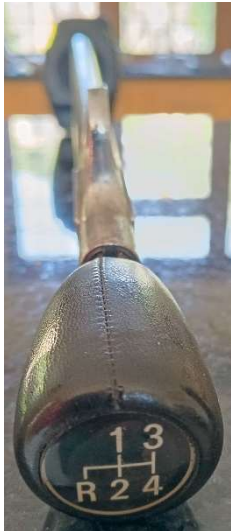
As part of the pedal work, I also cleaned the gear lever that was in the box with the pedals before adding a new gear lever knob. Eric came with an oddball gear lever extension that was about 18 inches longer than standard and a huge gear lever that looked like a golf club. That has been replaced with the gear knob from my old MGB GT that I sold 25 years ago and the knob has been in my toolbox ever since. The gear pattern is the same!

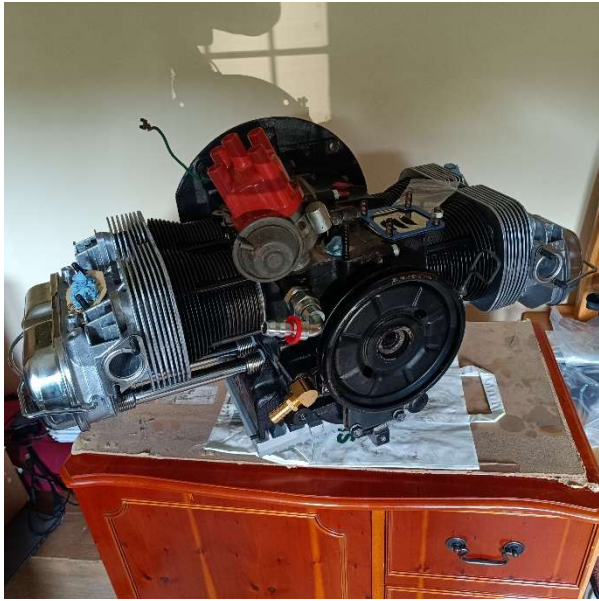
The big news however is that on the run home from the Golden Valley Vintage event in Herefordshire, we stopped in at Stateside Tuning at Moreton in Marsh and picked up Eric's engine from James. In summary, James has built me a 1776cc performance engine with a type 3 case and dynamically balanced crank, extra deep sump and external oil filter. He also supplied an air housing / doghouse suitable for a VW "The Thing" (Jeep like open vehicle) / Type 181 and a Type 4 oil cooler, as you get 20% more cooling. With the increase from 2.5 litres of oil to 4.5 litres and the increase in air cooling ability plus a properly built engine, I will hopefully be running nice and cool. It looks cracking.

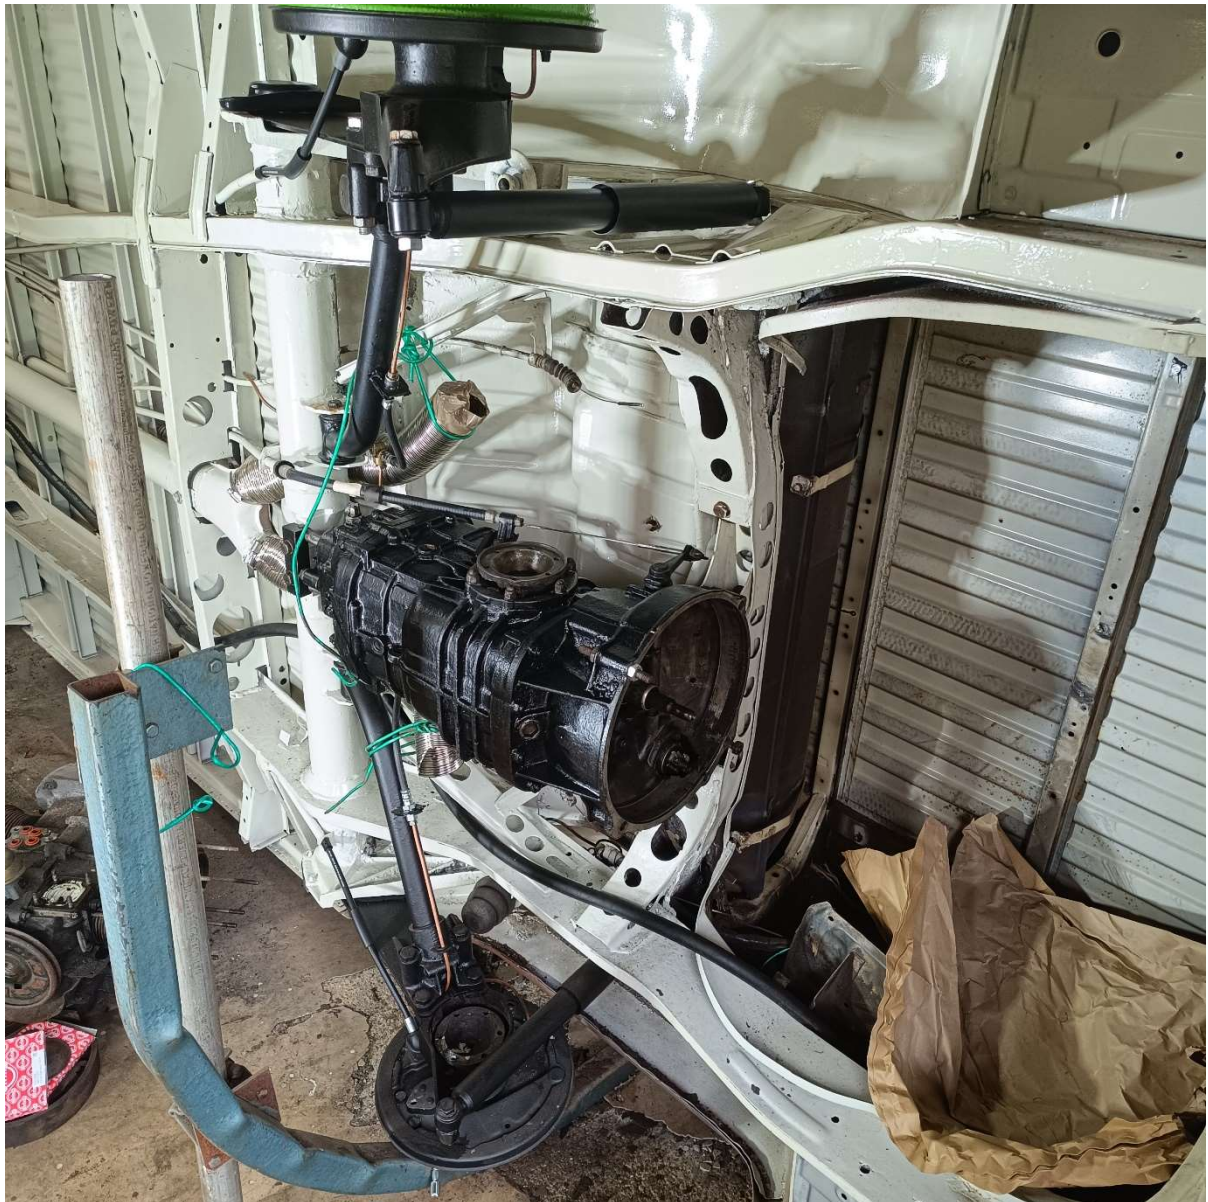
The front gasket was also changed since I had serviced everything in there and with assistance from my able assistant (my wife), the gearbox was mounted onto the chassis when Eric was on his side. Which is not easy!

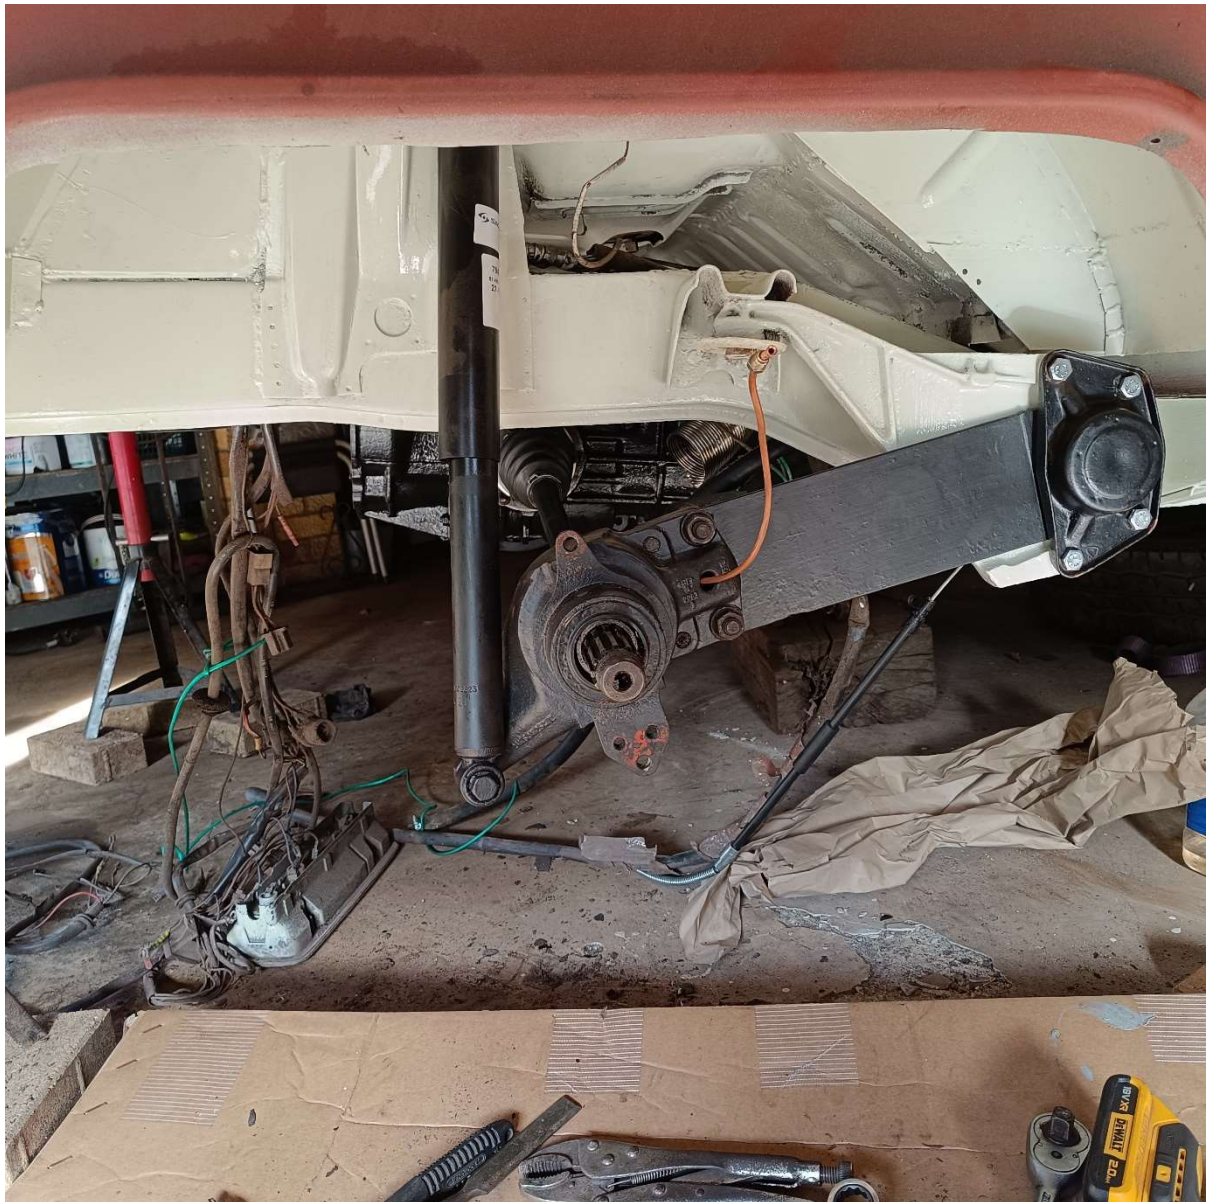
Tinware has been stripped for the engine and an impromptu clothesline affair put up for rustproofing and priming plus the inlet manifold and exhaust manifold were stripped as well. Then Eric was ready to go back on his wheels. This allowed some brilliant progress – the nose panel has been prepared and primed, the cab floor has been prepared.

As that was drying, the rear hubs and CV joints were cleaned, driveshafts built up and installed meaning that from the back wheel to the other back wheel is complete and painted. During assembly, there were a few areas in the rear wheelarch that were sub-standard and they received an extra coat of L90D pastel white paint which really makes it all look very smart against the black of the running gear.
